Service Action

Code: 91DC

91CZ

Subject Infotainment System Software Update

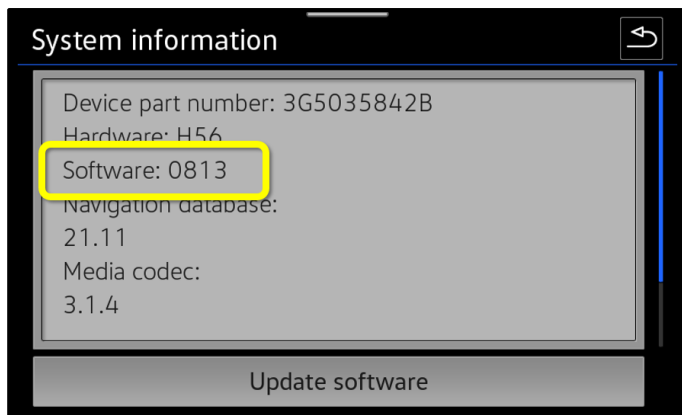
- Check the current software version.
 - Click Menu
 - Settings
 - System Information
- If software version is 0813 or higher:
 - No further work is required.
 - Proceed to Section D.
- If software version is lower than 0813:
 - MIB3 system requires updating.
 - Proceed to the next step.
- Open the hood.
- Open the battery cover.
- Switch the ignition on.
- Apply the parking brake.
- Switch off all consumers (headlights, heated seats, climate control, etc.).
- Attach the GRX3000VAS Tester/Charger (or equivalent) IN POWER SUPPLY MODE to the vehicle battery.
