QUALITY ACTION

Engine Control Module (ECM) Reprogram Dealer Inventory

Reference: PC863
Date: January 19, 2022

PC863 – 2022 FRONTIER ECM REPROGRAM

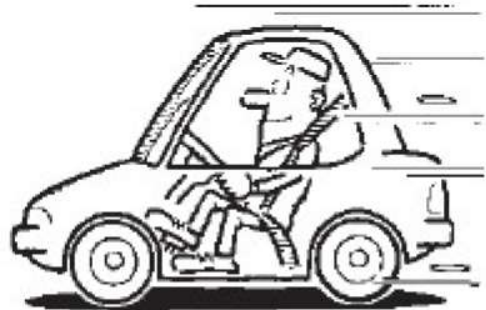
Figure A

- Most instructions for reprogramming with CONSULT-III plus (C-III plus) are displayed on the CONSULT PC screen
- Take the vehicle for a 10 minute drive in order to meet the following Idle Air Volume Learn (IAVL) conditions:
 - Engine coolant temperature: 70 -100°C (158 - 212°F)
 - Battery voltage: More than 12.9V (At idle)
 - Transmission: Warmed up
- After reprogramming is complete, you will be required to perform Throttle Valve Closed Position, Idle Air Volume Learn, Accelerator Closed Position, and DTC erase.

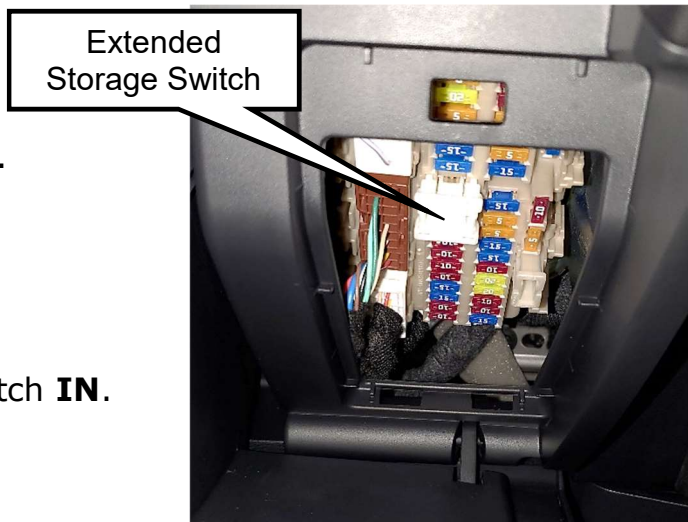
Figure 1

1. Verify the extended storage switch is pushed **IN** (Figure 1).

- a. Turn the ignition OFF.
- b. Open the passenger front door.
- c. Open the glove box.
- d. Remove the fuse panel cover.
- e. Push the extended storage switch **IN**.
- f. Wait at least 2 seconds.
- g. Turn the ignition ON.
- h. Make sure the extended storage warning message is **not** displayed in the combination meter/display.

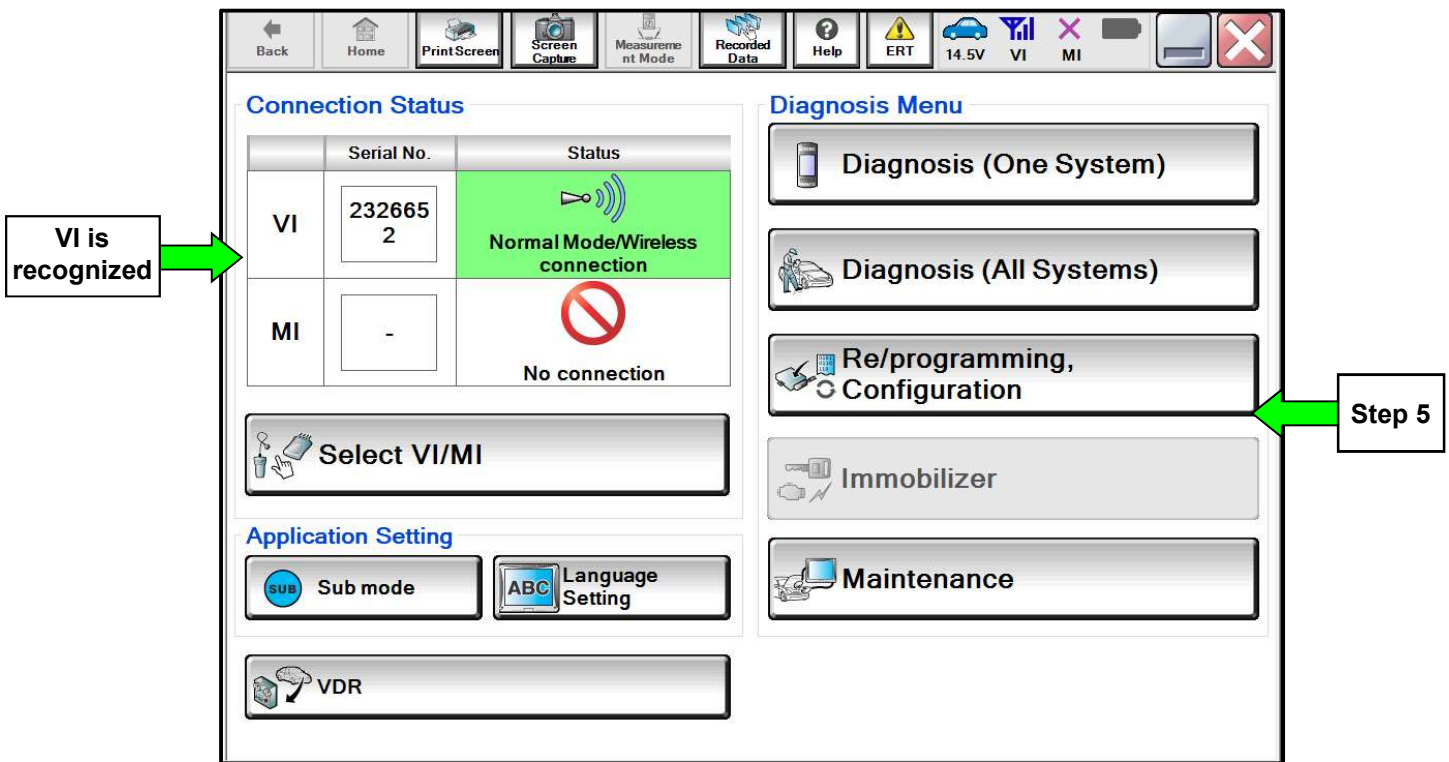
Figure 2

2. Connect the CONSULT PC to the vehicle to begin the reprogramming procedure.
3. Start C-III plus.
4. Wait for plus VI to be recognized/connected.
 - The serial number will display when the plus VI is recognized/connected
5. Select Re/programming, Configuration.

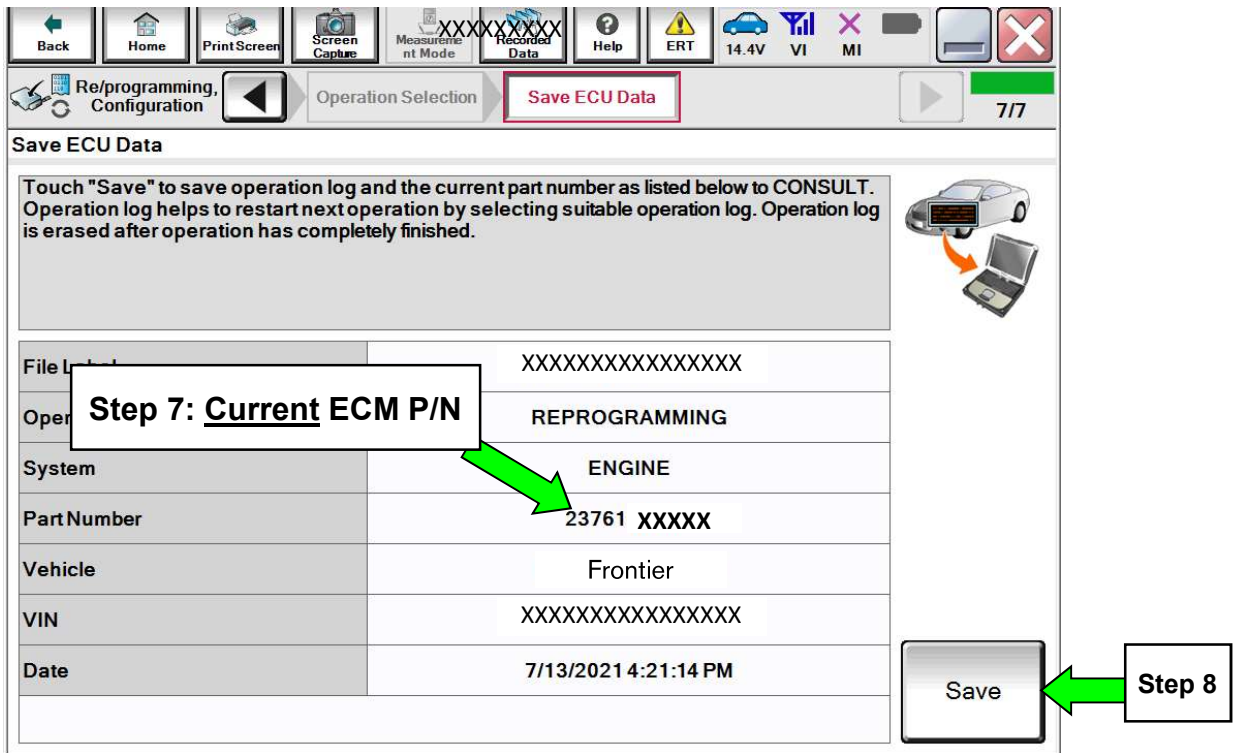
6. Follow the on-screen instructions and navigate the C-III plus to the screen in Figure 3.

7. Write the current ECM Part Number shown in Figure 3 on the Repair Order.

8. Compare the P/N you wrote down to the numbers in the Current ECM Part Number column in Table A, below.

- If there is a match, this service procedure applies. Continue with the reprogramming procedure by selecting **Save**.
- If there is not a match, reprogramming is not needed or it has already been done. Refer to Service COMM to confirm this campaign applies to the vehicle you are working on.

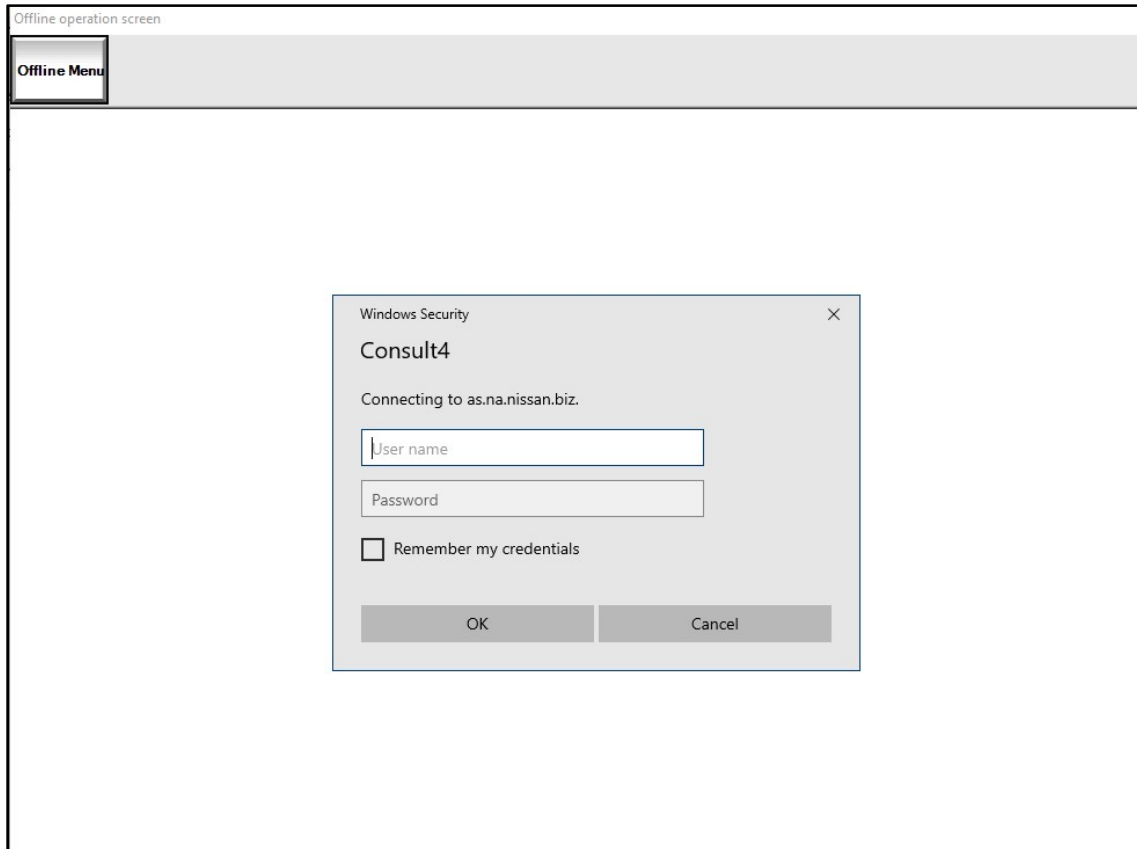
Figure 4

9. Follow the on-screen instructions to navigate C-III plus and reprogram the ECM.
- Before reprogramming will start, you will be required to enter your User Name and Password.
 - The CONSULT PC must be connected to the Internet (Wi-Fi or cable).
 - If you do not know your User Name and Password, contact your Service Manager.

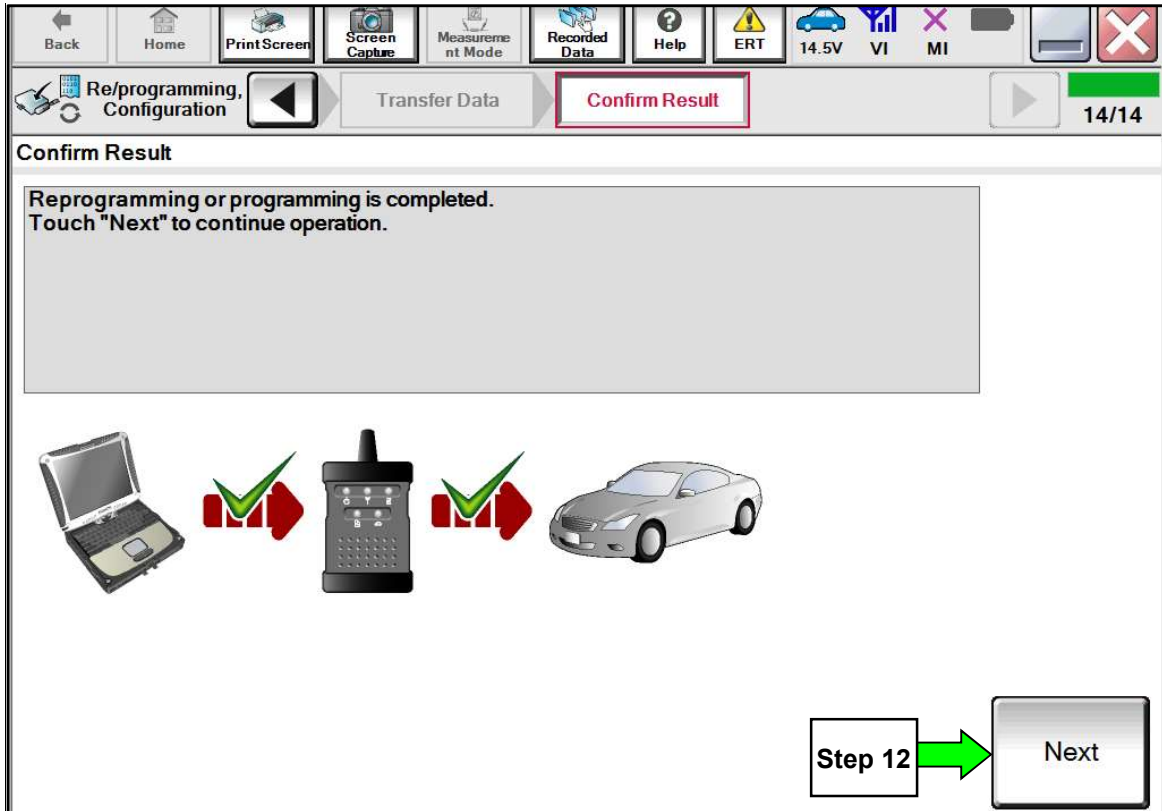
10. When the screen in Figure 5 displays, reprogramming is complete.

NOTE: If the screen in Figure 5 does **not** display (reprogramming did not complete), refer to the ECM Recovery information on Page 8.

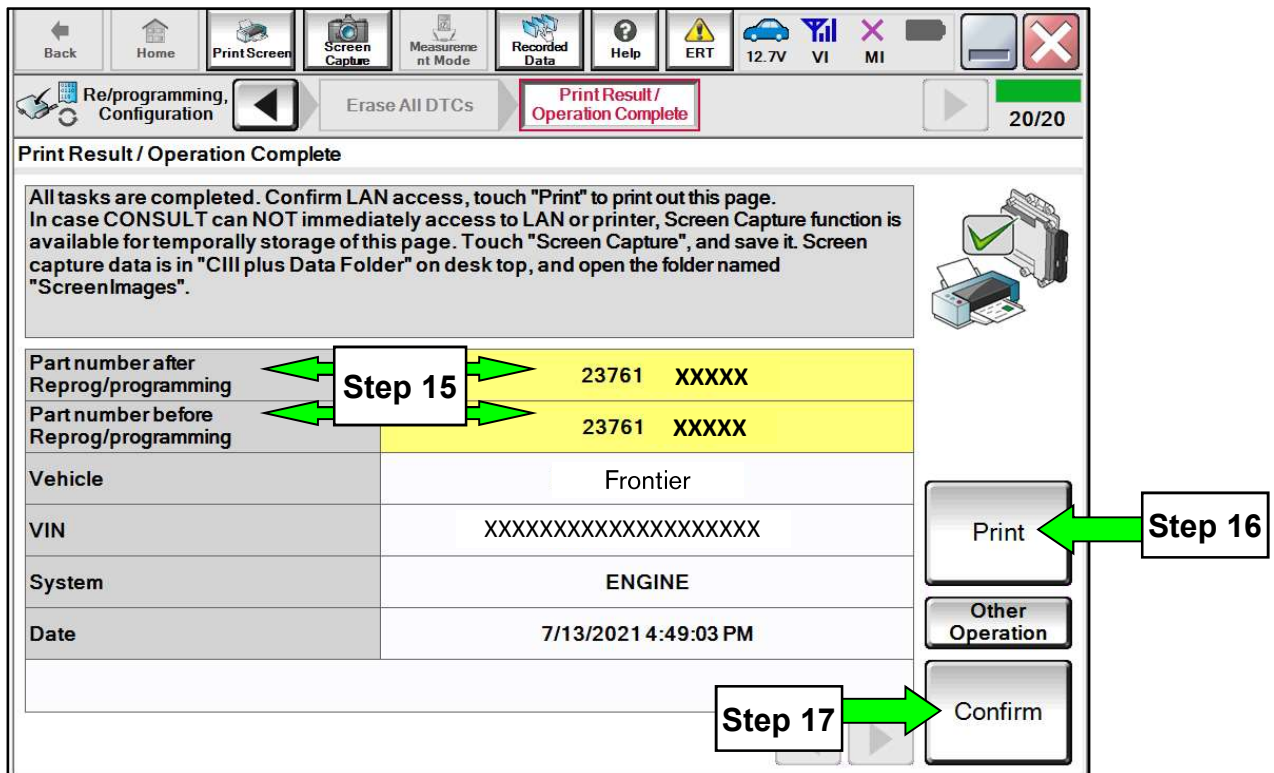
14. When the entire reprogramming process is complete, the screen Figure 6 will display.

15. Verify the before and after part numbers are different.

16. Print a copy of this screen (Figure 6) and attach it to the repair order for documentation.

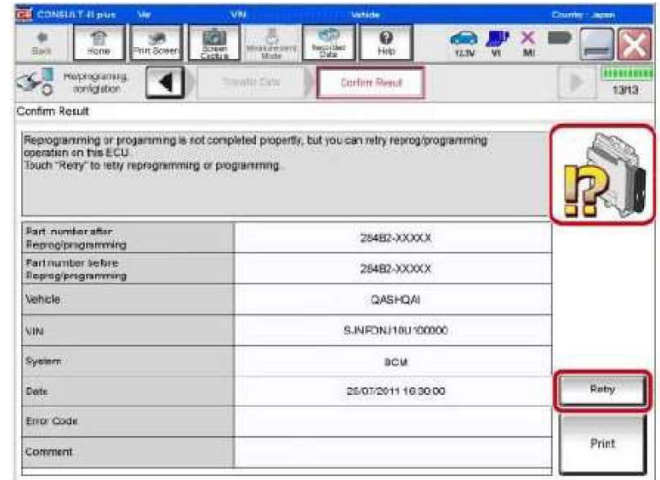
Figure 7

If reprogramming does not complete and the “!?” icon displays as shown in Figure 7:

- Check battery voltage (12.0–15.5 V)
- Ignition is ON, engine OFF
- External Bluetooth® devices are OFF
- All electrical loads are OFF
- **Select retry and follow the on screen instructions**
- “Retry” may not go through on first attempt and can be selected more than once

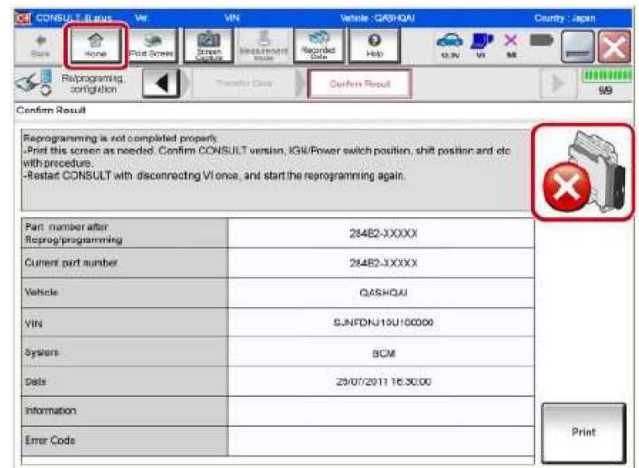
Figure 8

If reprogramming does not complete and the “X” icon displays as shown in Figure 8:

- Check battery voltage (12.0 – 15.5 V)
- CONSULT A/C adapter is plugged in
- Ignition is ON, engine OFF
- Transmission is in Park
- All C-III plus / VI cables are securely connected
- All C-III plus updates are installed
- **Select Home, and restart the reprogram procedure from the beginning**
