# Audio Head Unit Software Update (Panasonic)

**Service Category** Audio/Visual/Telematics

**Section** Navigation/Multi Info Display

## Audio Head Unit Software Update (Panasonic)

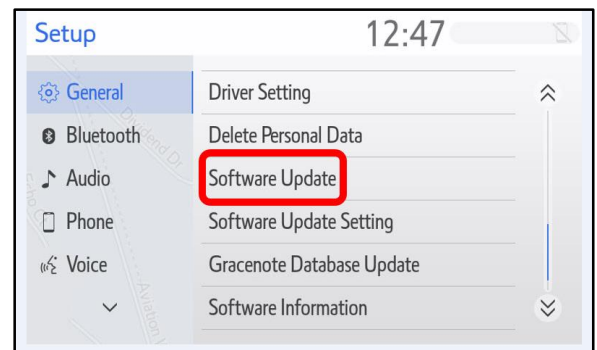
**Figure 3.**

4. Scroll down and select Software Update.

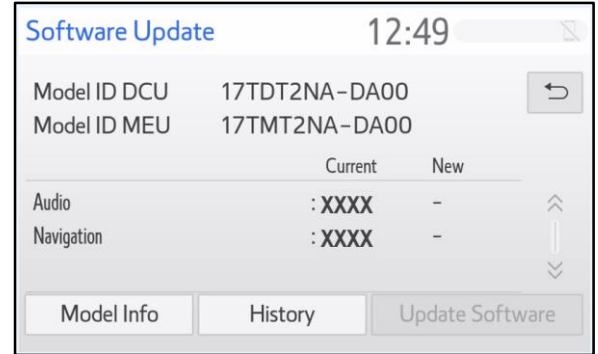
**Figure 4.**

- Verify that the software version is the same or earlier as indicated in the Introduction.

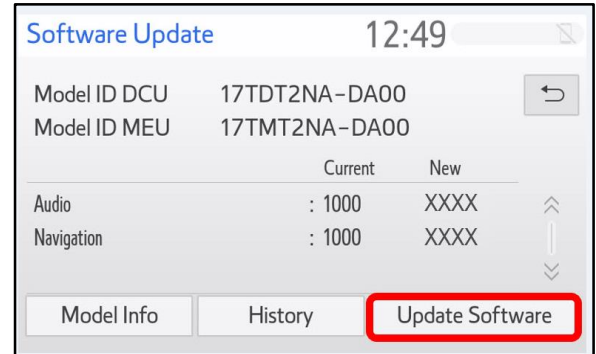
**Figure 6.**

9. Press the Update Software button in the lower right-hand corner.

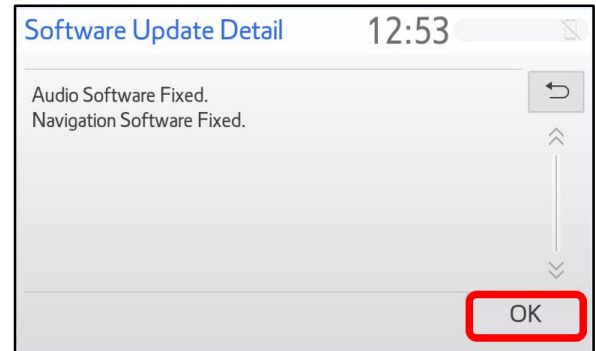
**Figure 7.**

10. Select OK on the Software Update Detail screen.

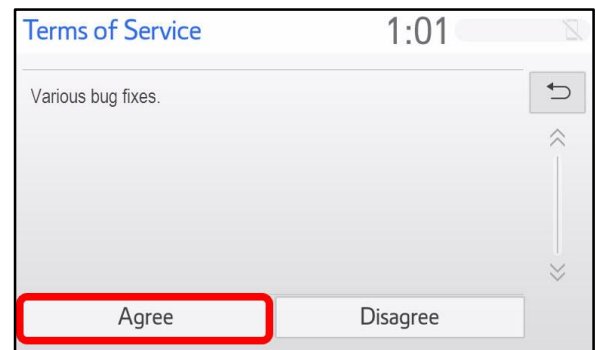
**Figure 8.**

11. Select Agree on the Terms of Service screen.

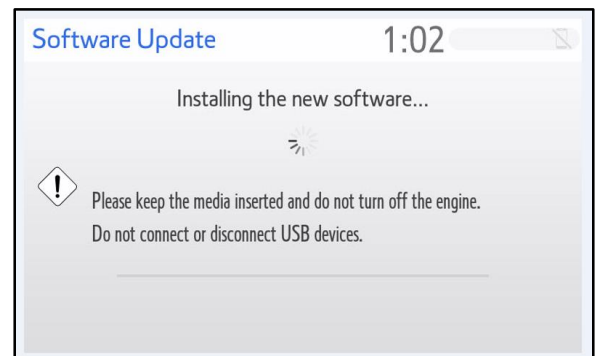
**Figure 10.**

13. Once the head unit begins installation, the update will take about 10 minutes.

- Do NOT turn OFF the engine or ACC BEFORE the software is ready for updating.
- Do NOT remove the USB flash drive out of the vehicle USB port before the software is ready for updating.

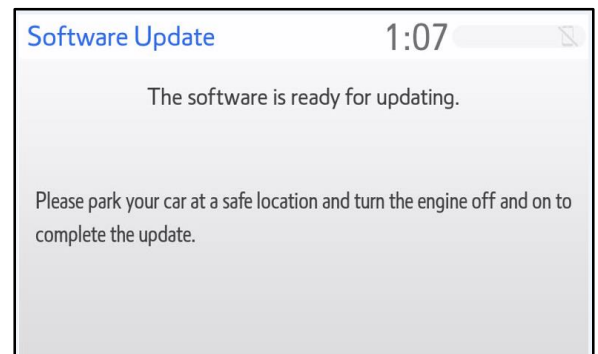
**Figure 11.**

14. When “The software is ready for updating” screen appears, turn the engine OFF.

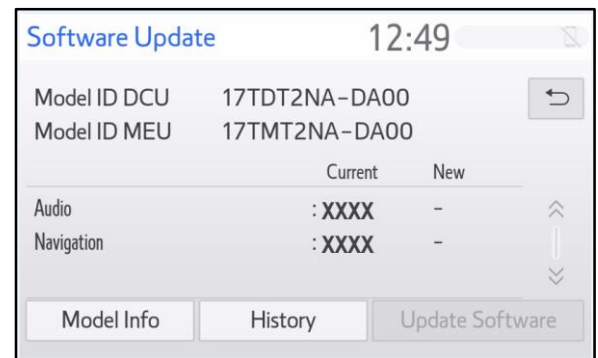
**Figure 12.**

17. Perform steps 1 – 4 to verify that the software version matches the current Software Version Information table below.
