Parking Sensor Software Update

AFFECTED VEHICLES

SYMPTOM

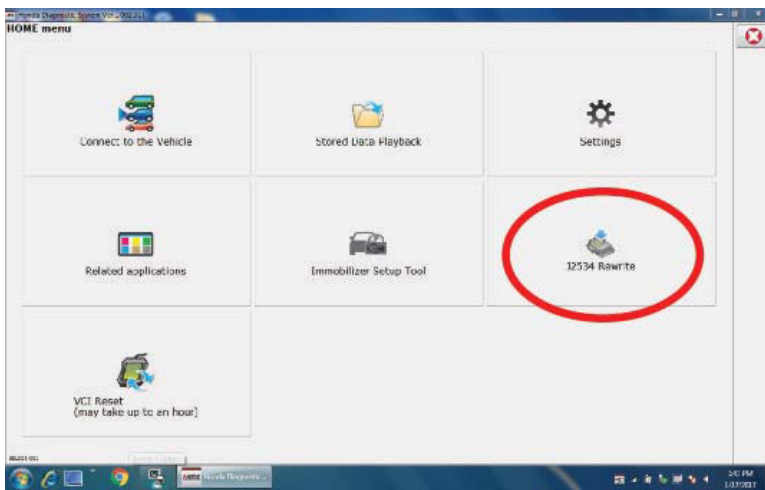
2. From the HOME menu, select the **J2534 Rewrite**.

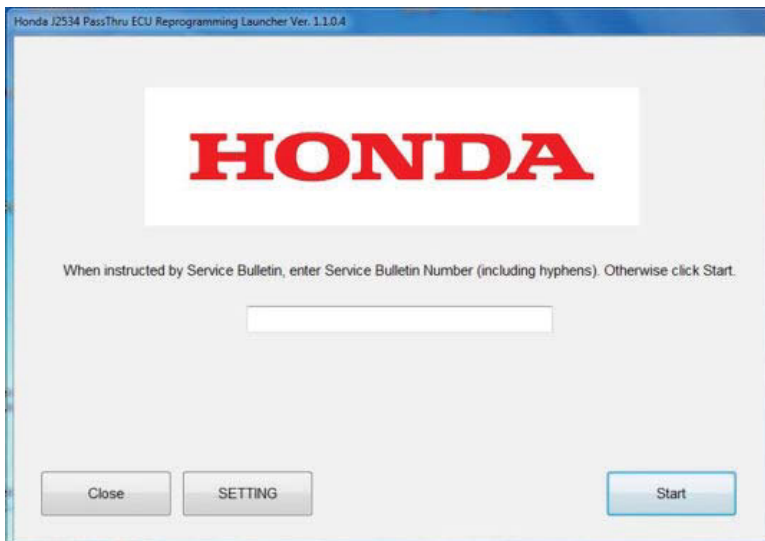
3. When prompted select **Start**, do not enter a service bulletin number.

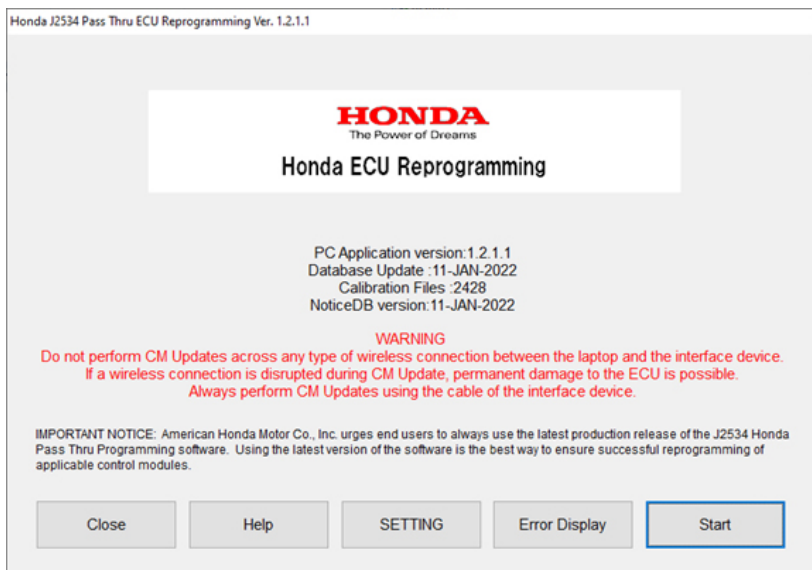
4. Connect the i-HDS to the vehicle and select **Start** to begin reprogramming.

Use a battery booster while reprogramming the vehicle.
Press ENTER.

1. Connect the PC to the Pass-thru device.
2. At the vehicle, turn the ignition switch ON(II), then connect the pass-thru device to the vehicle's SAE J1962 connector (DLC).
3. Click Next to continue.

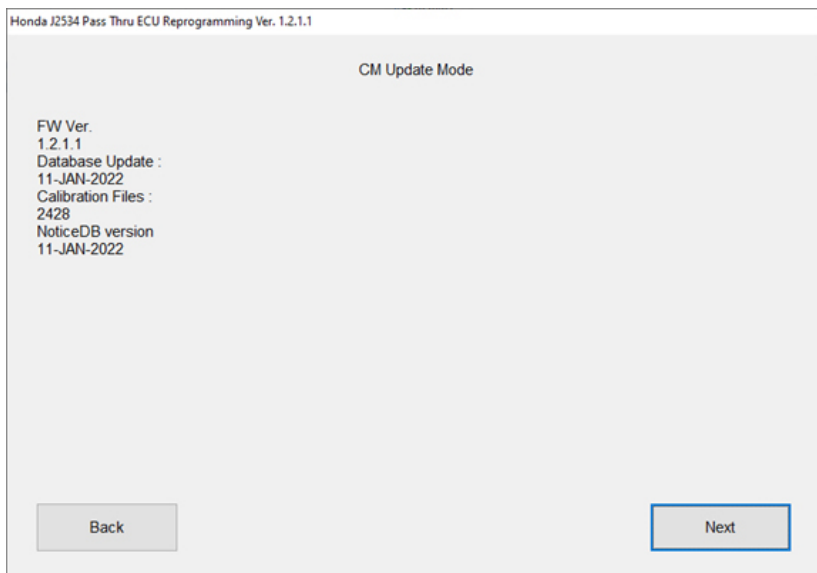
5. Follow the screen prompts, then select **Next**.

Honda J2534 Pass Thru ECU Reprogramming Ver. 1.2.1.1

VIN & Repair Order

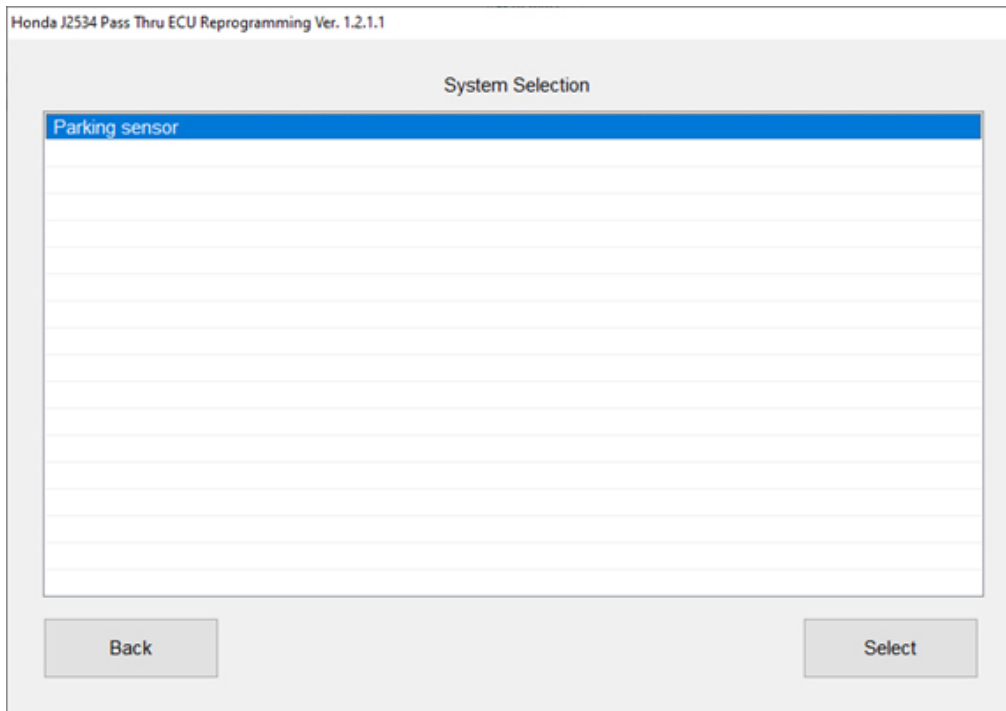
7. Select the **PARKING sensor**, and then **Select**.

NOTE: Wait until vehicle communication has completed.

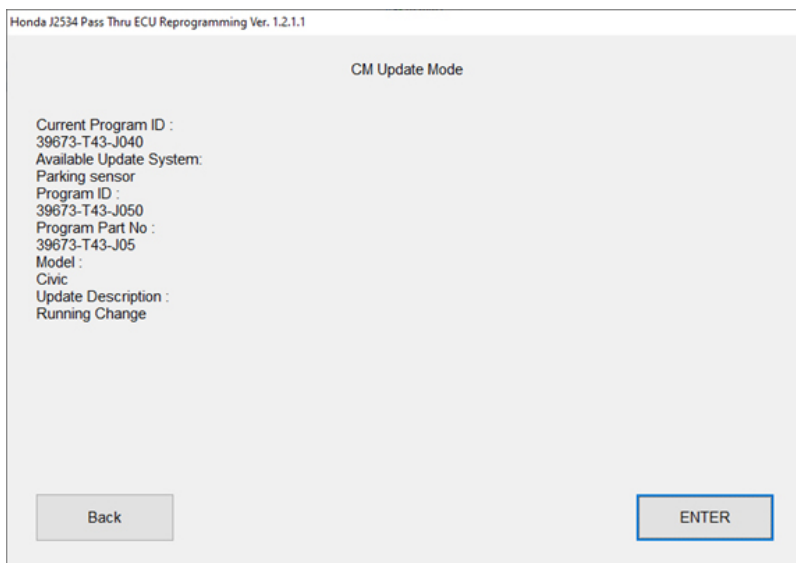
8. Confirm the update information, then select **ENTER** to start reprogramming.

CM Update Mode

Press the "ENTER" button to start the Control Module Update.

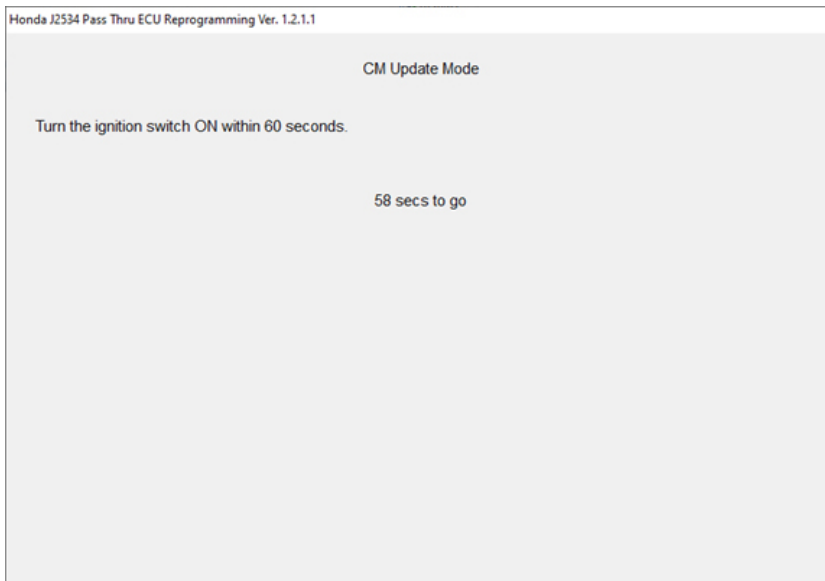
Programming...
Do not turn off the ignition switch.
70%

CM Update Mode

Parking sensor
Completed.
Turn the ignition switch OFF.

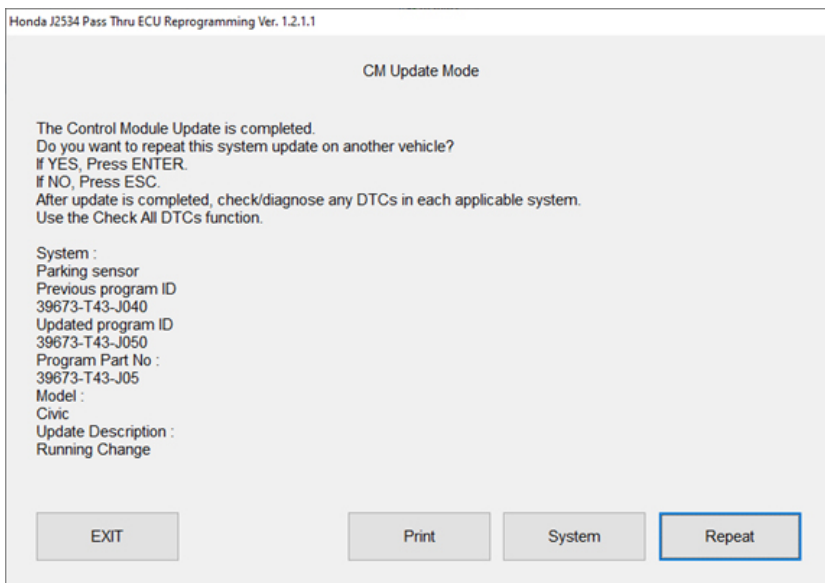
Once the module is updated, the following screen appears.

9. Code B2600-96 will be stored after the update. To clear, carefully follow the iN procedure under Resetting the Parking and Back-up Sensor Control Unit. When complete. Press and hold the power switch to OFF.
10. Do an ALL DTC Check to clear any codes that may have set during the update.
11. Check that the front and rear parking sensors are functioning correctly.
