February 18, 2022

Version 1

## Emissions Recall: 2021-22 TLX Type S PGM-FI Software Update

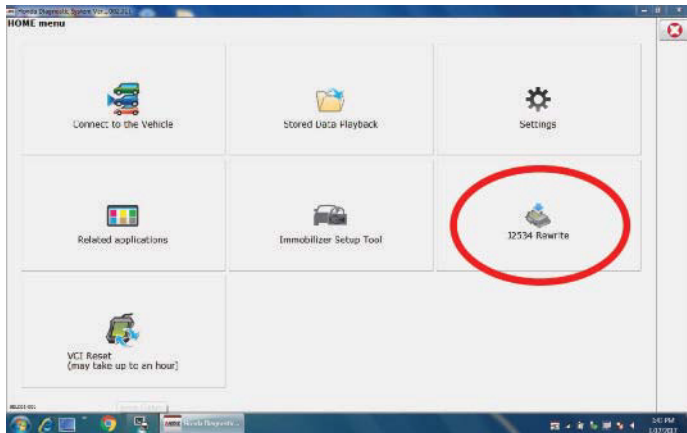
2. From the HOME menu, select the **J2534 Rewrite**.

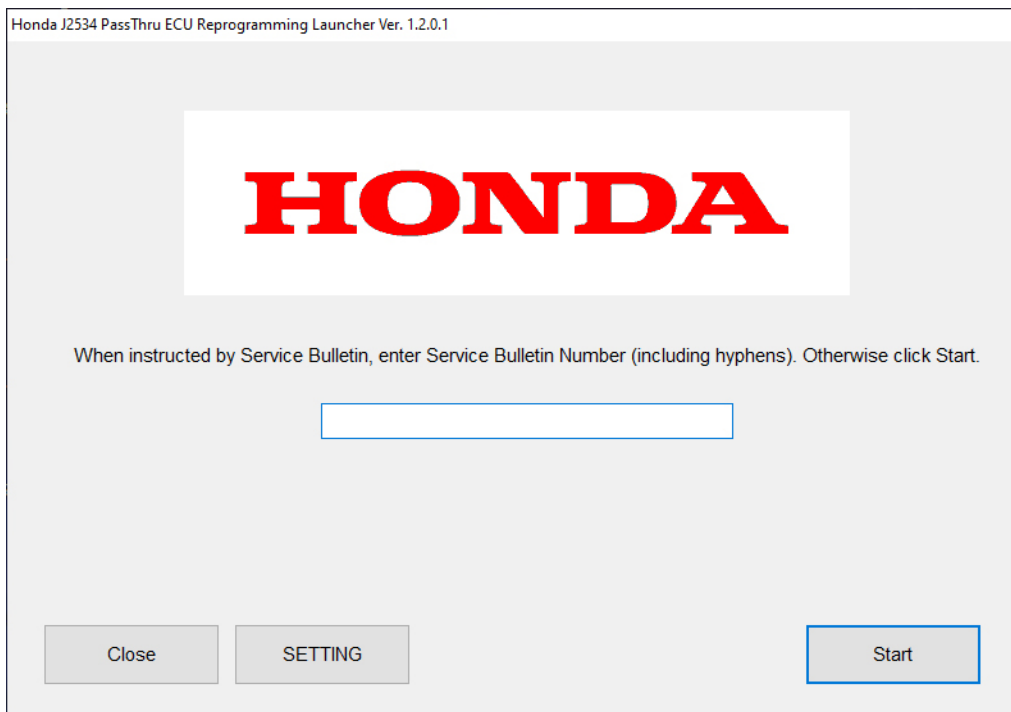
3. When prompted select **Start**, do not enter a service bulletin.

NOTE: Under certain conditions the **HOME menu** screen may come up. If it does, just minimize it to show the screen under it.

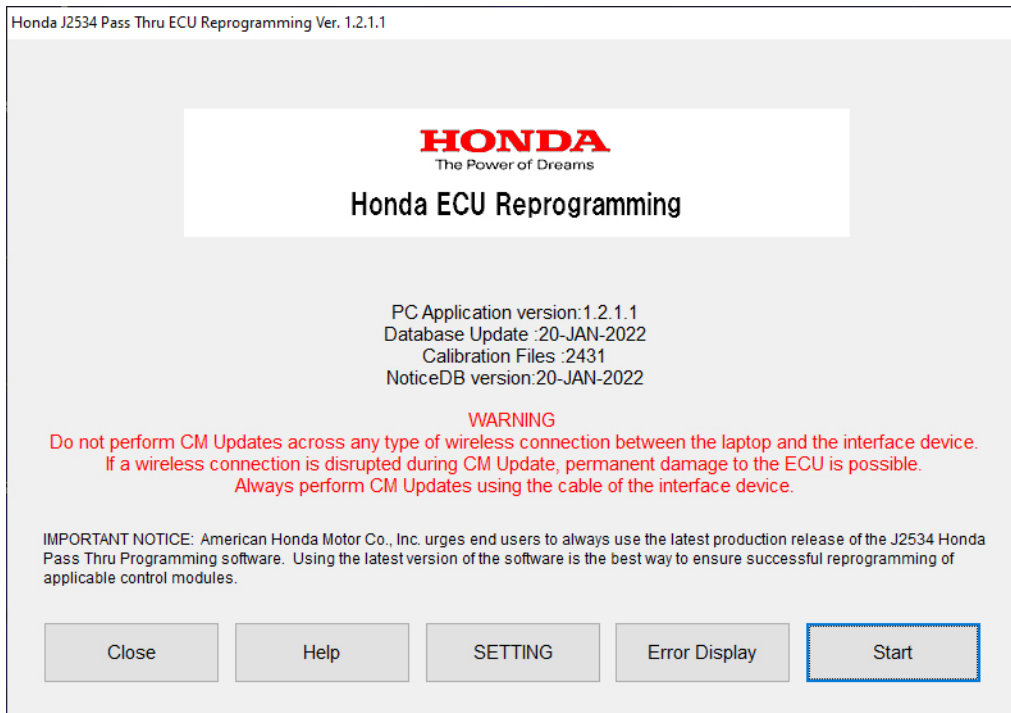
4. Connect the i-HDS to the vehicle and select **Start** to begin reprogramming.

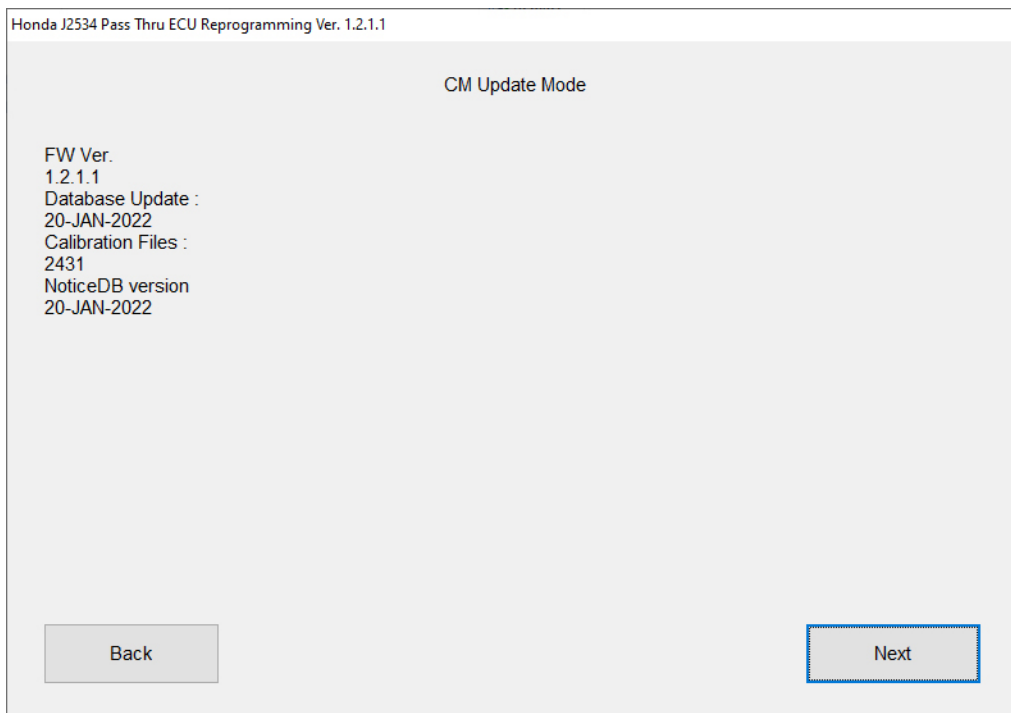
5. Follow the screen prompts, then select **Next**.
