August 2021
SF622A
SECOND REVISED NOTICE

Subject: Cascadia/49X ABS MBSP+ Controller Software Update

Models Affected: Specific Model Year 2019-2022 Freightliner Cascadia, and Western Star 49X vehicles, manufactured September 12, 2018, through March 22, 2021.

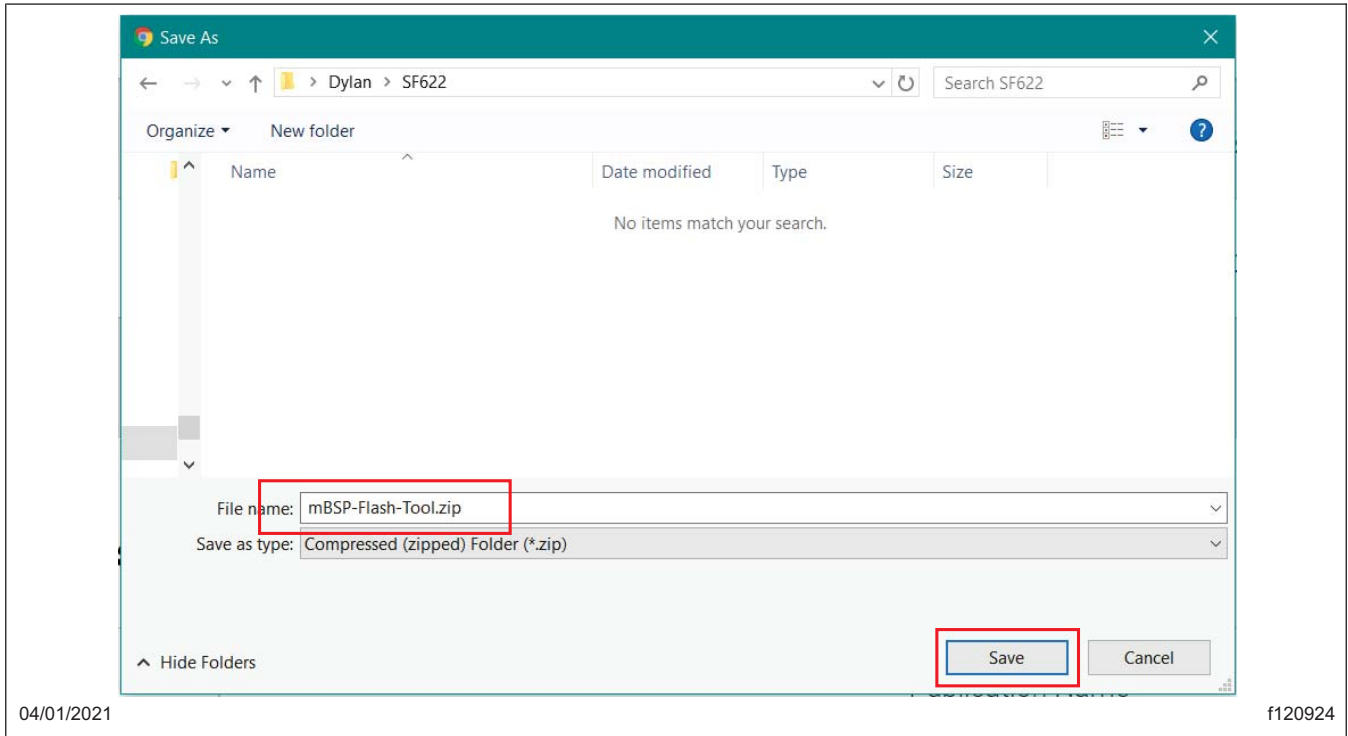
Fig. 5, Saving mBSP Flash Tool Package

5.3 Save the 'mBSP-Flash-Tool.zip' file to a location on the local hard drive. See [Fig. 5](#).

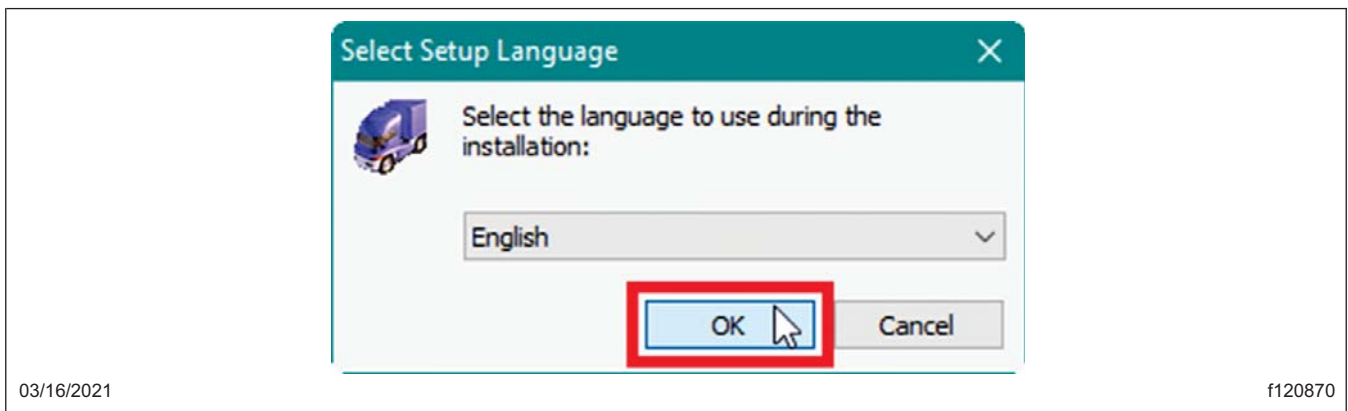
Fig. 10, Language Selection

- 7.4 When asked to 'Select Setup Language,' choose English and select 'OK.' See [Fig. 10](#).

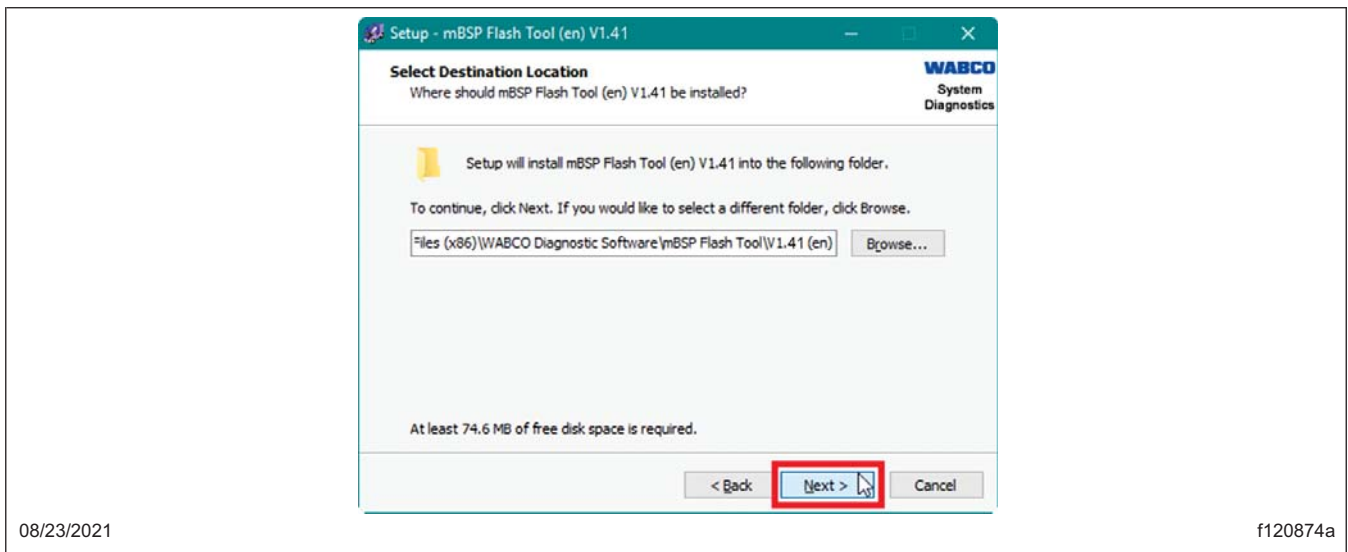
Fig. 14, Selecting the Destination Location of the mBSP Flash Tool

7.8 The 'Select Destination Location' window will appear. Verify the destination and select 'Next.' See [Fig. 14](#).

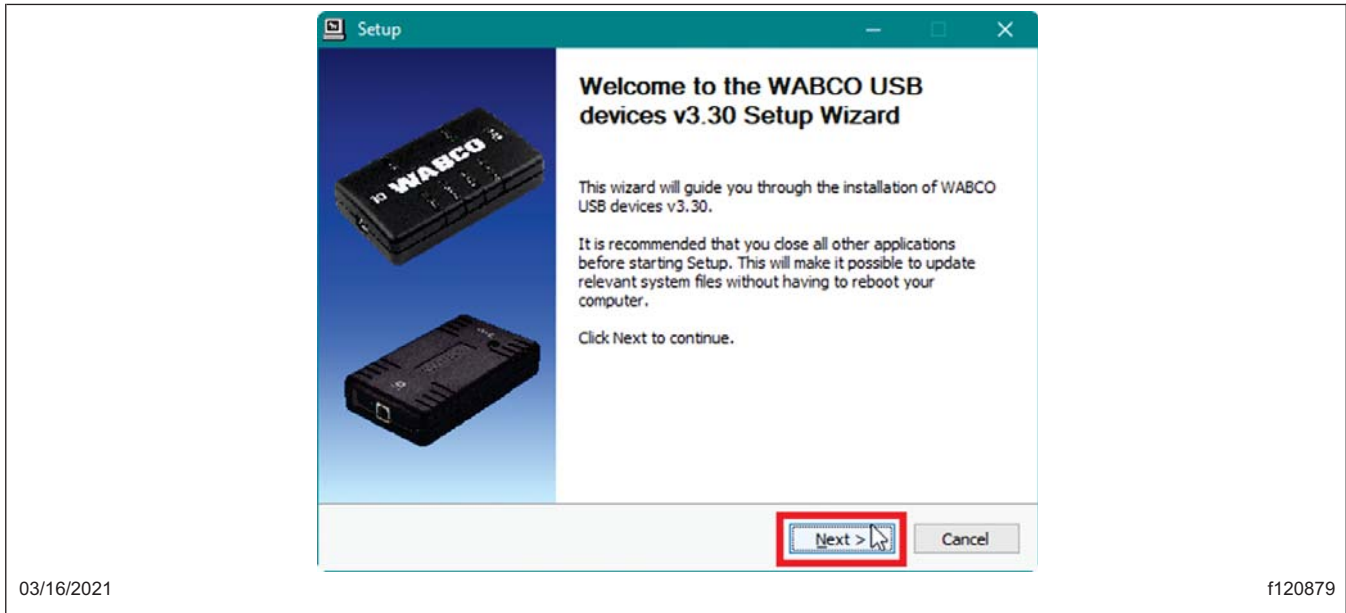
Fig. 19, WABCO USB Devices Setup Window

7.13 The setup program will install the mBSP Flash tool. At the 'Welcome to the WABCO USB devices Setup Wizard' window, select 'Next.' See [Fig. 19](#).

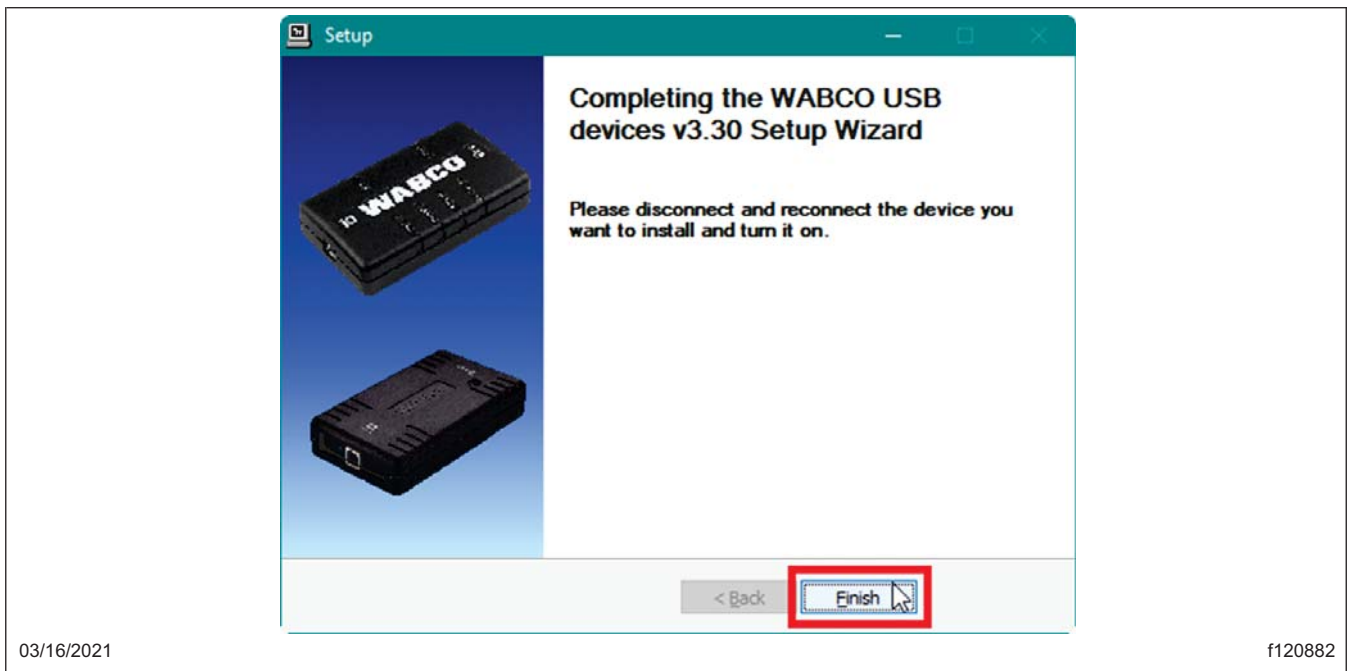
Fig. 22, Completing the WABCO USB Setup Wizard

7.16 In the next window: 'Completing the WABCO USB devices Setup Wizard,' select 'Finish.' See [Fig. 22](#).

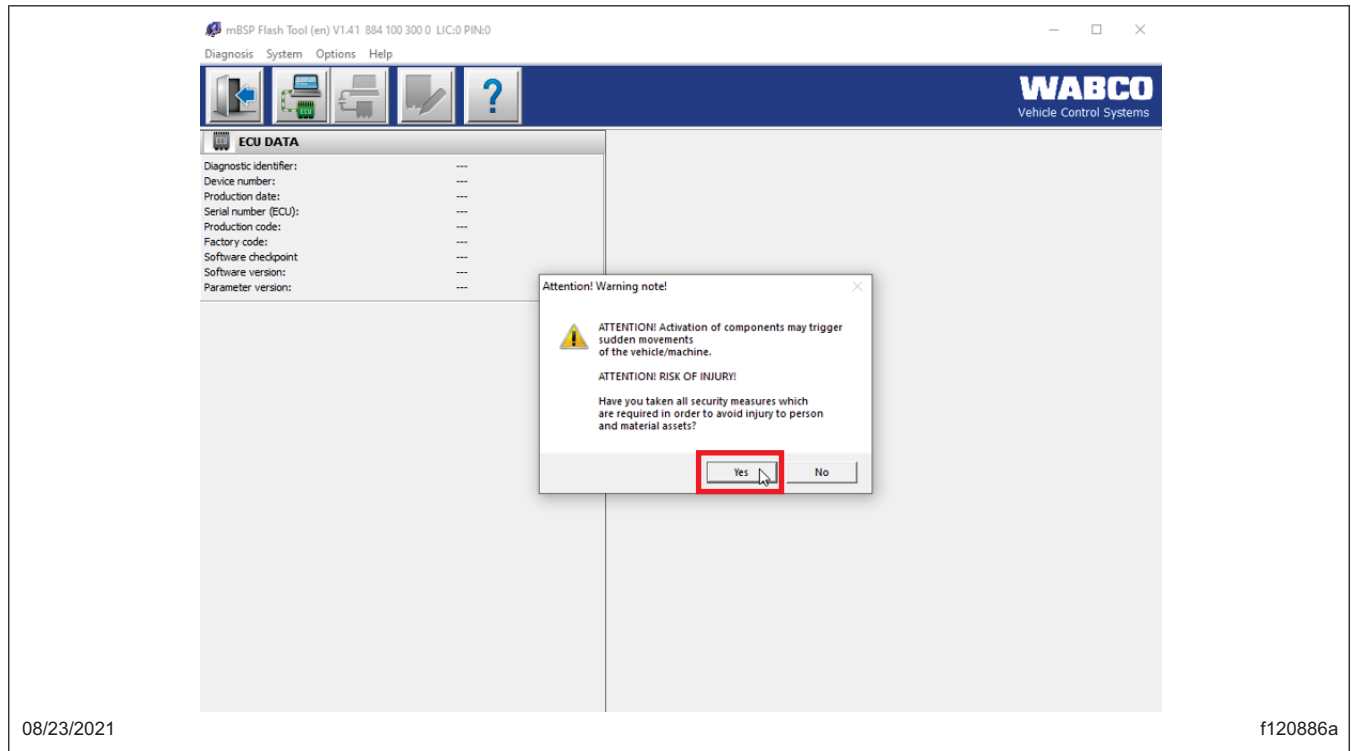
Fig. 26, Accepting the Warning

11. The program will open with a warning note. See [Fig. 26](#). Read the warning note. If the vehicle is secure, select 'Yes.'

IMPORTANT: The ECU may not connect automatically due to wrong adaptor settings. To make sure correct adaptor settings are selected, go to 'Options,' 'Settings,' 'Change port.'

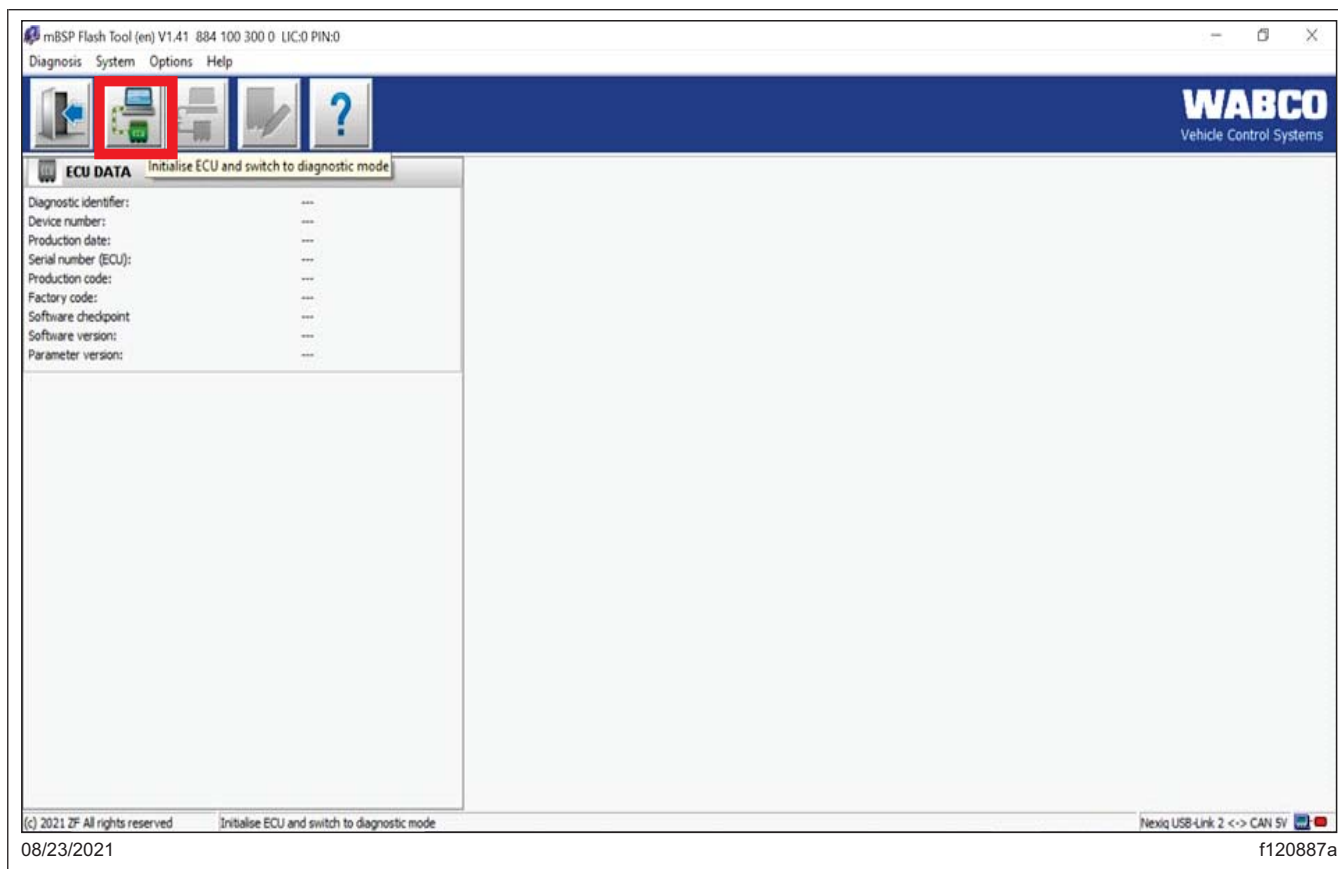
Fig. 27, Initialize ECU and Switch to Diagnostic Mode

12. If the ECU does not automatically connect, select the button in [Fig. 27](#) 'Initialize ECU and switch to diagnostic mode.'

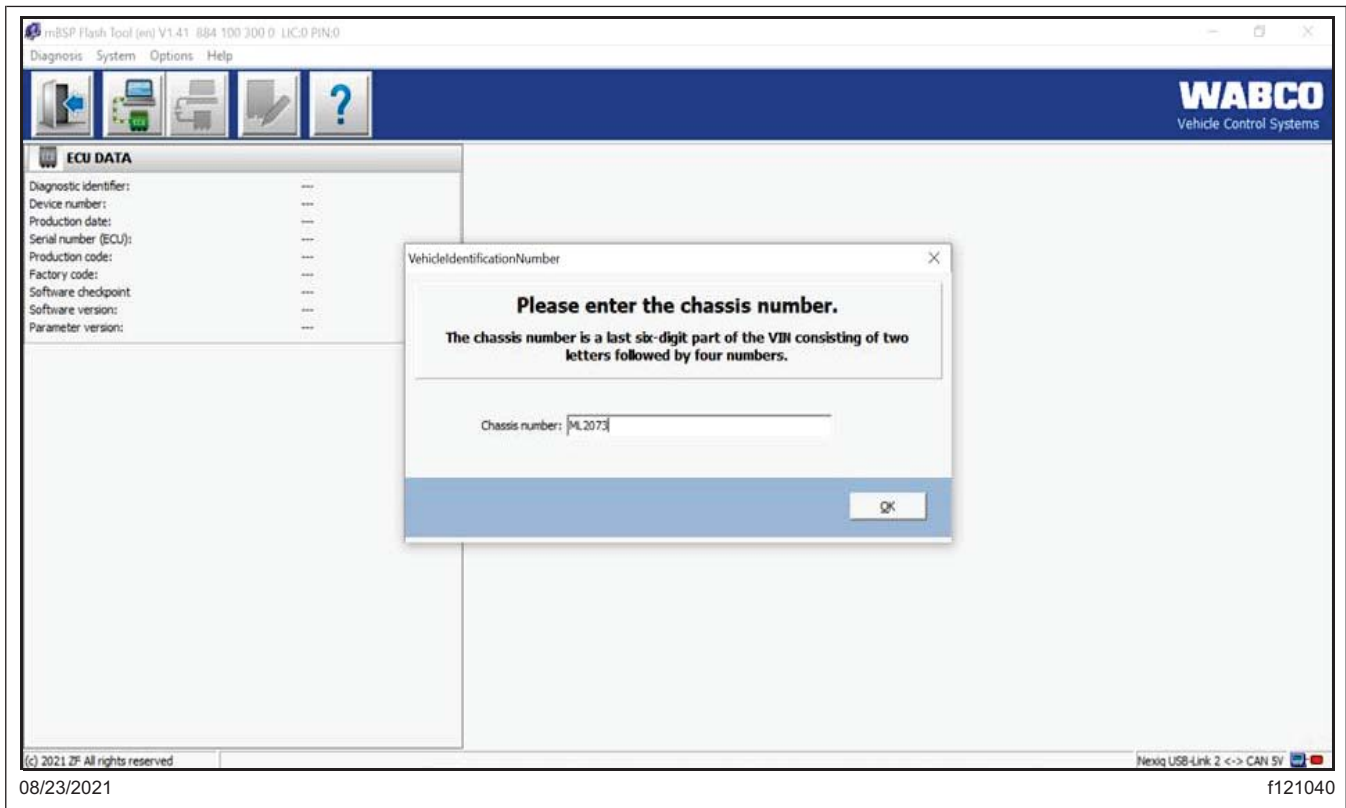
Fig. 28, Entering the Chassis Number

13. A window will now open, requesting the chassis number to be entered. Enter the vehicle chassis number. See [Fig. 28](#).

NOTE: The chassis number is the last six-characters of the VIN which consists of two letters followed by four numbers (also known as serial number).

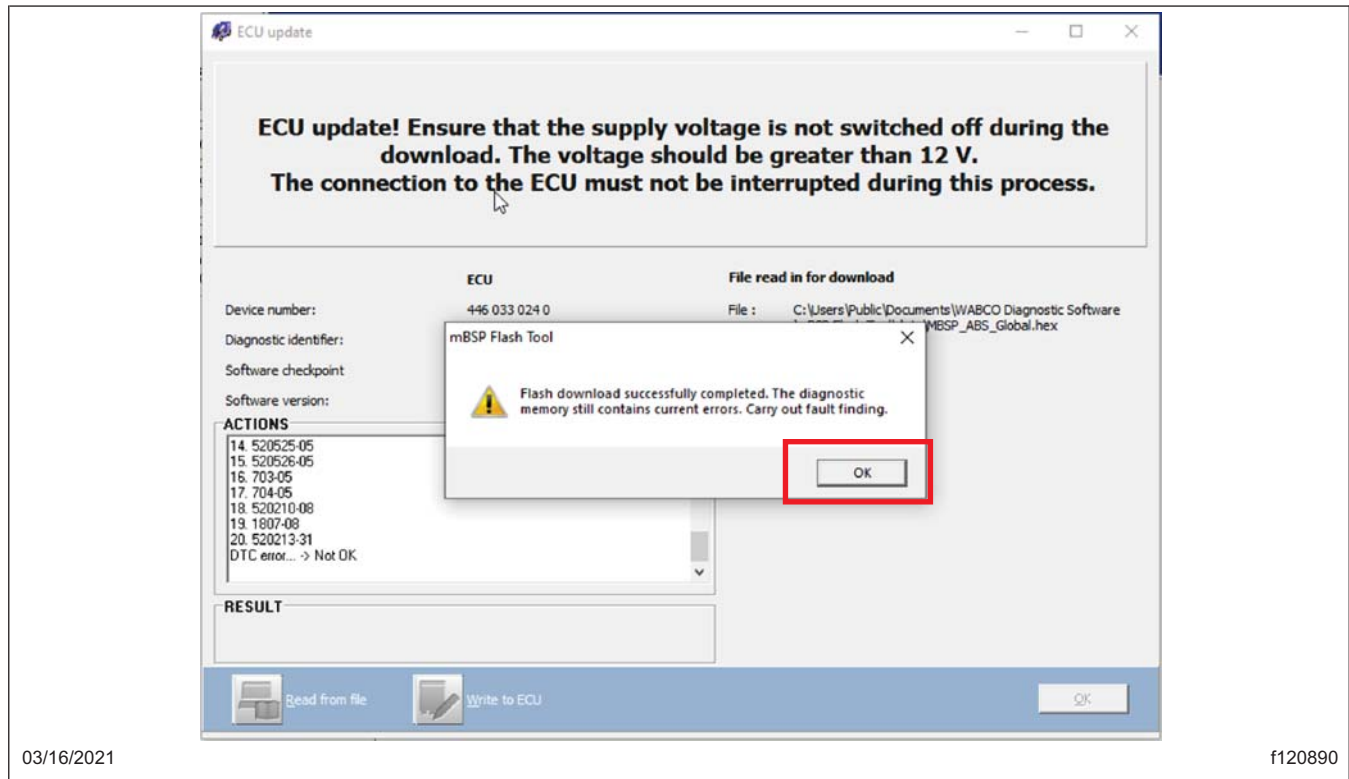
Fig. 31, Carrying Out Fault Finding

NOTE: ESC calibration will be required after the flashing process is complete.

16. Once the ECU update is complete, some ECU errors may be present. Select 'OK' and close out of the flash tool and start the calibration mode. See [Fig. 31](#).

17. The ABS ECU is now in ESC calibration mode. Complete the driving portion of the End of Line (EOL) procedure. After approximately 100 yards of straight-line driving, and then a 90 to 180 degree turn is recorded by the ABS ECU, the stability lamp on the dash will turn off.
18. Perform a key cycle that completes a truck sleep cycle to save the calibration data.

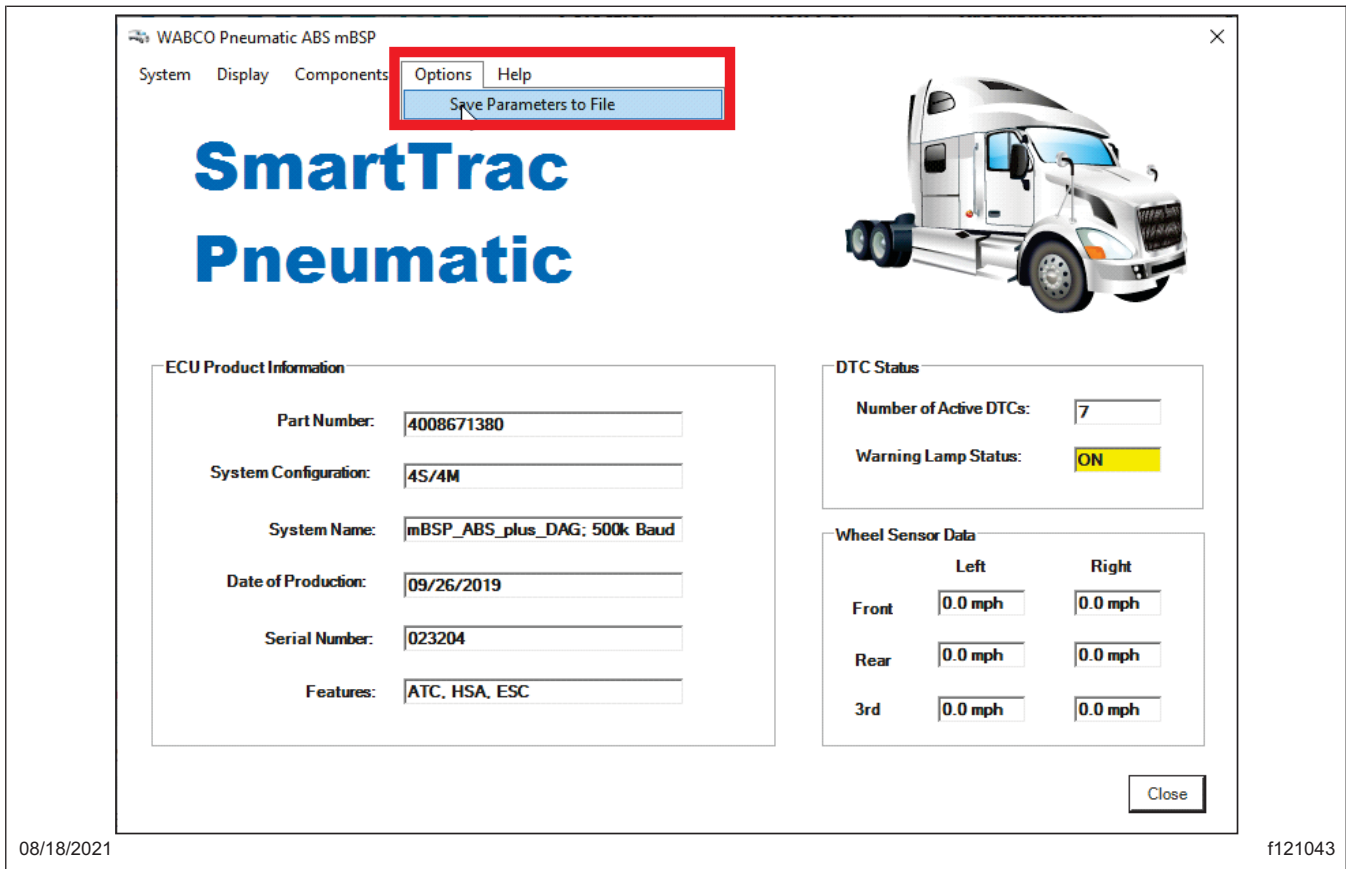
Fig. 33, Choosing the Install Location

20. Go to the 'Option" menu and select 'Save Parameters to File.' See [Fig. 33](#).

NOTE: Certain vehicles with 8x4 configuration equipped with a pusher axle may not register a fourth axle within the 'Wheel Sensor Data' screen due to vehicle wheel sensor locations, and Wabco Toolbox Plus screen layout. This will not affect the programming, and the parameter update will be completed successfully.
