Technical Service Bulletin

SUBJECT: DISPLAY MESSAGE ERRORS OCCUR IN HEADS UP DISPLAY DUE TO COMMUNICATION ERROR BETWEEN ADAS-ECU AND FRONT RADAR			No: TSB-22-54-001
			DATE: February 2022
			MODEL: 2022 Outlander
CIRCULATE TO:	<input type="checkbox"/> GENERAL MANAGER	<input checked="" type="checkbox"/> PARTS MANAGER	<input checked="" type="checkbox"/> TECHNICIAN
<input checked="" type="checkbox"/> SERVICE ADVISOR	<input checked="" type="checkbox"/> SERVICE MANAGER	<input checked="" type="checkbox"/> WARRANTY PROCESSOR	<input checked="" type="checkbox"/> SALES MANAGER

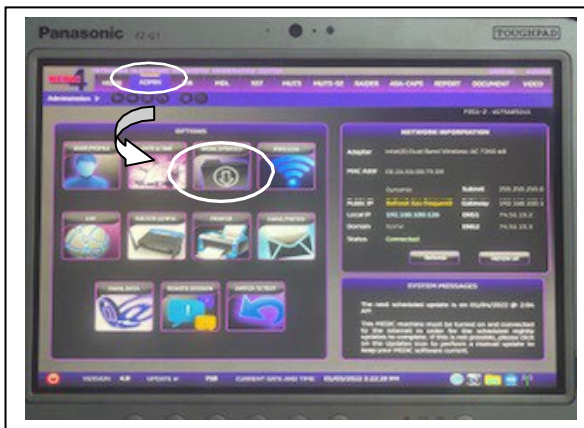
3. Select the MEDIC 3.5/4 Admin tab and click on "Updates".

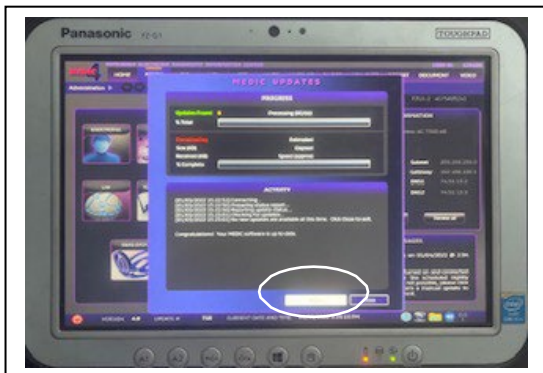
4. If the MEDIC update screen advises updates are available, click the "Begin" button. After all updates are complete, **GO TO THE REPROGRAMMING PROCEDURE.**

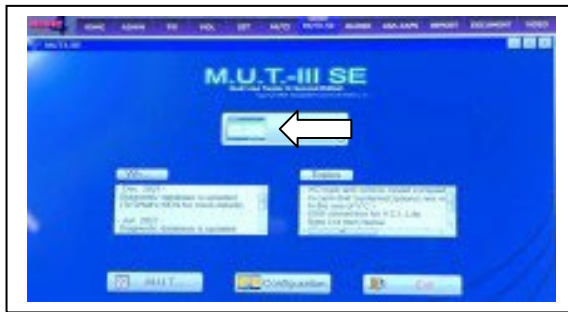
a. Click "STV".

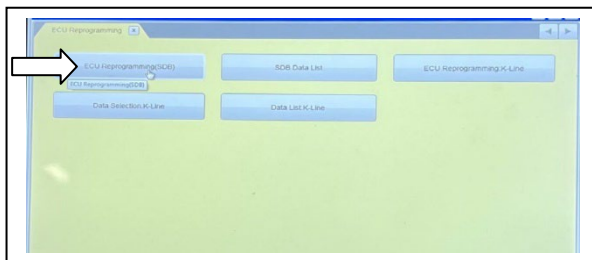
c. Click "SDB Data List, select the reprogramming data system and press the OK button".

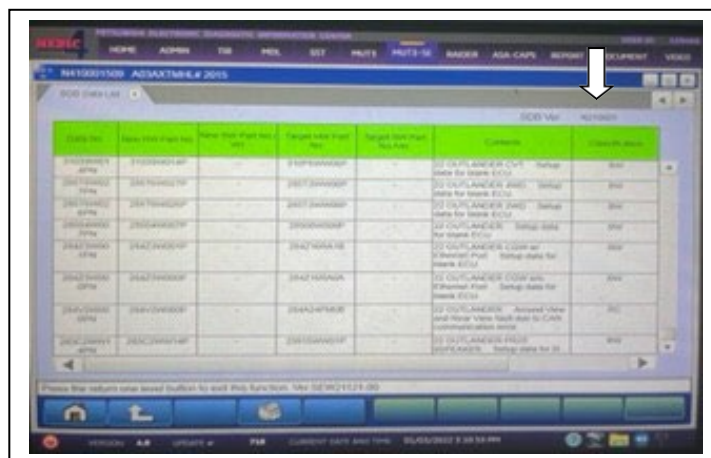
d. Confirm that the database number displayed in the upper right above the chart is **N211201** or higher

- i. If the database number displayed on your MUT3-SE is **N211201** or greater, continue to the next section.
- ii. If the reprogramming database number displayed on your MUT3-SE is lower than **N211201**, then the MUT3-SE database needs to be updated.

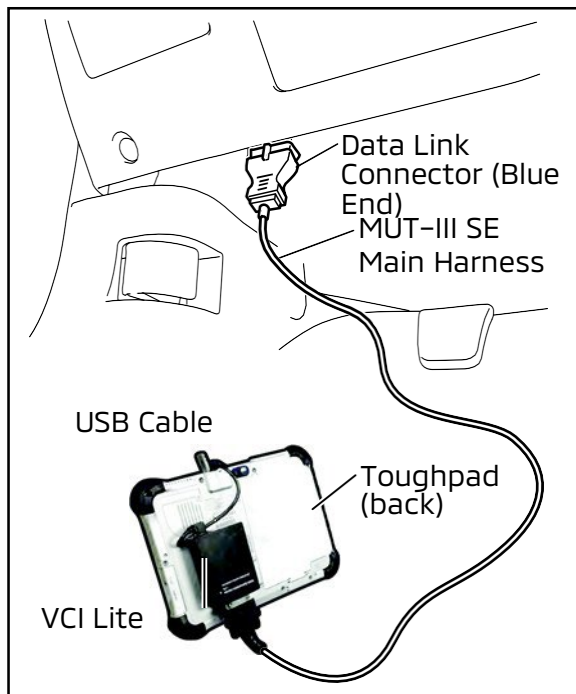
1. Connect the equipment as follows:

NOTE: VCI Lite and MEDIC 4.0 Toughpad shown for illustration purposes only.

- Turn the MEDIC PC/tablet on. If the battery indicator in the lower right hand corner of the screen does not show a full charge, it is recommended that either the battery be charged prior to beginning or be used with the A/C power adaptor connected.
- Connect the USB cable to the VCI/VCI Lite. When the laptop/tablet displays the MUT-III SE main screen, connect the USB cable to the device.
- Connect the MUT-III SE main harness with the blue DLC connection to the VCI/VCI Lite. Connect the blue connection of the MUT-III SE main harness to the vehicle's data link connector.
- For VCI only (p/n MB991824): Turn the VCI power switch ON. Verify that the indicator lamp in the upper right corner of the screen is green.

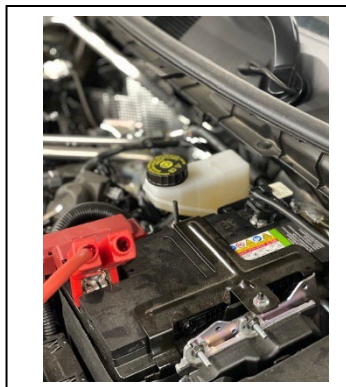
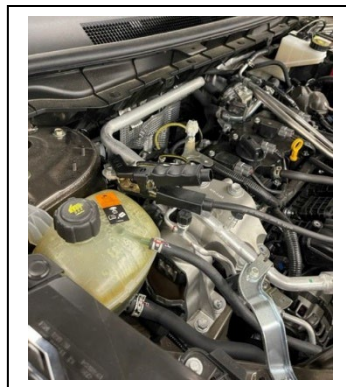
NOTE: Due to limited space it may be easiest to connect cable onto negative ground post and ground strap as shown below.

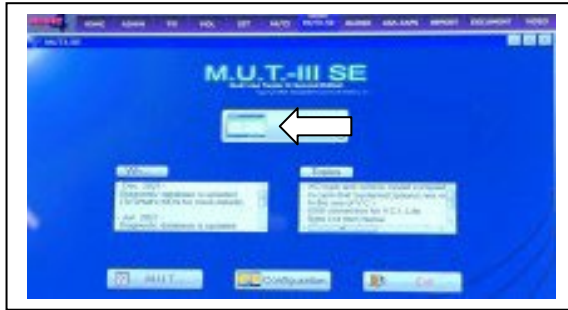
- Using MEDIC, from the main page, click the "MUT3-SE" icon at the top center of the screen.

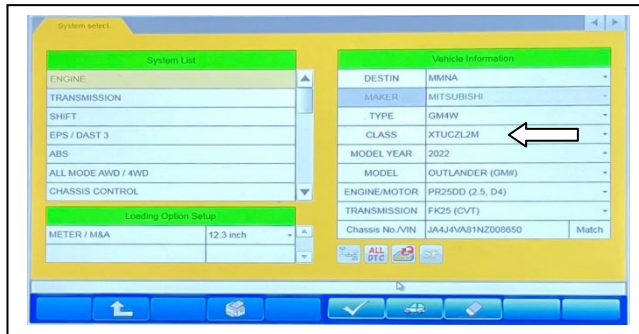
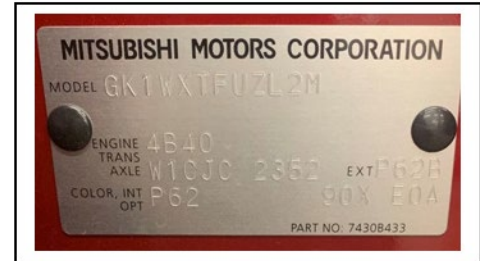
- The System Select screen opens and populates with some basic information from the vehicle. Look at the label on the passenger side B pillar to identify the appropriate class. (See B pillar label below; class is labeled as "model"). If necessary, select the correct class from the drop-downlist.

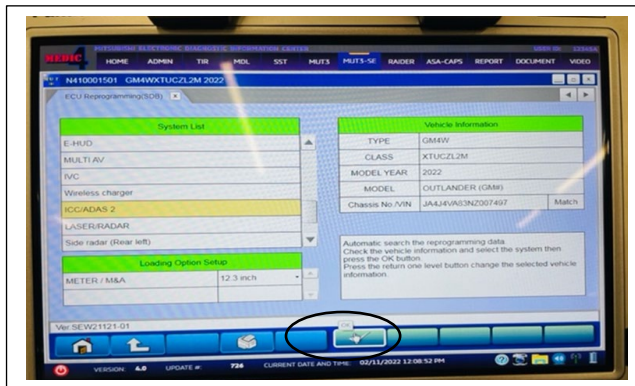
d. Click **ICC/ADAS 2** and press the OK button.

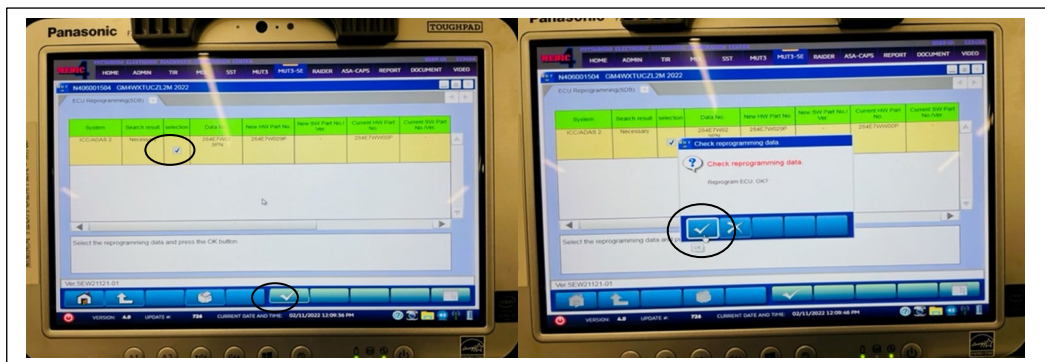
e. Click to select and press and on the next screen press OK.

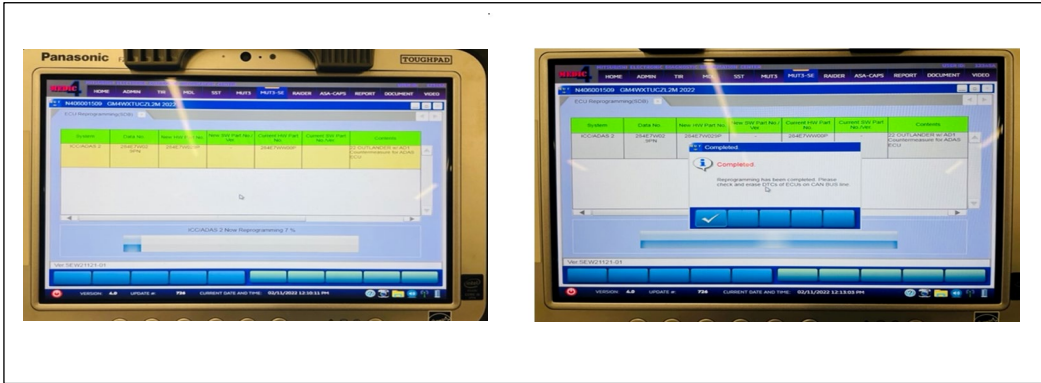
f. The reprogramming will begin, and a notification will appear upon completion.

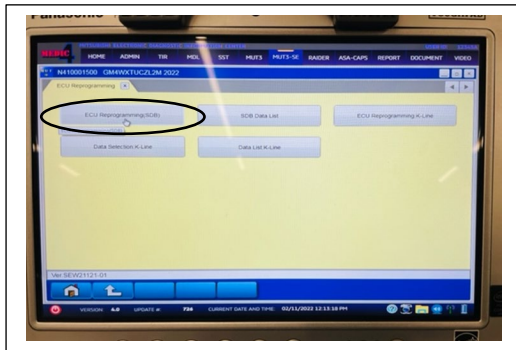
g. Go back to ECU Reprogramming (SDB) and select it.

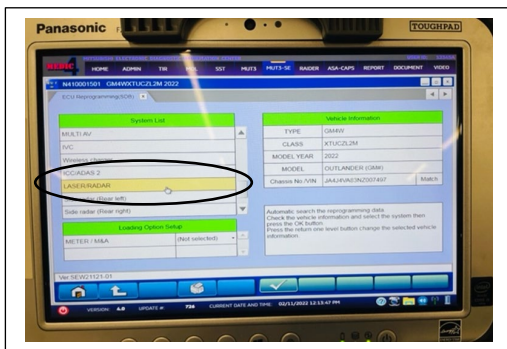
h. Choose **Laser/Radar** in the System List.

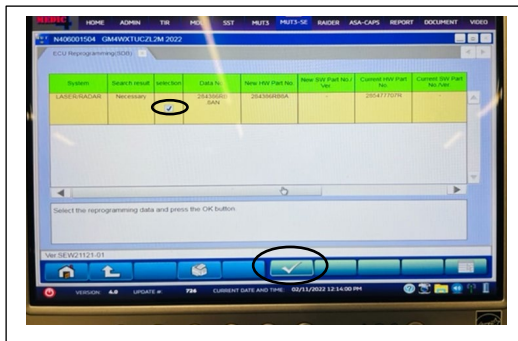
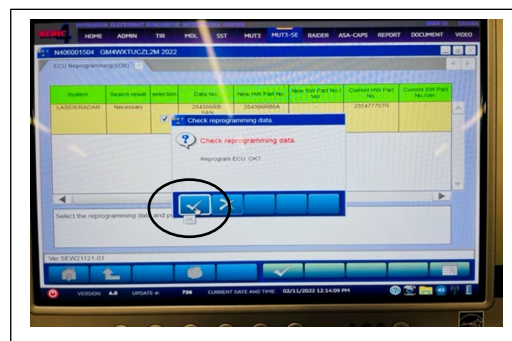
i. Click the selection and press the OK button.

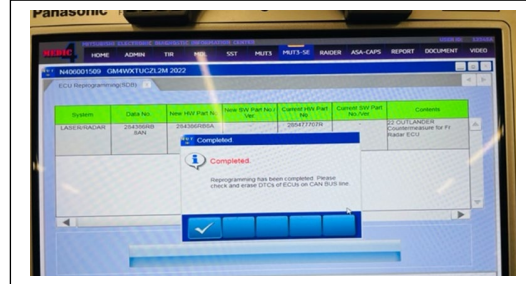
j. The reprogramming will begin, and a notification will appear upon completion.

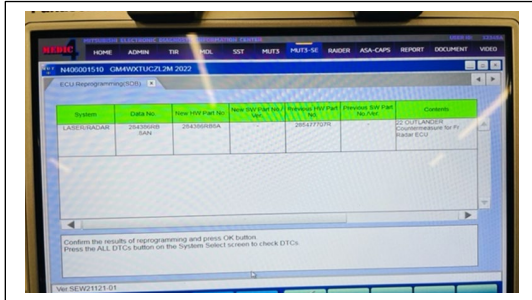
k. Confirm the results then click the ALL DTCs button on the System Select screen to check DTCs.

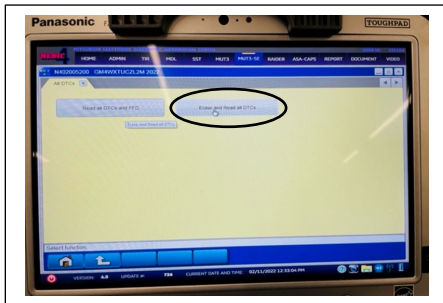
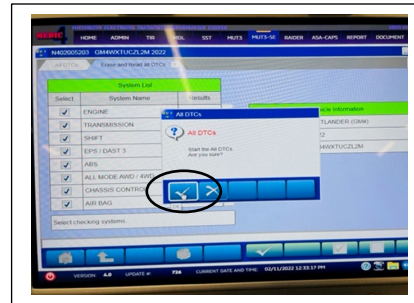
l. Select Erase and Read all DTCs, then click the OK to begin checking all DTCs.

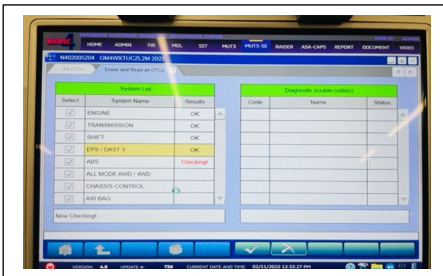
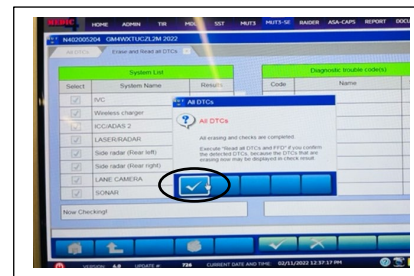
m. Once the DTCs have been checked and erased, click OK.

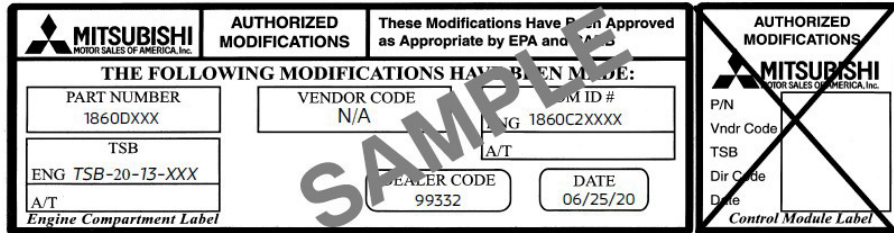
- Using a ball-point pen, enter the appropriate ECU part number, Software Part Number (ROMID#), this Technical Service Bulletin number, your dealer code, and the current date on the Engine Compartment/Control Module Label (p/n MSSF024G00). The Vendor Code is not applicable. The label is available from your facing PDC.
