Technical Service Bulletin

SUBJECT:		No: TSB-22-55-001	
A/C INOPERATIVE WITH DTC B20C8-14		DATE: February 2022	
		MODEL: 2022 Outlander	
CIRCULATE TO:	<input type="checkbox"/> GENERAL MANAGER	<input checked="" type="checkbox"/> PARTS MANAGER	<input checked="" type="checkbox"/> TECHNICIAN
<input checked="" type="checkbox"/> SERVICE ADVISOR	<input checked="" type="checkbox"/> SERVICE MANAGER	<input checked="" type="checkbox"/> WARRANTY PROCESSOR	<input checked="" type="checkbox"/> SALES MANAGER

This reflash is to correct the IPDM (Intelligent Power Distribution Module) software. The air conditioner is not operative with the A/C switch on and illuminated (see image below). DTC B20C8-14 ECV (Electrical Control Valve) is stored in the IPDM E/R. Please perform this reflash first, then proceed to diagnosing other codes if they persist.

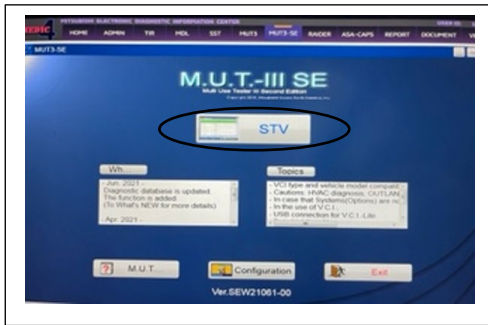
5. Click "STV".

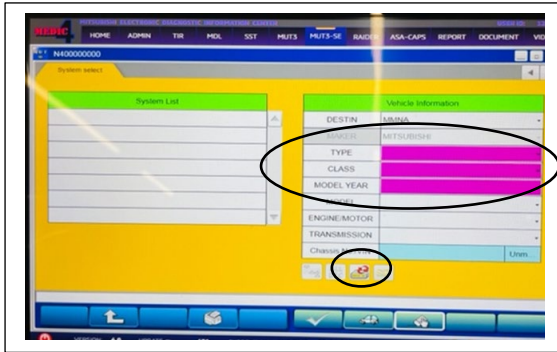
a. Fill in the vehicle information and click the ECU reprogramming button.

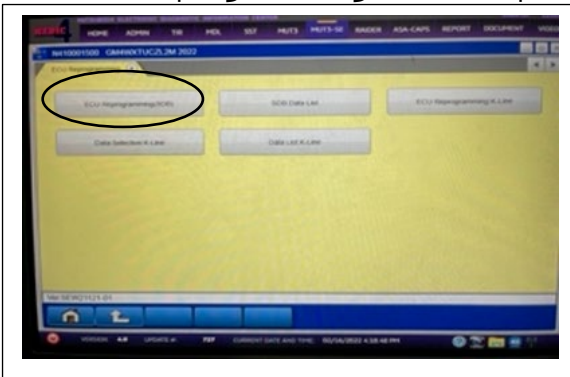
b. Click "ECU Reprogramming (SDB) and press the OK button".

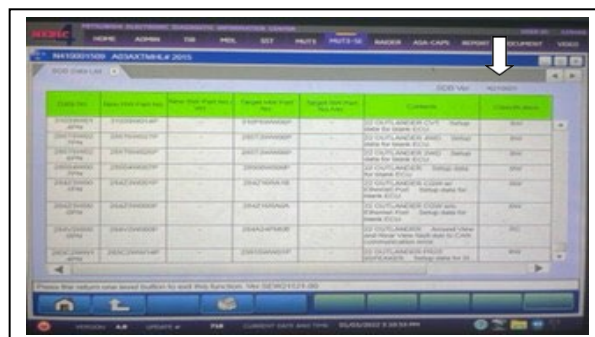
c. Confirm that the database number displayed in the upper right above the chart is **N220101** or higher

- i. If the database number displayed on your MUT3-SE is **N220101** or greater, continue to the next section.
- ii. If the reprogramming database number displayed on your MUT3-SE is lower than **N220101**, then the MUT3-SE database needs to be updated.

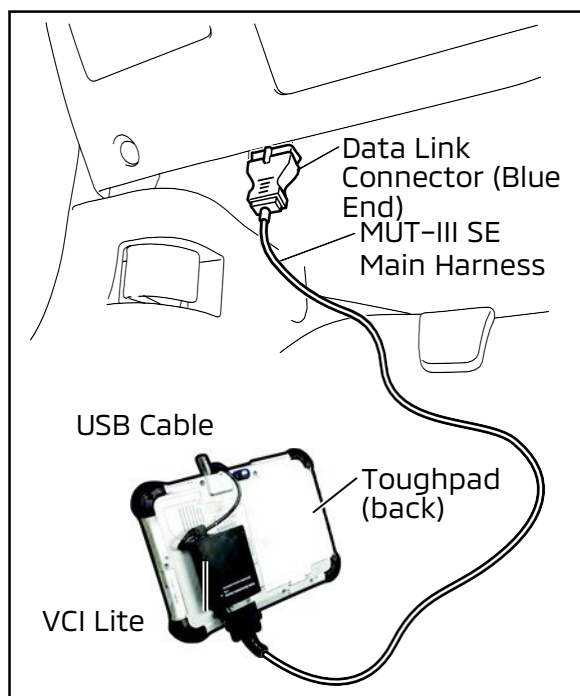
1. Connect the equipment as follows:

NOTE: VCI Lite and MEDIC 4.0 Toughpad shown for illustration purposes only.

- Turn the MEDIC PC/tablet on. If the battery indicator in the lower right hand corner of the screen does not show a full charge, it is recommended that either the battery be charged prior to beginning or be used with the A/C power adaptor connected.
- Connect the USB cable to the VCI/VCI Lite. When the laptop/tablet displays the MUT-III SE main screen, connect the USB cable to the device.
- Connect the MUT-III SE main harness with the blue DLC connection to the VCI/VCI Lite. Connect the blue connection of the MUT-III SE main harness to the vehicle's data link connector.
- For VCI only (p/n MB991824): Turn the VCI power switch ON. Verify that the indicator lamp in the upper right corner of the screen is green.

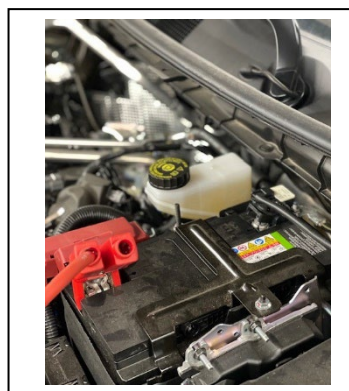
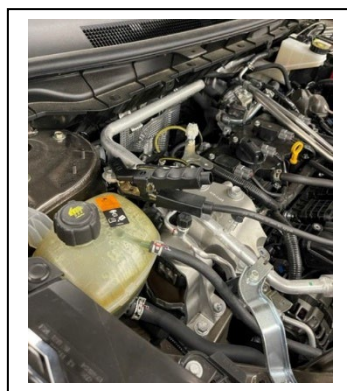
NOTE: Due to limited space it may be easiest to connect cable onto negative ground post and ground strap as shown below.

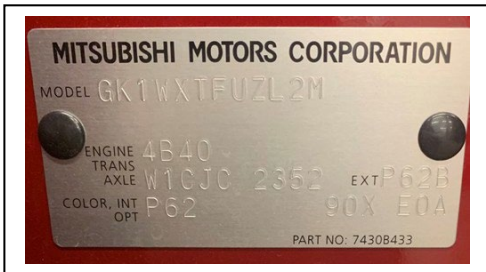
4. The System Select screen opens and populates with some basic information from the vehicle. Look at the label on the passenger side B pillar to identify the appropriate class. (See B pillar label below; class is labeled as "model"). If necessary, select the correct class from the drop-down list.

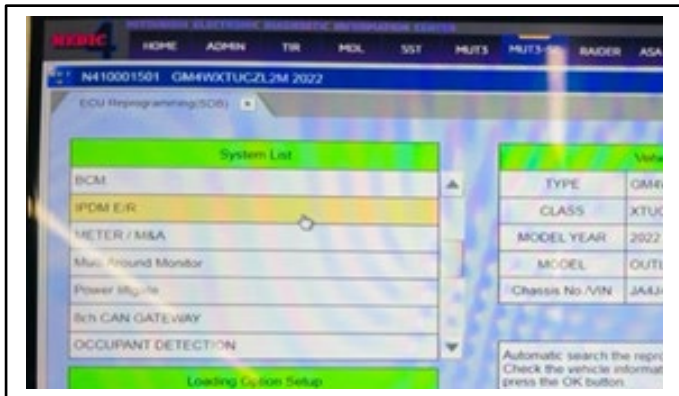
a. Select ECU Reprogramming (SDB).

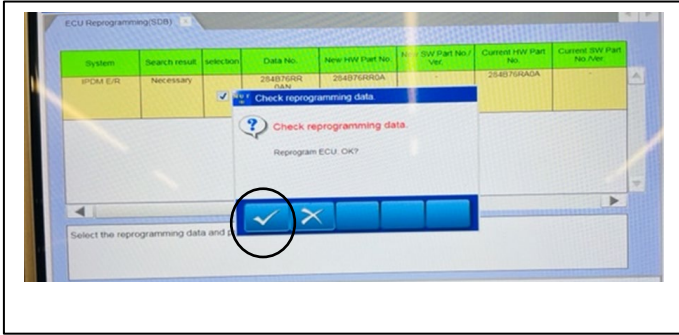
b. Select "IPDM E/R" from Systems List and click the OK button.

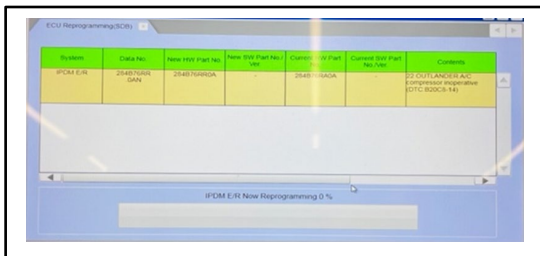
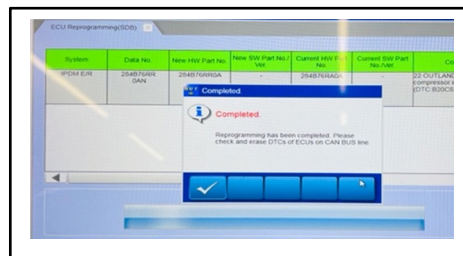
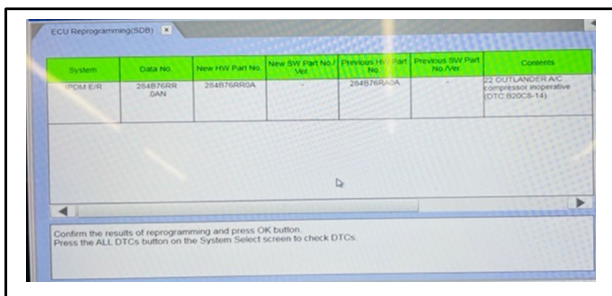
e. Reprogramming will begin and a progress bar will appear followed by a notification upon successful completion.

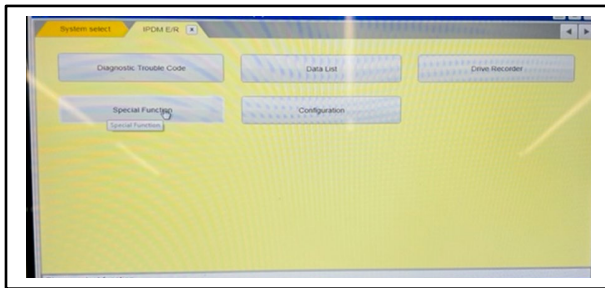
a. Select IPDM E/R in the System List.

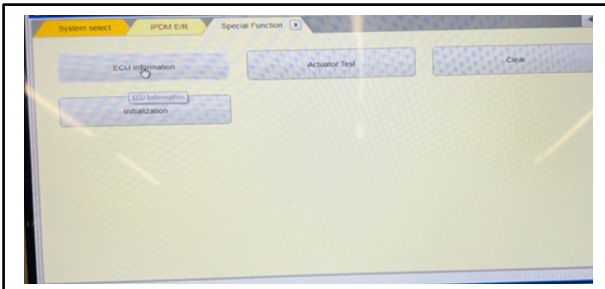
b. Select the Special Function button.

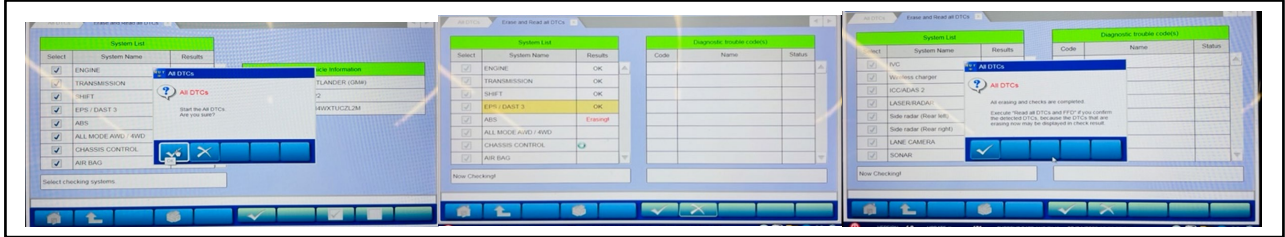
e. Select Erase and Read all DTCs.

f. Select OK to start the All DTCs and ensure the erasing and checks are completed.

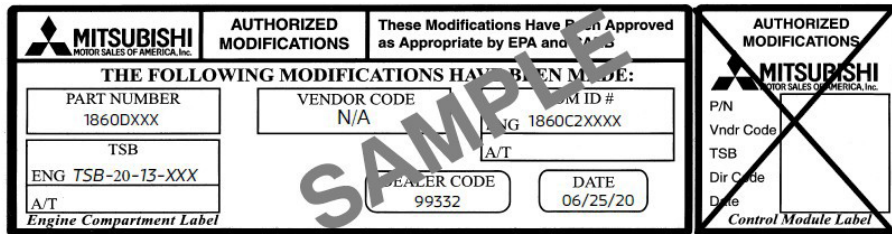
7. Using a ball-point pen, enter the appropriate ECU part number, Software Part Number (ROM ID#), this Technical Service Bulletin number, your dealer code, and the current date on the Engine Compartment/Control Module Label (p/n MSSF024G00). The Vendor Code is not applicable. The label is available from your facing PDC.
