HYUNDAI Technical Service Bulletin	GROUP CAMPAIGN	NUMBER 22-01-021H
	DATE FEBRUARY, 2022	MODEL(S) Tucson (NX4), Tucson (NX4A), Tucson Hybrid (NX4 HEV), Tucson Plugin (NX4 PHEV)
SUBJECT: LANE KEEP ASSIST SOFTWARE UPDATE (SERVICE CAMPAIGN T7X)

Description: This bulletin provides information related to Lane Keep Assist (LKA) software update, logic revision for Tucson (NX4, NX4A, NX4 HEV, NX4 PHEV) vehicles. Update will reduce sensitivity of LKA warning and misrecognition of missing lanes when entering the interstate.

LANE KEEP ASSIST LOGIC IMPROVEMENT PROCEDURE

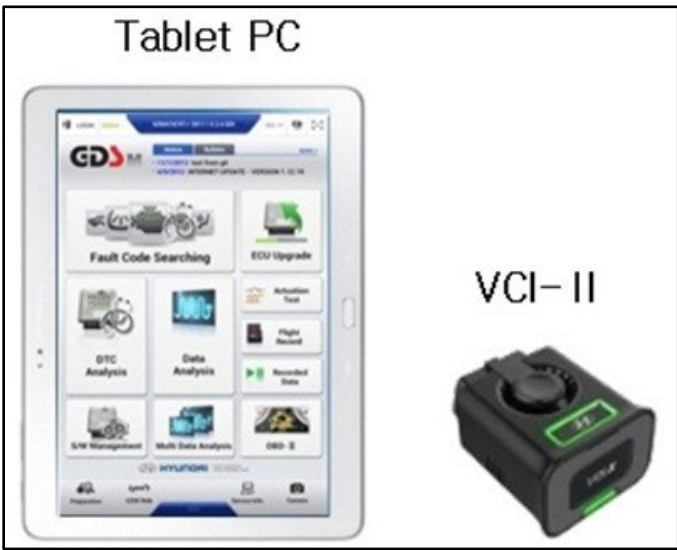
ECU upgrade function on GDS-Mobile is basically operating in wireless communication and Wi-Fi direct. Also, it's possible to be performing via USB cable between Tablet PC and VCI-II.

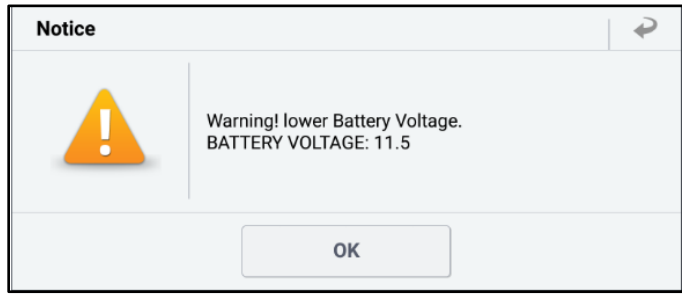
4. The vehicle battery voltage is checked to make sure it is at least 12 volts to ensure reliable upgrade results. Click **OK** if the results indicate voltage is OK.

If battery voltage is below 12 voltages as below, click BACK and then run the engine to assure an adequate battery charge state for reliable upgrade results.

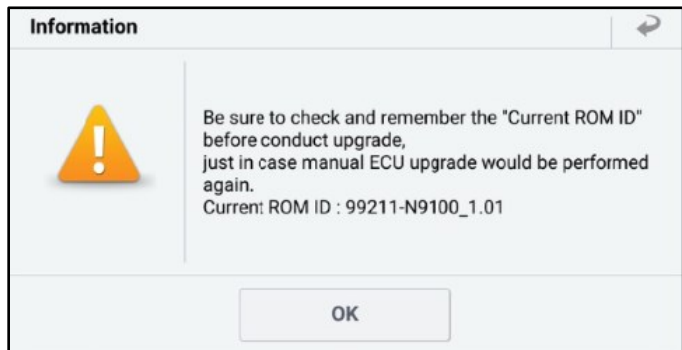
5. Pop-up may generate to check “Current ROM ID”. Select **OK** and continue with update.

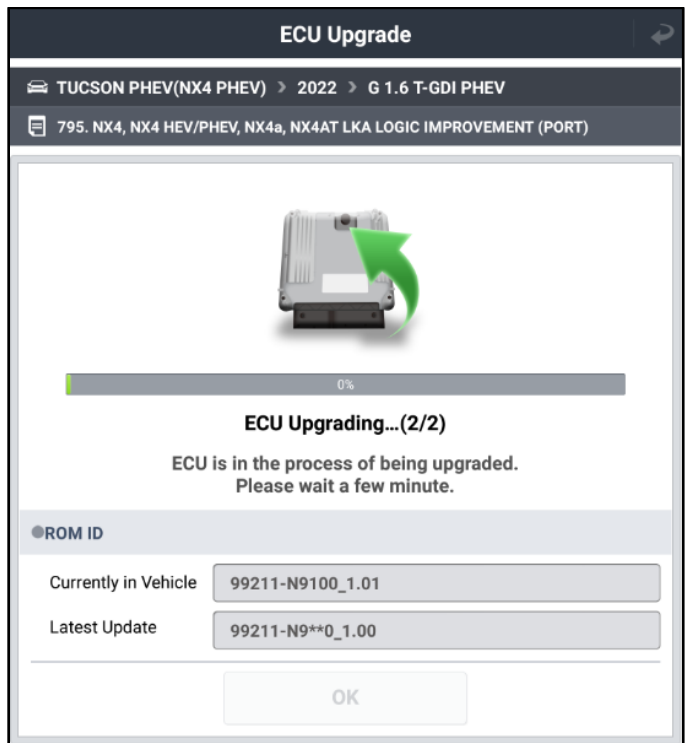
- 7. Upgrade (2/2) will begin, and the progress of the upgrade will appear in the bar graph.

Upgrade (2/2) will occur until 100% is reached on the bar graph.

After progress bar reaches 100%, turn the ignition key off for 10 seconds. Turn the ignition back to the on position, and then click OK to continue according to information displayed on the screen.

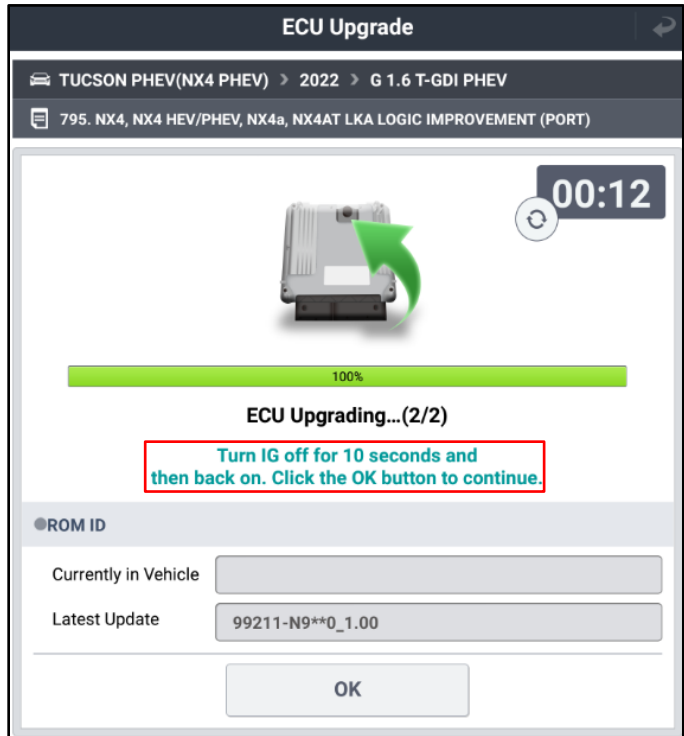
- 8. When upgrade reaches 100%, Tablet will direct Technician to “Turn IG off for 10 seconds and then back on. Click the OK button to continue.”

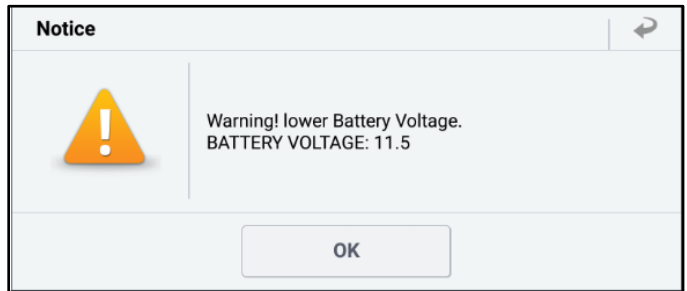
- The vehicle battery voltage is checked to make sure it is at least 12 volts to ensure reliable upgrade results. Click OK if the results indicate voltage is OK.

If battery voltage is below 12 voltages as below, click BACK and then run the engine to assure an adequate battery charge state for reliable upgrade results.

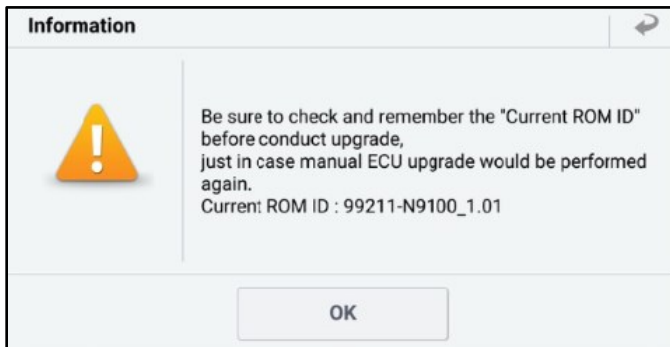
- 5. Pop-up may generate to check "Current ROM ID". Select **OK** and continue with update.

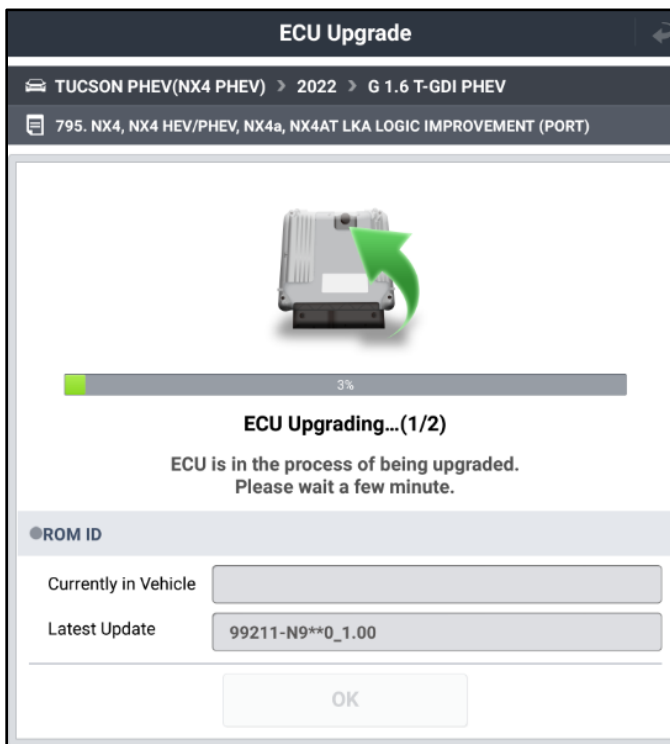
- 5. Upgrade (1/2) will begin, and the progress of the upgrade will appear on the bar graph. Upgrade (1/2) will occur until 100% is reached on the bar graph.

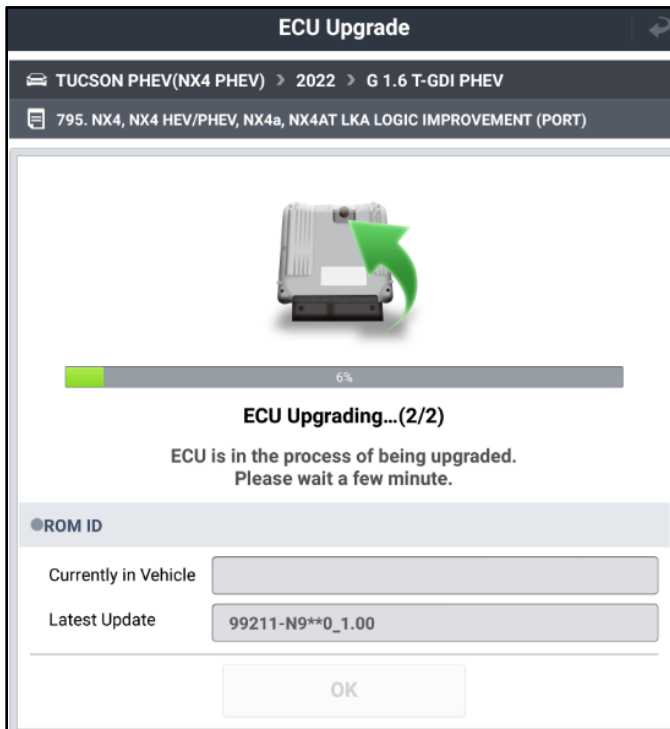
- 6. Upgrade (2/2) will begin, and the progress of the upgrade will appear in the bar graph.

Upgrade (2/2) will occur until 100% is reached on the bar graph.

After progress bar reaches 100%, turn the ignition key off for 10 seconds. Turn the key back to the on position, and then click OK to continue according to information displayed on the screen.

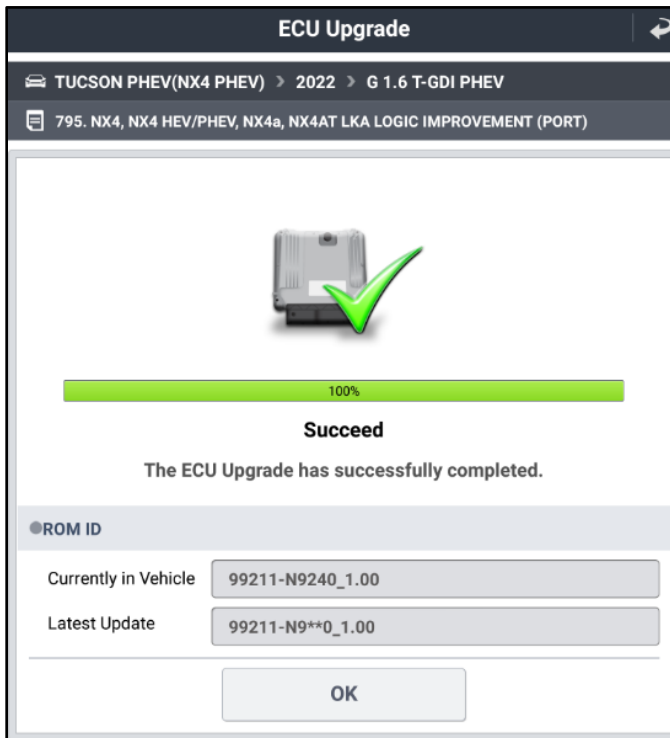
- 8. Click OK on the final screen, which indicates upgrade is complete.

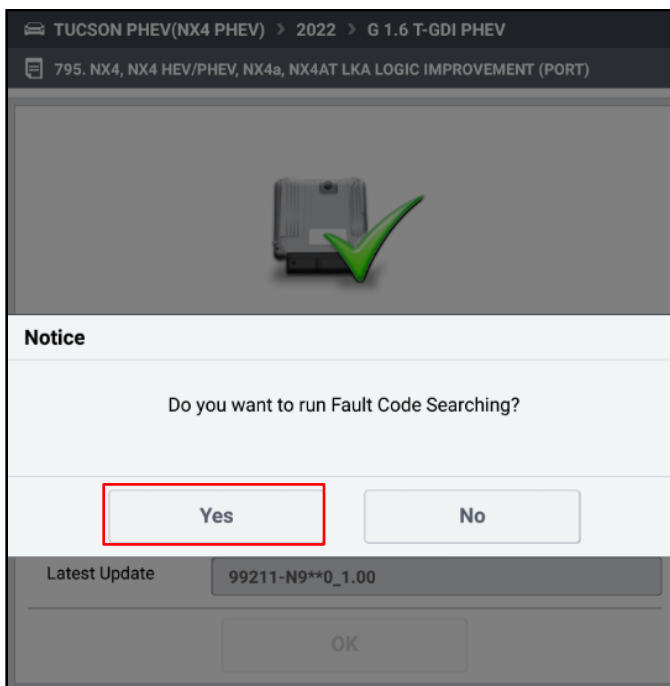
- 9. Check if any incidental Diagnostic Trouble Codes (DTC) have been created by the upgrade and clear the DTC(s) present.
