Service Action

Code: 91CD

Subject 3G Cellular Network Sunset

Section C – 4G/LTE Retrofit Kit Installation

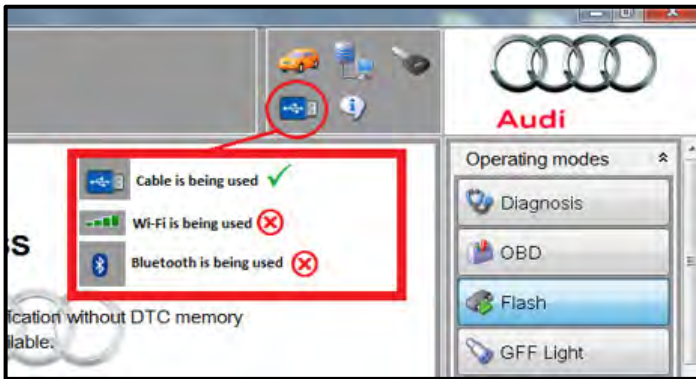
- Confirm that scan tool is communicating with the diagnostic head by USB cable.
 - If the Bluetooth or WiFi symbol is shown, then disconnect the diagnostic head from the vehicle and reconnect the USB cable to the diagnostic head and then reattach to the vehicle.

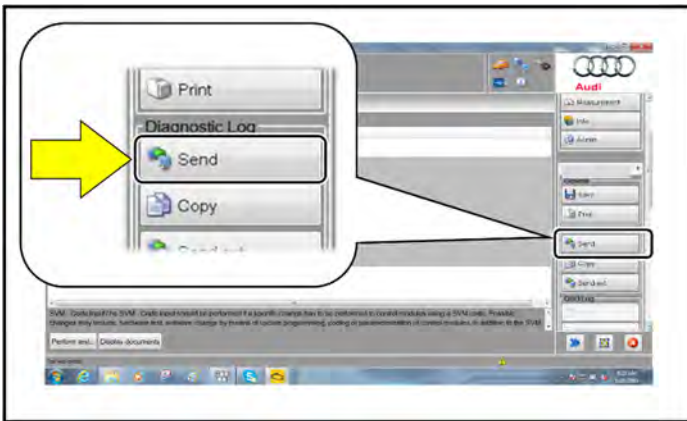
- After receiving confirmation that the flash completed successfully, select “Send” to send the diagnostic protocol online.
- Follow the on-screen prompts.

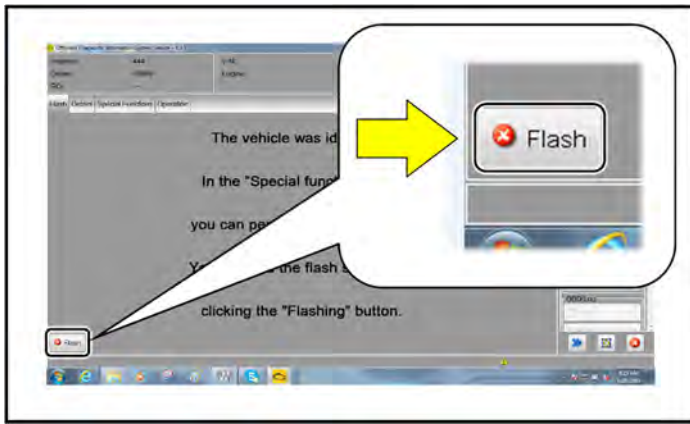
- Click "Flash" to exit the flash session.
- Various event memory entries may be generated after the flashing procedure on some vehicles. Put the vehicle in a corresponding bus sleep mode after performing the update in order to clear the faults.

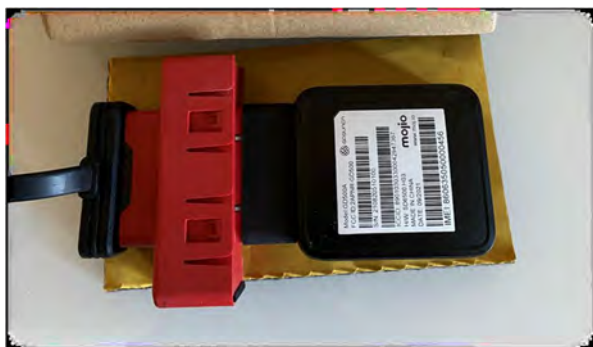
- For the Q7, the insulation material must be placed on the warning label side. The barcode will be exposed.

The barcode on the LTE Retrofit Telematics Device must be point upwards because of the position of GNSS antenna.

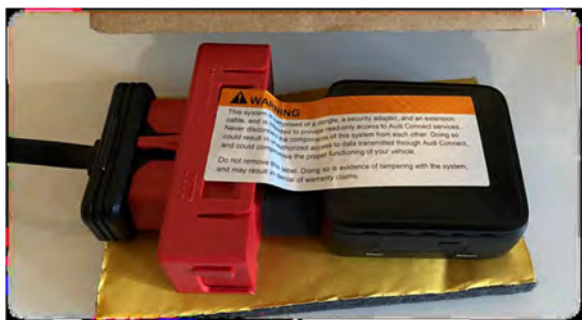
- For the A4 and A5 variants, the insulation material must be placed on the bar code side. The warning label will be exposed.

<p>! NOTE</p>
<p>The warning label on the LTE Retrofit Telematics Device must be point upwards because of the position of GNSS antenna.</p>

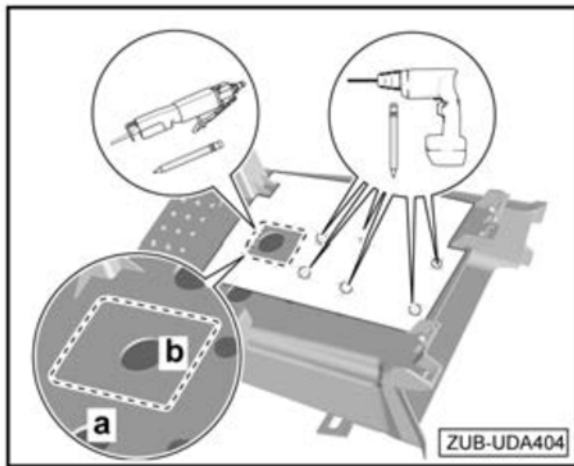
- Cut out the template.
- Position the template for the LTE Retrofit Telematics Device on the storage compartment in the installation position and mark the holes for the cable ties and cable ducts.
- Drill M5 holes for the cable ties.
- Using suitable workshop equipment, drill and deburr the opening -a-b- for the OBDII extension cable.

Drilling pilot holes at the corners of the -a-b- cutout will make cutting easier.

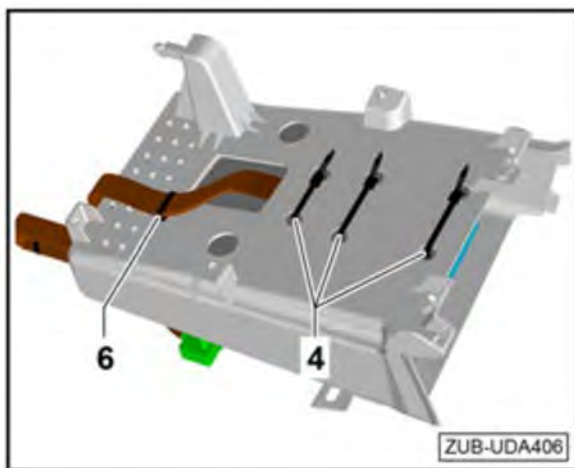
- Position the LTE Retrofit Telematics Device with the insulation material attached in the storage compartment in the installation position and secure with cable ties -4-.
- Route the OBDII extension cable towards the position of the OBDII slot in the vehicle and secure it in a suitable place using a cable tie with adhesive pad -6- to prevent noise from occurring.

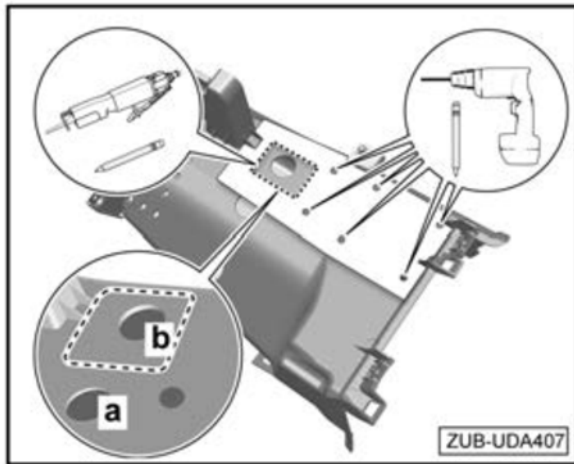
- Cut out the template.
- Position the template for the LTE Retrofit Telematics Device on the storage compartment in the installation position and mark the holes for the cable ties and cable ducts.
- Drill M5 holes for the cable ties.
- Using suitable workshop equipment, drill and deburr the opening -a-b- for the OBDII extension cable.

TIP
 Drilling pilot holes at the corners of the -a-b- cutout will make cutting easier.

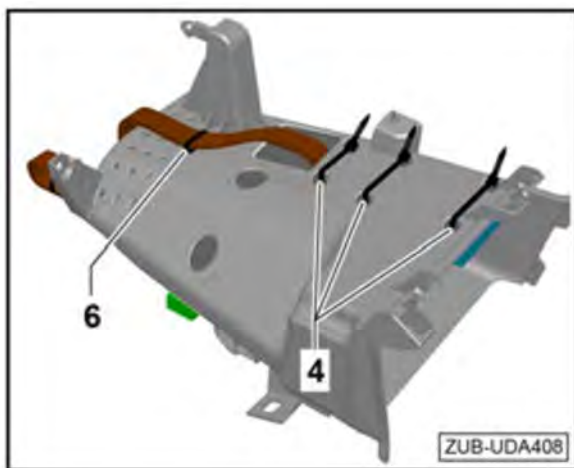
- Position the LTE Retrofit Telematics Device with the insulation material attached in the storage compartment in the installation position and secure with cable ties -4-.
- Route the OBDII extension cable towards the position of the OBDII slot in the vehicle and secure it in a suitable place using a cable tie with adhesive pad -6- to prevent noise from occurring.

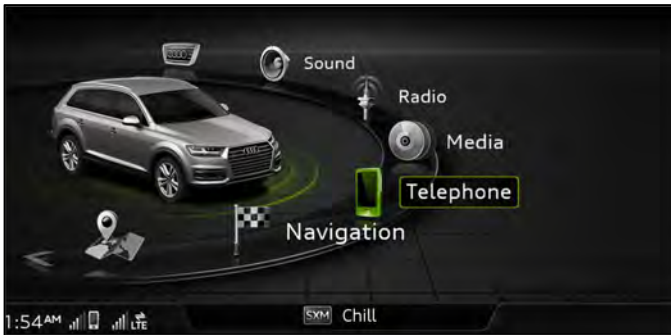
- Select “Telephone”

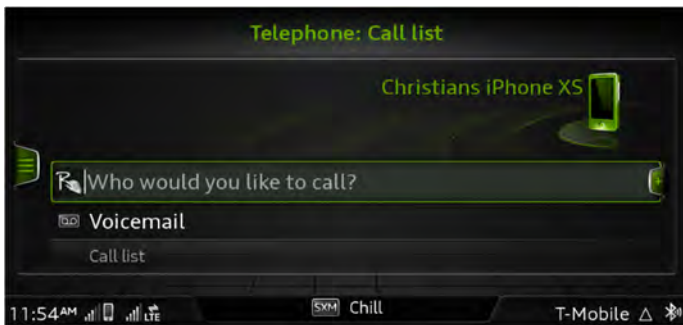
- Example: Customer phone shown as connected device.

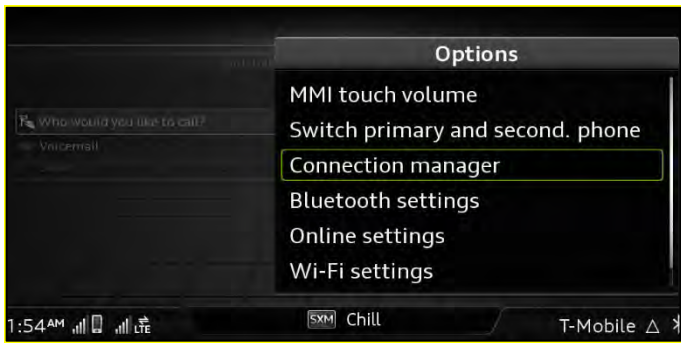
- Select “Connection manager”

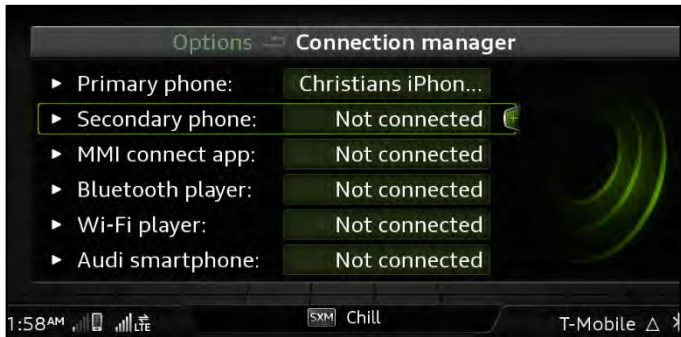
- Select “Secondary phone”

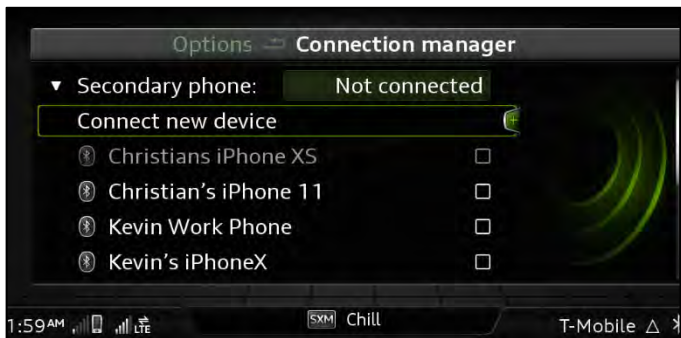
- Select “Connect new device”

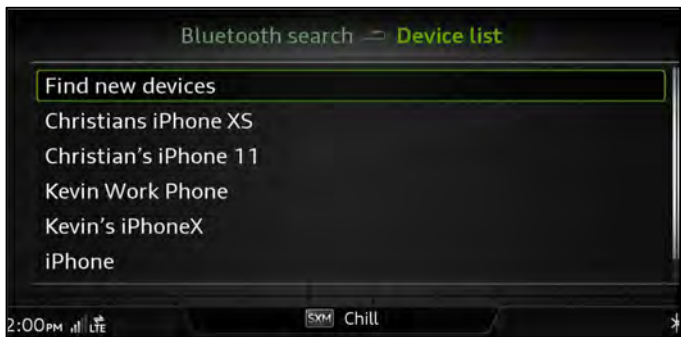
- Select “Find new devices”

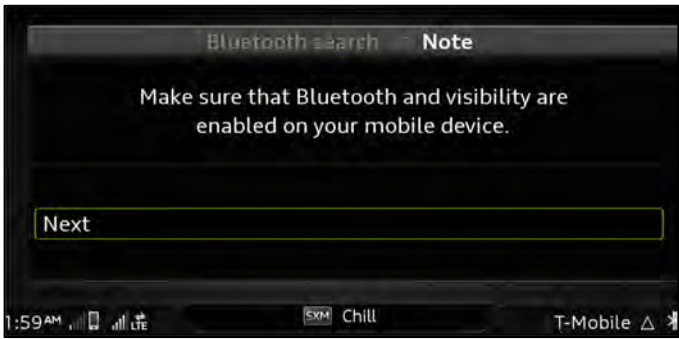
- Select “Next”

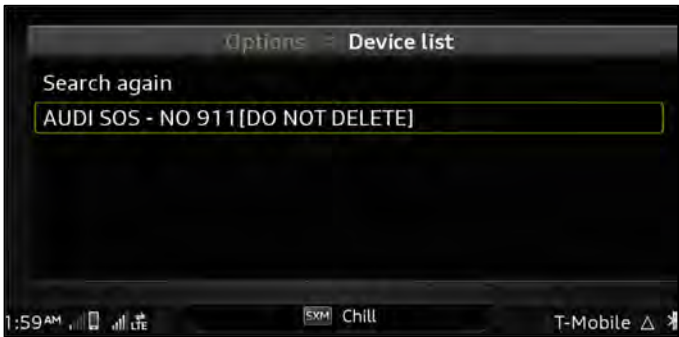
- Select “AUDI SOS – NO 911 [DO NOT DELETE]” from the device list.

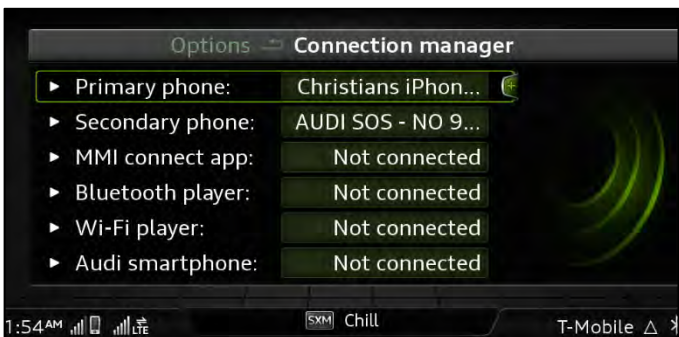
- LTE Retrofit device is now a secondary connected device.

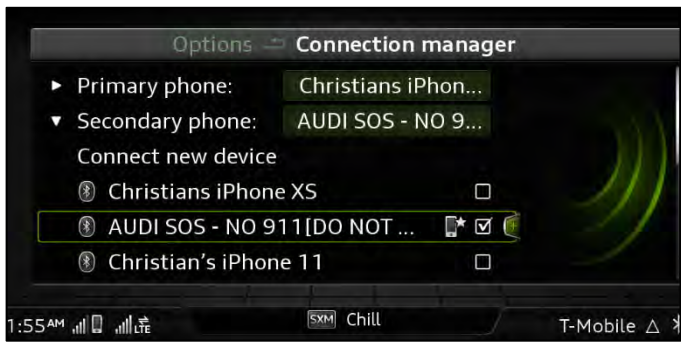
- Ensure “AUDI SOS – NO 911 [DO NOT DELETE]” is selected as the default device.

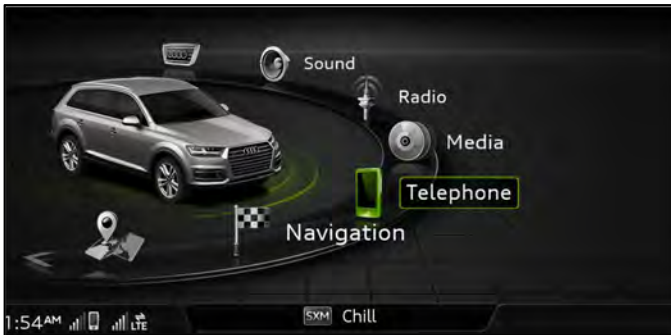
- Select "Telephone"

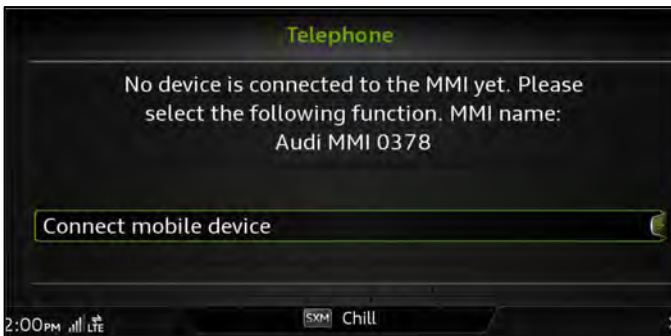
- Select "Connect mobile device"

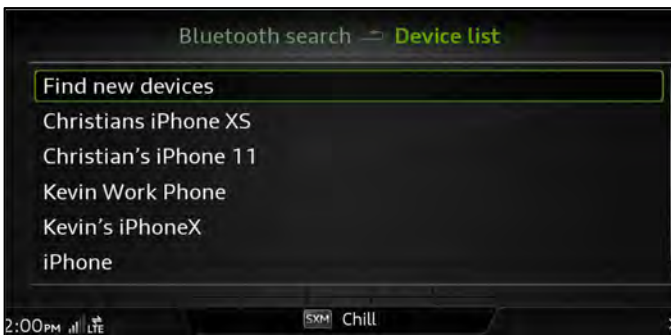
- Select "Find new devices"

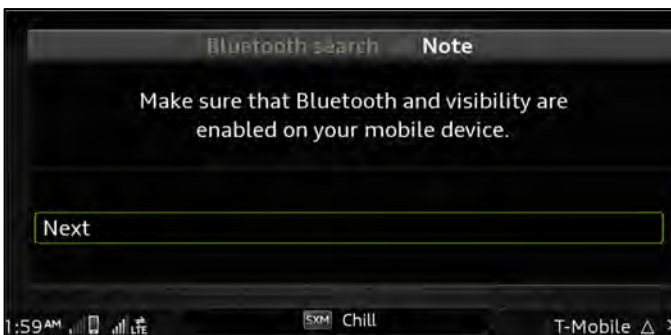
- Select "Next"

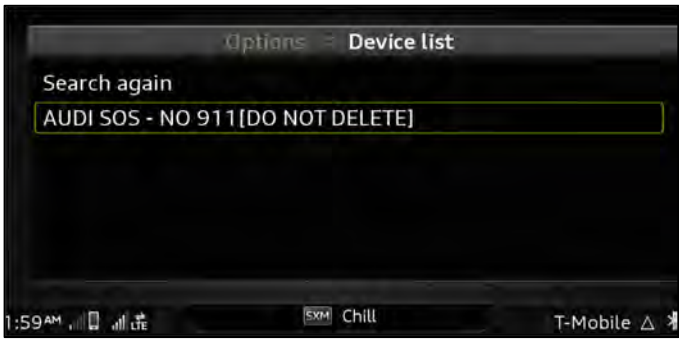
- Select “AUDI SOS – NO 911 [DO NOT DELETE]” from the device list.

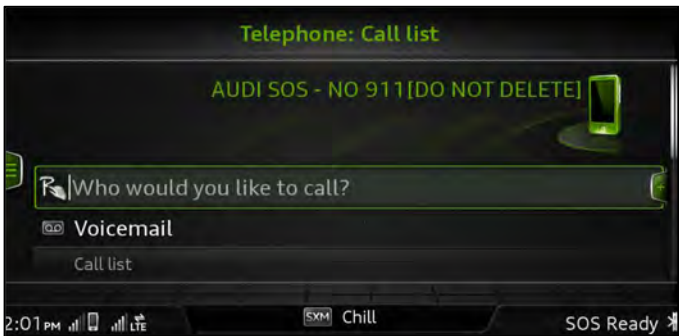
- “AUDI SOS – NO 911 [DO NOT DELETE]” shown as connected device.

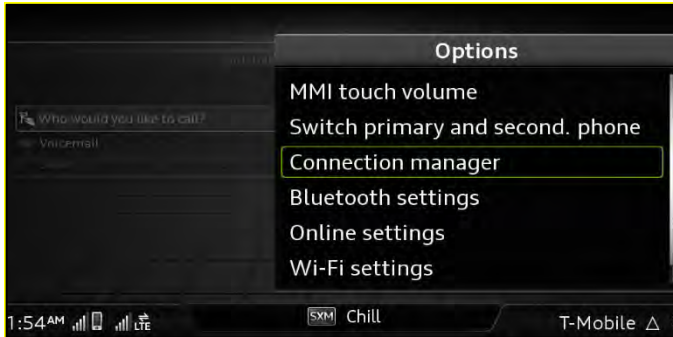
- Select "Connection manager"

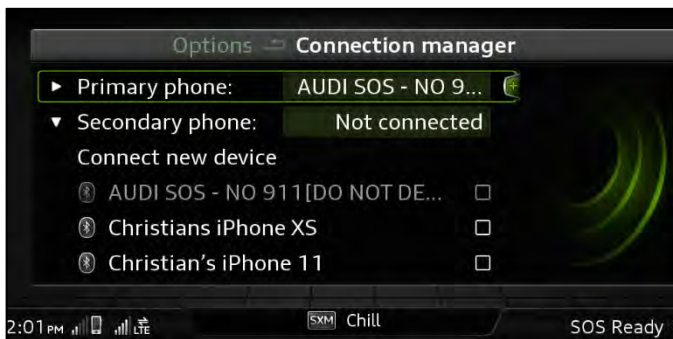
- Select "Primary phone"

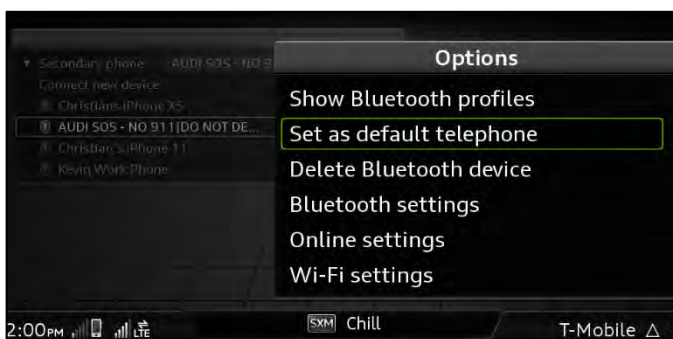
- Select "Set as default telephone"

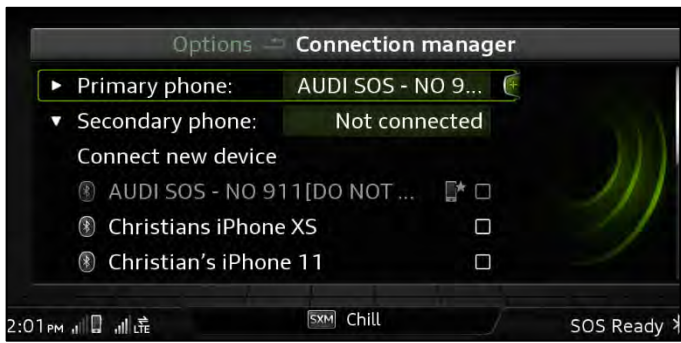
- LTE Retrofit device is now the primary connected device.

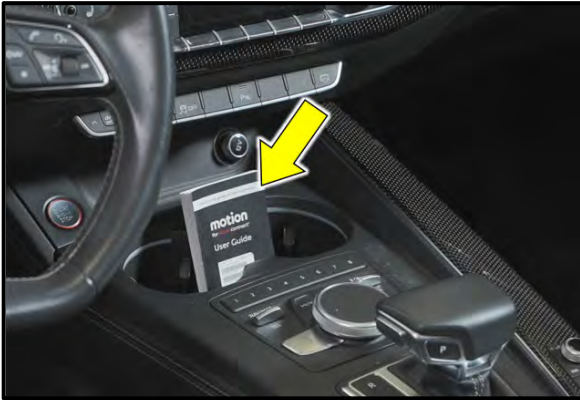
- The User Guide <arrow> from the retrofit kit must remain with the vehicle.
- The User Guide from the retrofit kit contains registration data unique to the retrofit kit that was installed in the vehicle.

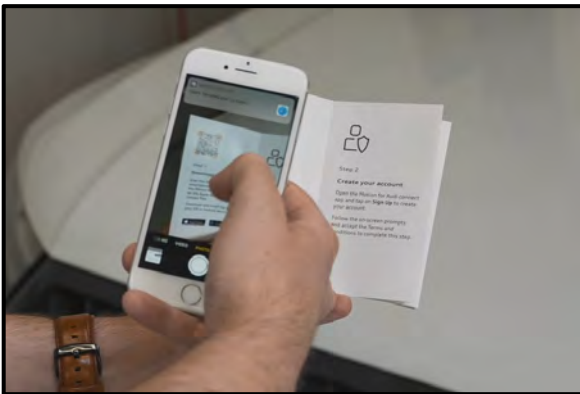
- In order for the customer to use the Motion for Audi Connect app, they must first download the app by scanning the QR code found in the User Guide

- Once the app is downloaded, and the customer creates an account, they must scan the unique barcode on the front of the User Guide in order to activate their services.
