# Service Action

**Subject** Infotainment System Software Update  
**Release Date** March 02, 2022  
**Revision Summary** 91Di code added for USA only  
**Affected Vehicles**

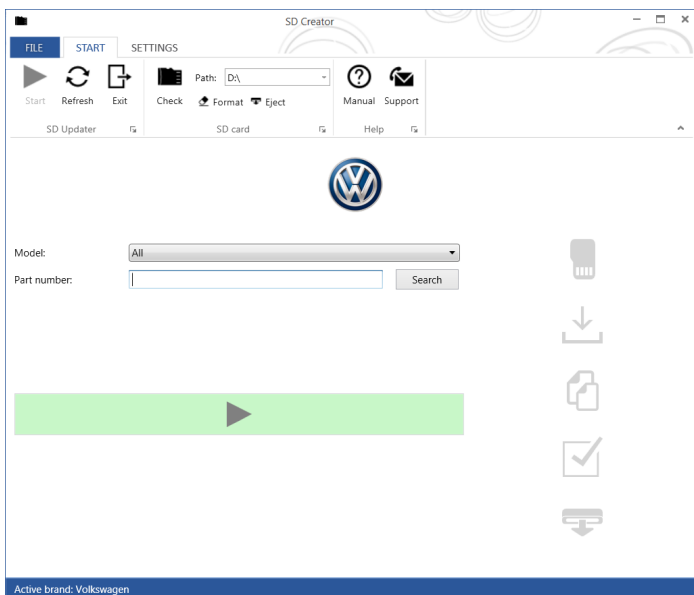
## Required USB Drive

- The required software will have to be downloaded onto a USB (or USB-C) drive using the SD Creator program
- **Reference the latest version of TSB 2054866 for additional information on the use of the SD Creator program.**

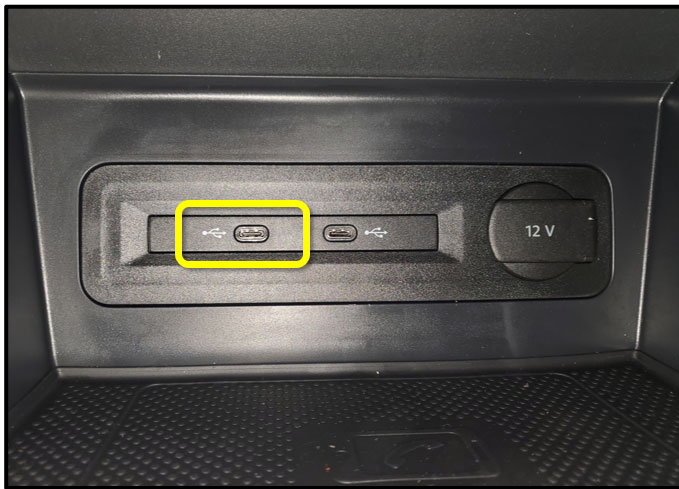
- Insert the USB drive in port 1 of the USB connection in front center console storage compartment.

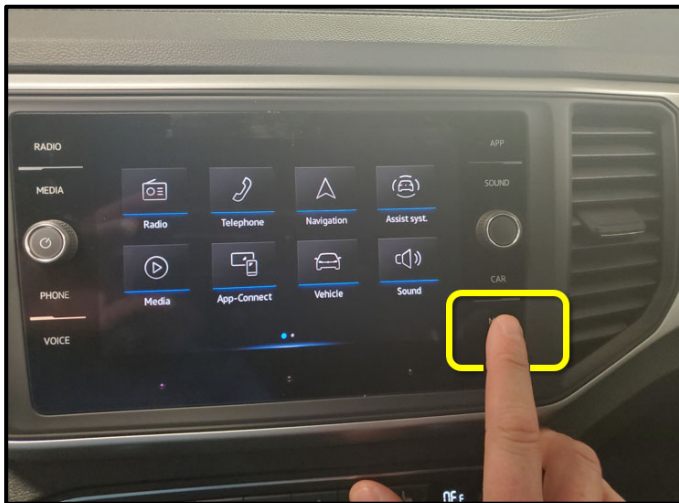
- Press and hold the "MENU" button located on the Radio for 5 seconds, wait until service mode is available.

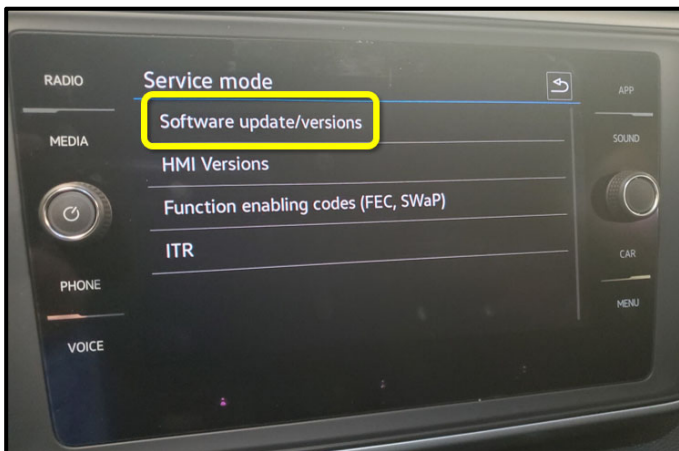
- Select the option "Software Update/Versions."

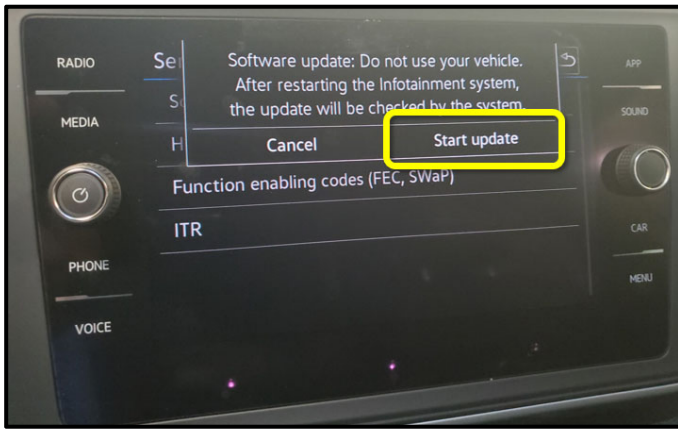
- Select "Start update."

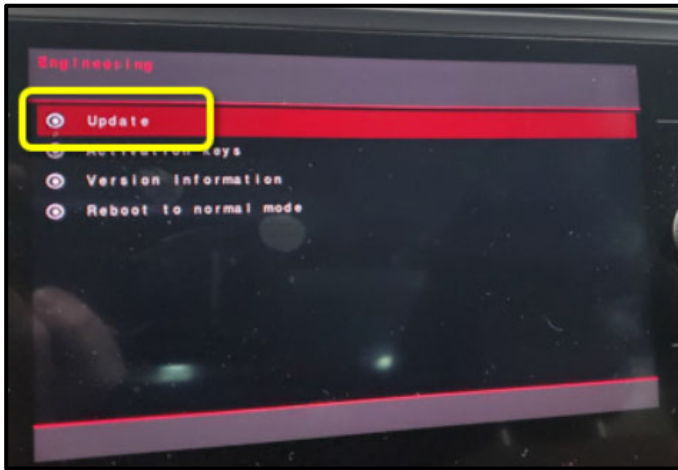
- Select Update.

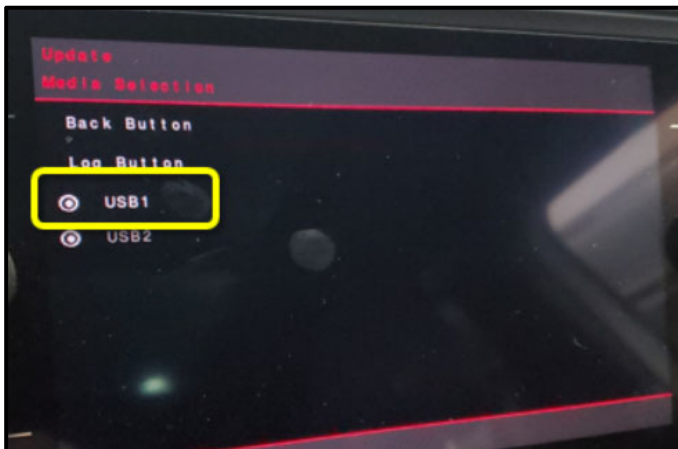
- Select the option USB 1.

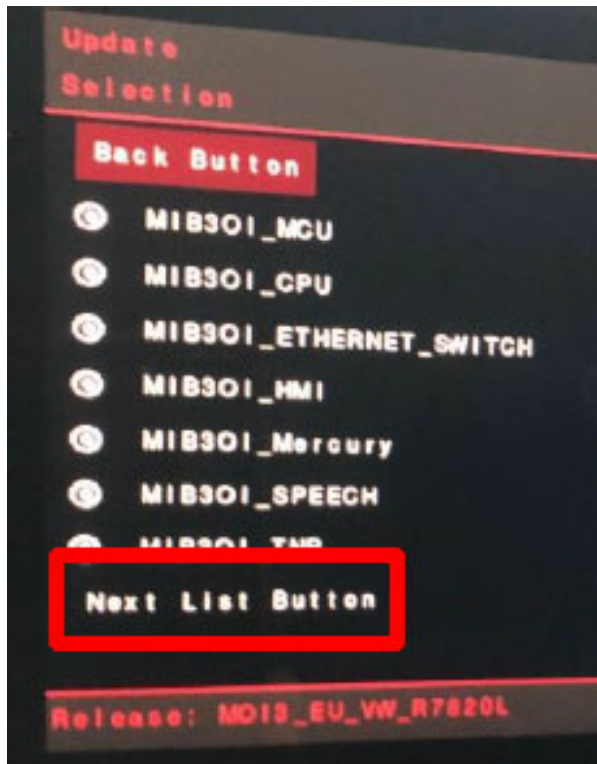
- Select "Next List Button" option (if present).

If the "Next List Button" is not present, proceed to the next step.

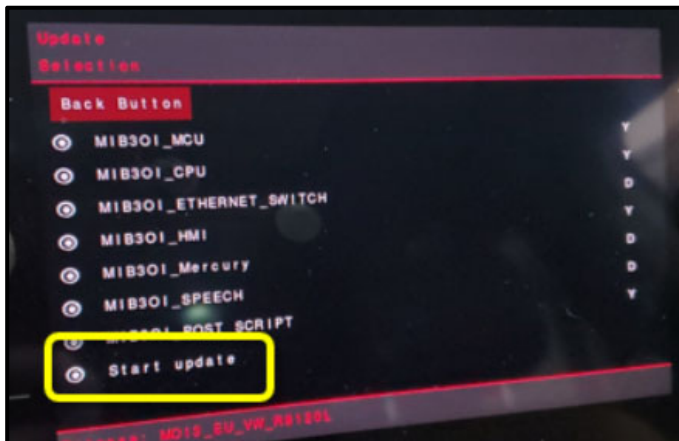
- Select "Start Update."

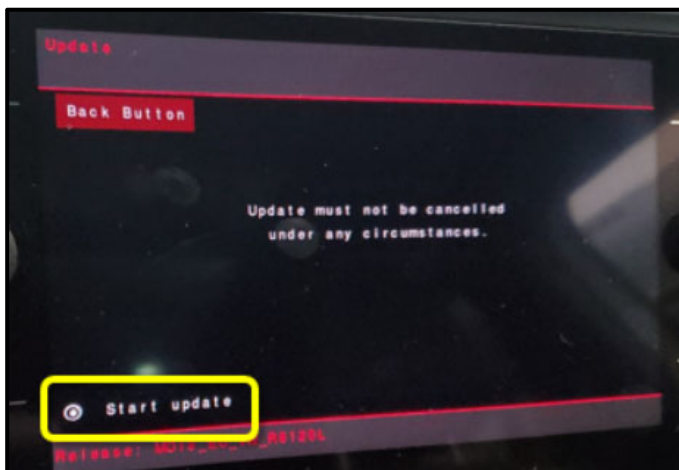
- Select "Start Update."

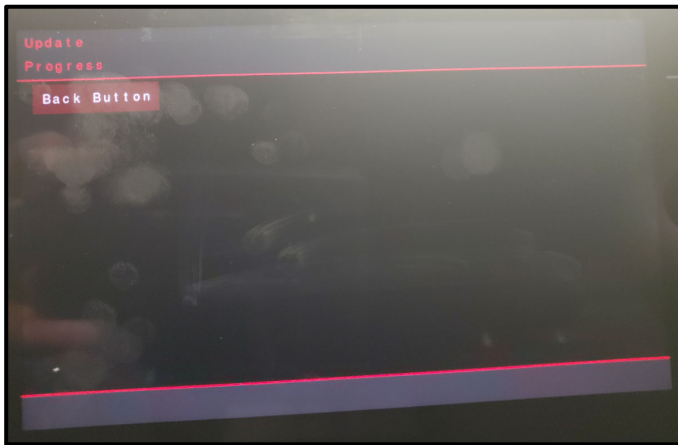
**! NOTE**  
 After starting the update, this screen may appear and remain for up to 5 minutes.

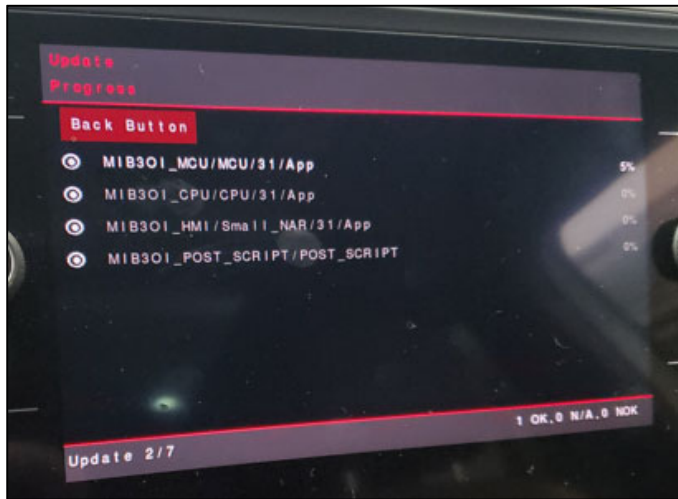
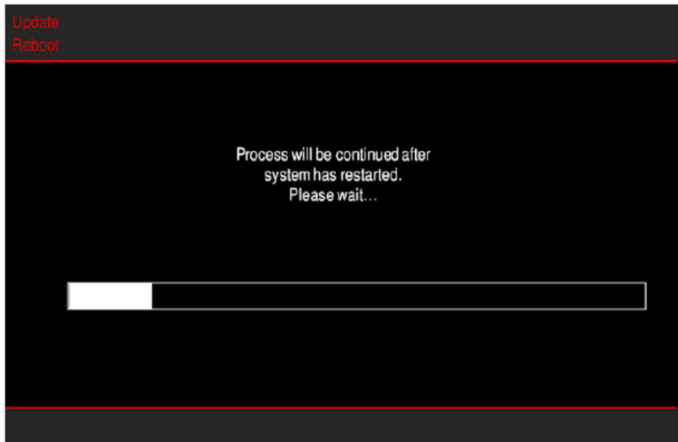
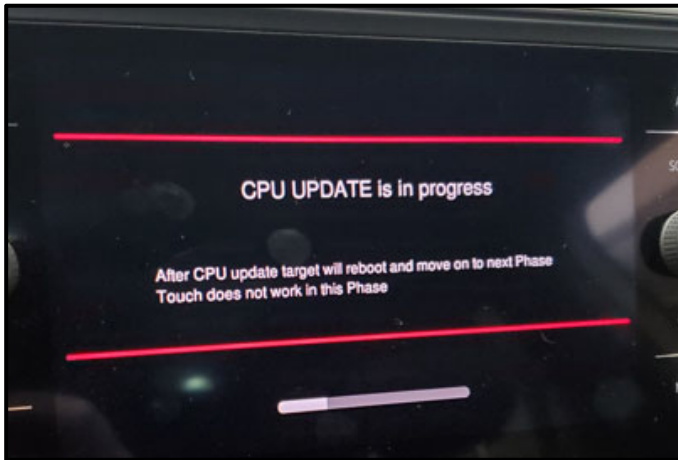
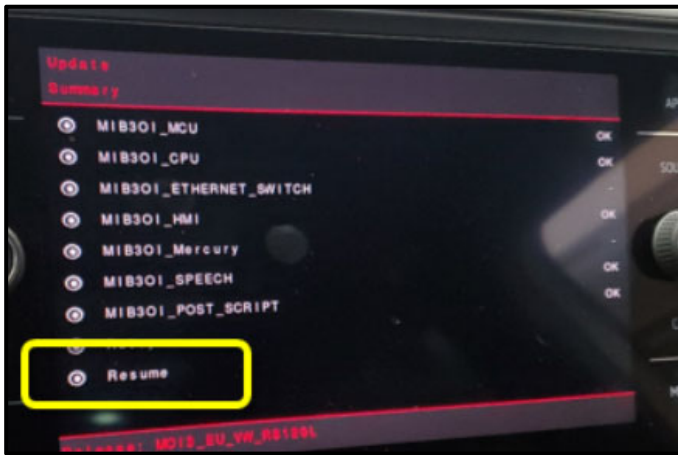
- Example Software Update progress screens shown here.

**! NOTE**  
 The screen may go blank a few times during the update.

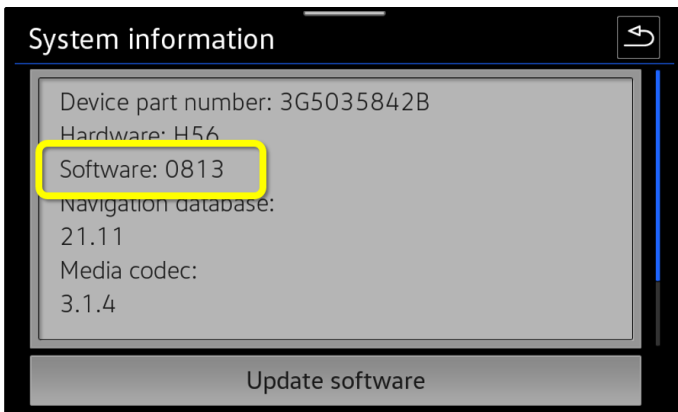
- Confirm the software is updated to version 0813.
  - Click Menu
  - Settings
  - System Information
- Switch off ignition
- Remove USB drive.

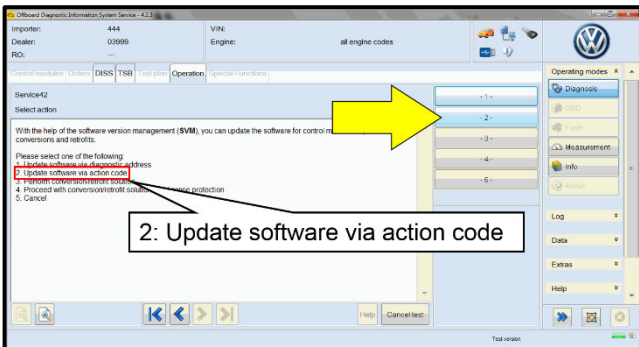
- Select the correct option to “Update software via action code” OR “Software update via measured code”.

**NOTE**  
The different options to perform the SVM operation may vary based on model.

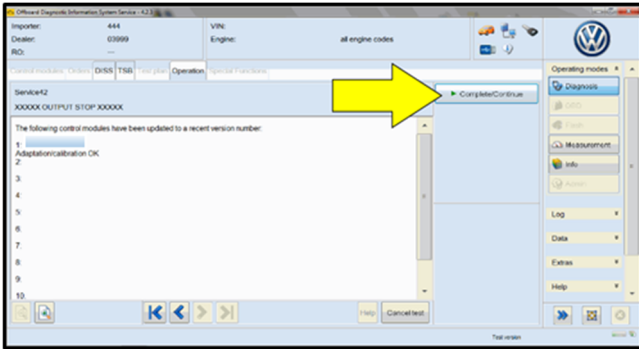
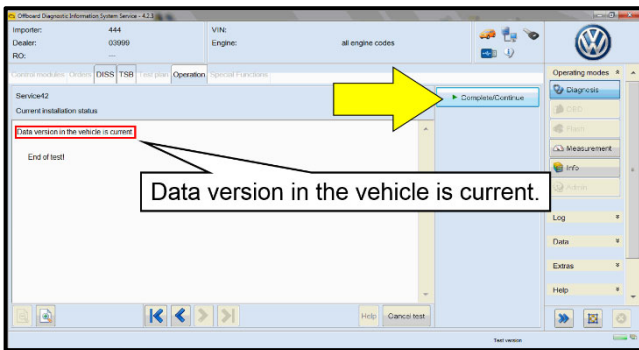
- Select "Accept" <arrow> and follow the on screen prompts.
- Select Complete/Continue <arrow> after each operation is completed.

- When the SVM update is complete a confirmation message is displayed <as shown>.
- Select "Complete/Continue" <arrow>.

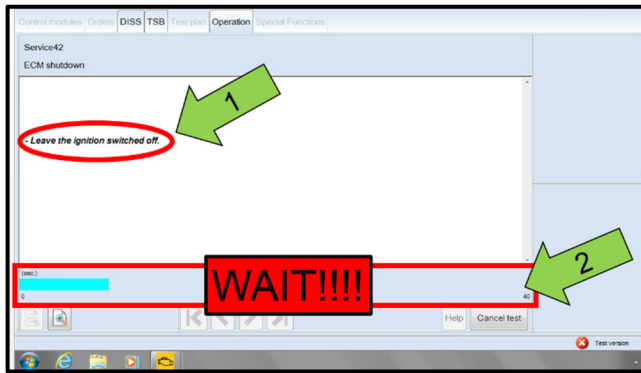
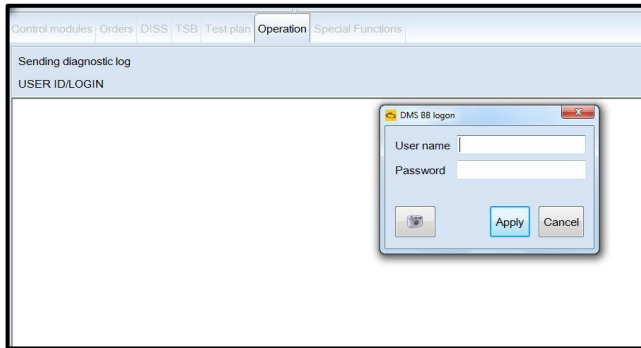
- It is **IMPERATIVE** that **ALL** of the ignition cycle on/off delay requests are fulfilled in their entirety during this flash process <arrow 1>.
- Failing to wait for the ignition on/off timing cycle to complete (progress bar and countdown timer <arrow 2>) before cycling the ignition on/off **MAY** damage a control module.
- Damage to control modules as a result of failing to wait the specified time displayed by the progress bar and countdown timer <arrow 2> are **NOT** covered under this action.
