TECHNICAL INSTRUCTIONS
FOR
22TC01
DATA COMMUNICATION MODULE (DCM) REPROGRAMMING

CERTAIN
2021 MODEL YEAR C-HR, RAV4 PRIME, TUNDRA

CERTAIN
**2021-2022 4RUNNER, HIGHLANDER, HIGHLANDER HV,
PRIUS PRIME, SEQUOIA, TACOMA**

CERTAIN
2022 PRIUS

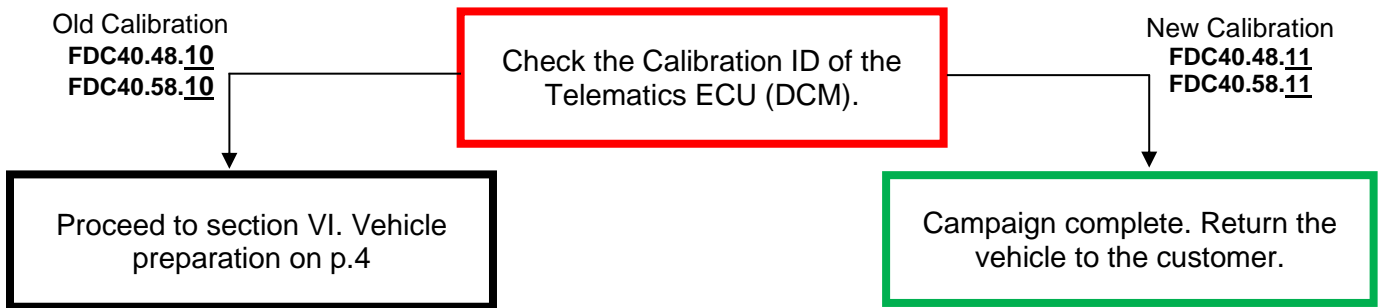
2. CHECK CURRENT CALIBRATION

- Locate the Calibration column for the Telematics in the Stored Data tab for this vehicle.
- Check the Calibration ID of the Telematics ECU (DCM).

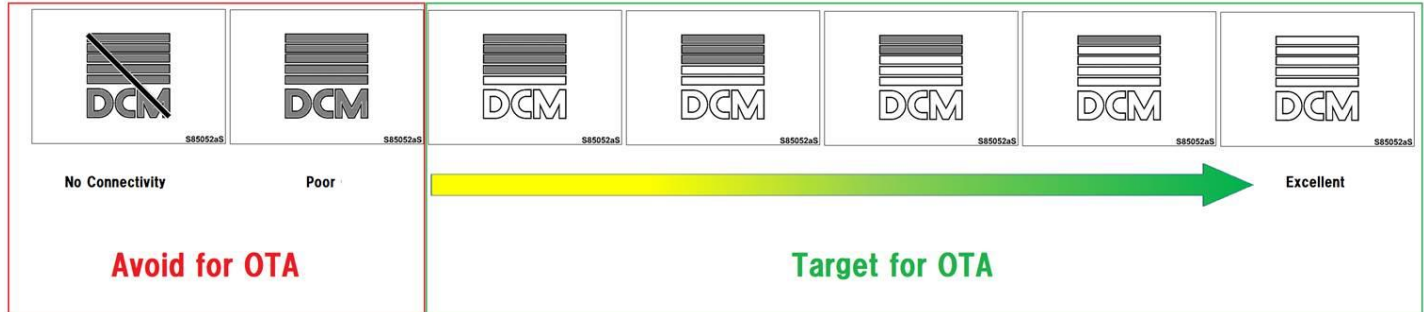
- a) Confirm that the DCM signal reception level shown in the upper right corner of the head unit display is not out of range. If the display shows poor or no connectivity, move the vehicle to another safe location with adequate signal reception.

- Refer to the image below for target signal reception.
- Full signal is not required but you must have at least one bar.

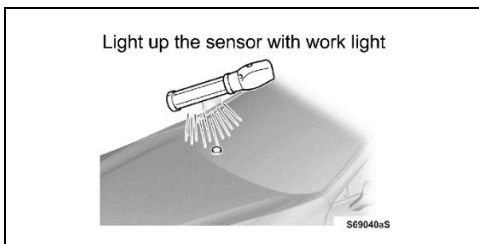
- a) Confirm the following conditions (Example):
 - Vehicle in the IG position (engine off).
 - Open the driver's door window.
 - Transaxle in P range.
 - Parking brake engaged.
 - Turn off all electrical accessories (i.e. air conditioning system, audio system, etc.)
 - Headlight switch in the DRL OFF position.(w/ DRL OFF position)
 - Windshield wiper switch in the OFF position.

- b) When the vehicle has no "off position" in the light control switch:
 - 1) Turn the IG ON.
 - 2) Set the light control switch to the AUTO position and make sure that the exterior lights are turned on.
 - 3) Light up the automatic light control sensor with work light to keep the exterior lights turned off.

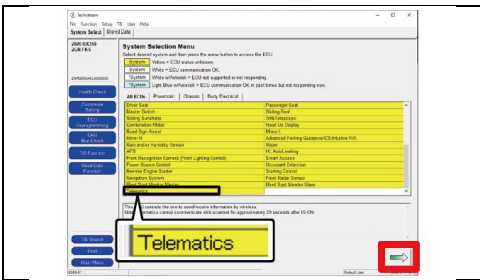
- b) Select the "System Select" tab at the top left of the screen, select "Telematics" and click the right-arrow.

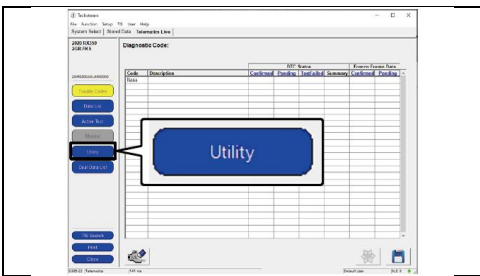
- c) Click "Utility".

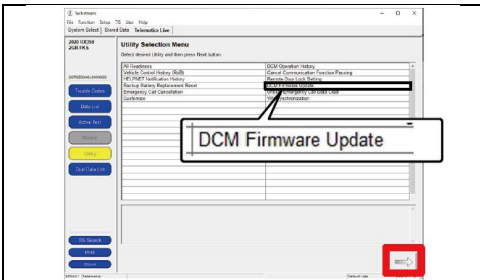
- d) Select "DCM Firmware Update" and click the right-arrow.

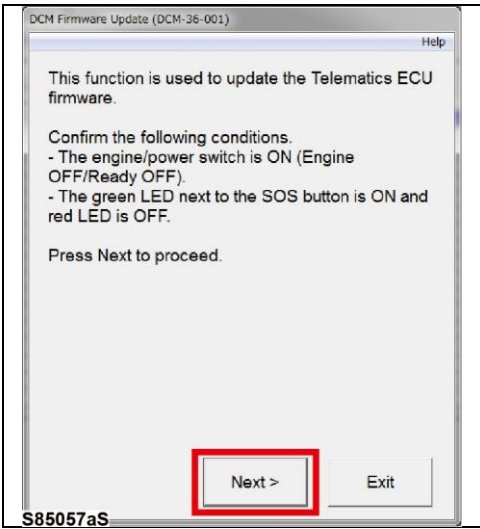
e) Click "Next".

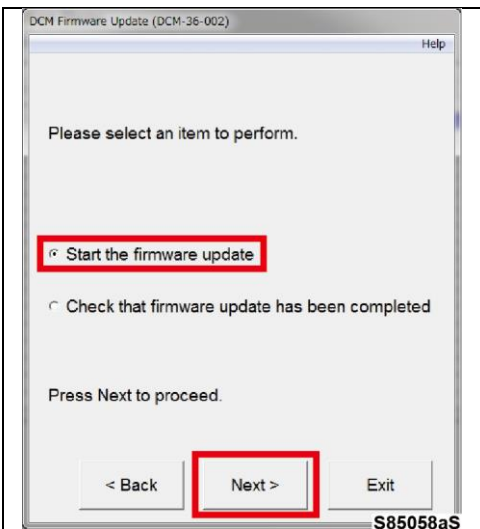
f) Select "Start the firmware update" and click "Next".

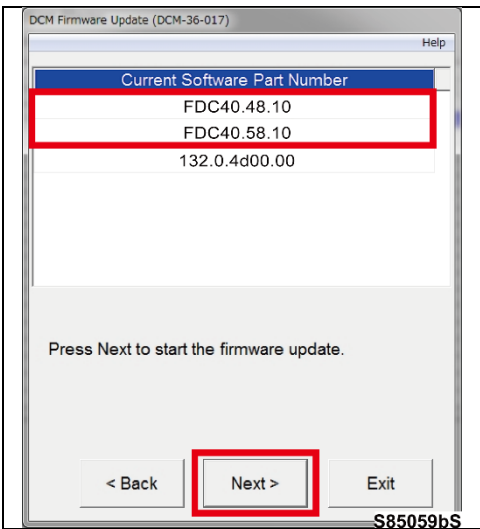
g) Confirm that the displayed software part number (Calibration ID) is the one to be reprogrammed, then click "Next".

Software Part Number to be reprogrammed	New Software Part Number
FDC40.48.10	FDC40.48.11
FDC40.58.10	FDC40.58.11

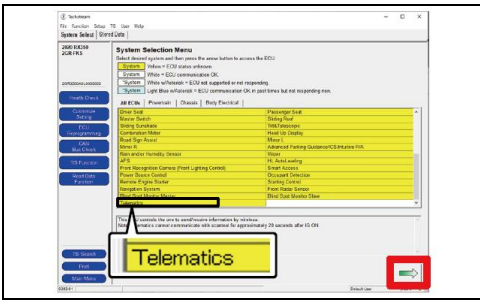
- a) Launch the left-side display, select “Telematics” and click the right-arrow.

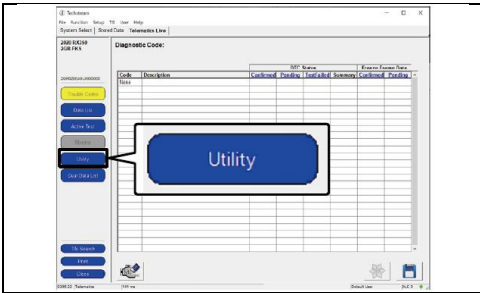
- b) Click “Utility”.

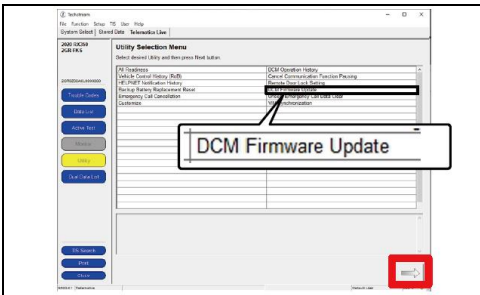
- c) Select “DCM Firmware Update” and click the right-arrow.

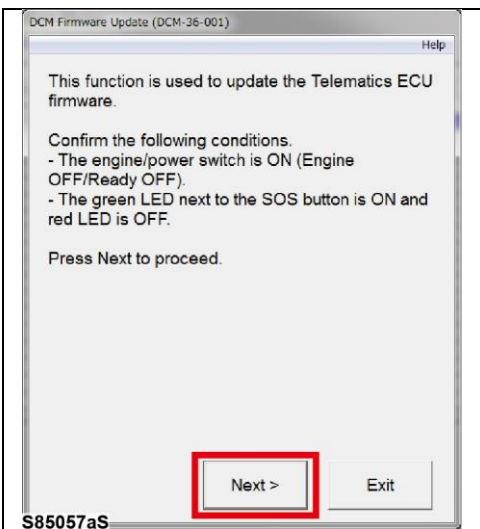
- d) Click “Next”.

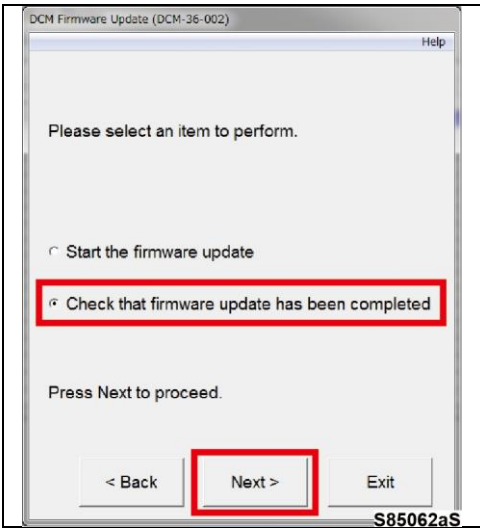
e) Select “Check that firmware update has been completed” and click “Next”.

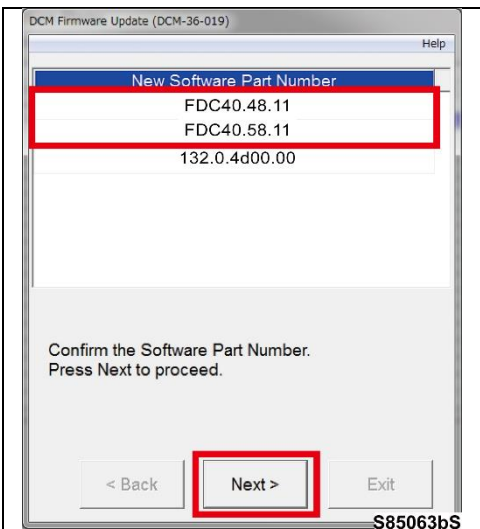
f) Confirm that the displayed software part number (Calibration ID) has been changed to the new one, then click “Next”.

New Software Part Number
FDC40.48.11
FDC40.58.11

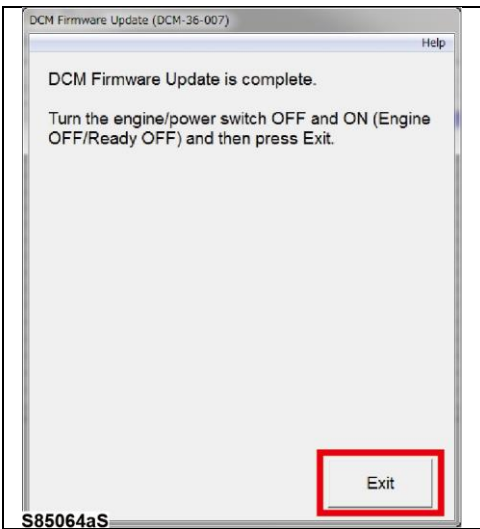
g) Turn the IG ON, then OFF, then ON, then click “Exit”.

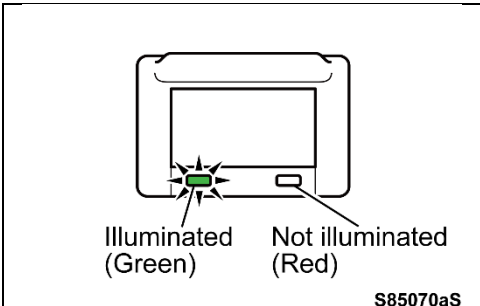
- Turn the IG ON.
- To confirm that the Safety Connect services are available, check that the green indicator is illuminated and the red indicator is not illuminated after approximately 2 seconds from the IG ON.

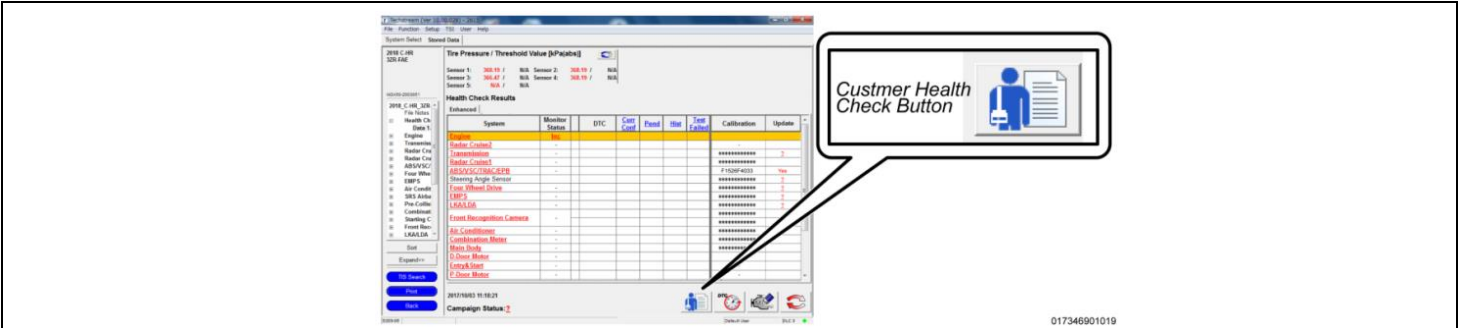
- a) From the Stored Data tab, select the Customer Health Check Report button (TIS will launch when button is pressed).

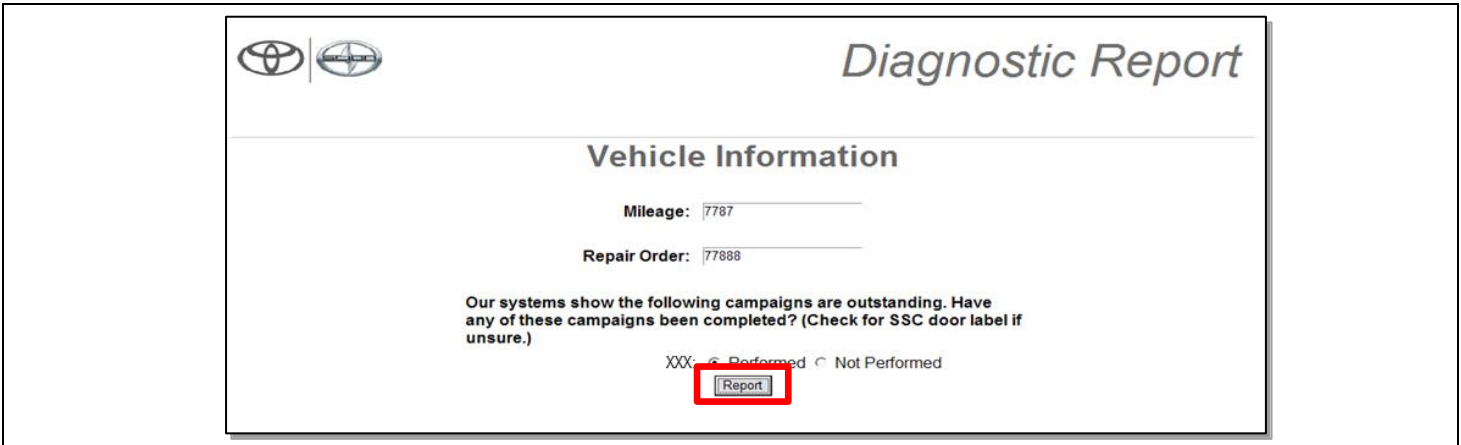
- b) Log in to TIS.
- c) Input Vehicle Mileage and Repair Order number.
- d) Check the “Performed” campaign radio button for the applicable campaigns completed during this service event.
- e) Select the Report button.

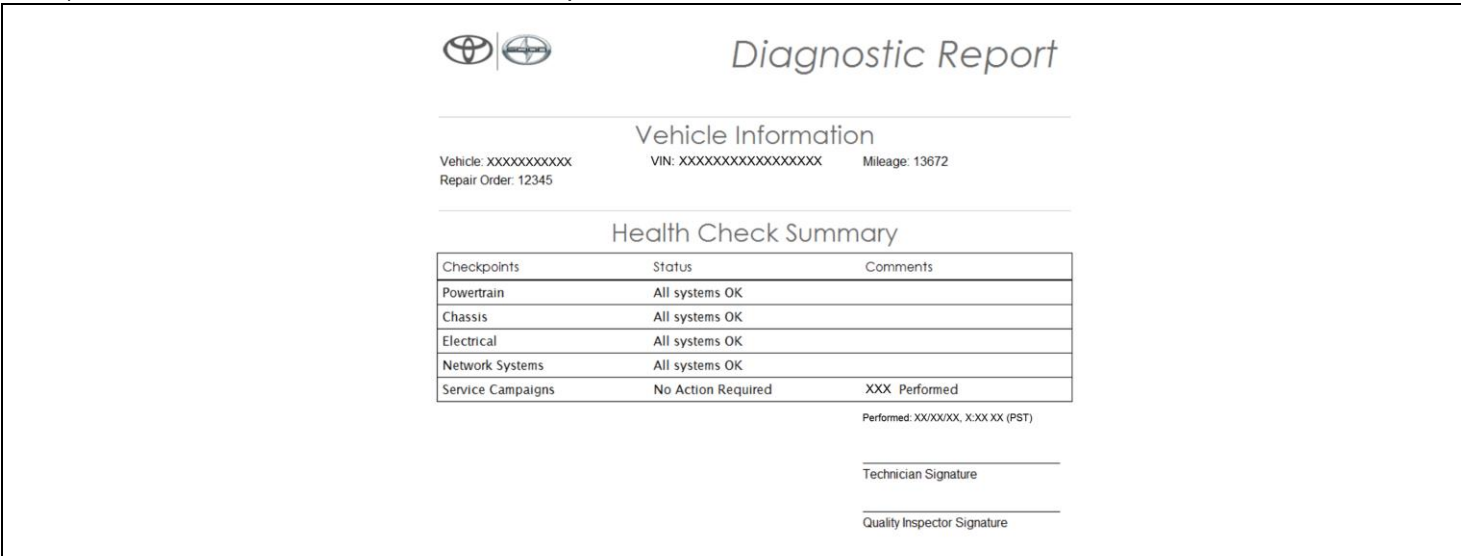
- f) Confirm Customer Health Check Report information is correct.
