SERVICE BULLETIN

INFOTAINMENT SYSTEM CONSTANTLY REBOOTS EVERY 4-5 MINUTES

APPLIED VEHICLES: 2022 Pathfinder (R53)
APPLIED GRADES: SV vehicles that are, or were, part of a rental fleet

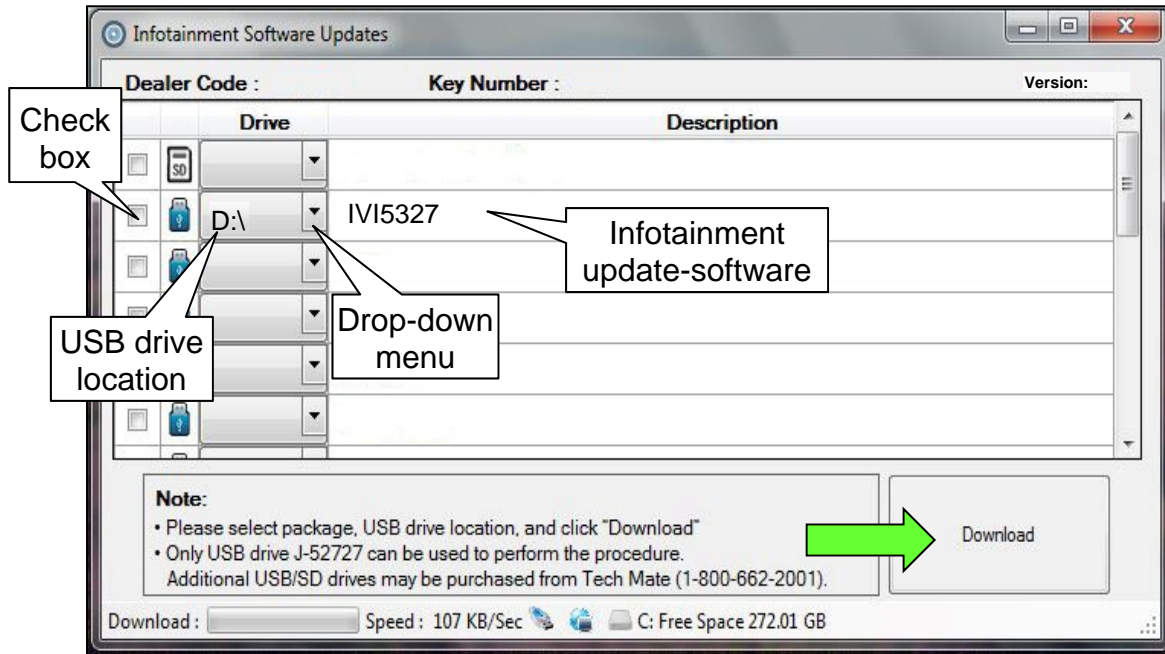
Figure 3

- Select the check box next to infotainment update-software ID **IVI5327** (Figure 3).
- Use the drop-down menu and select the location of the USB drive that was inserted in step 1 on page 3.

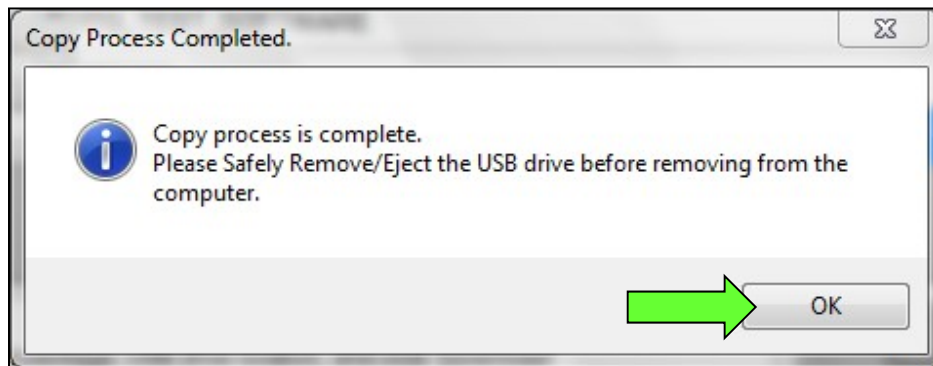
Figure 4

- Select **Download**, and then wait for the download to complete.
HINT: The update-software is estimated to take **4 hours** to download to the USB drive.
- Select **OK**.

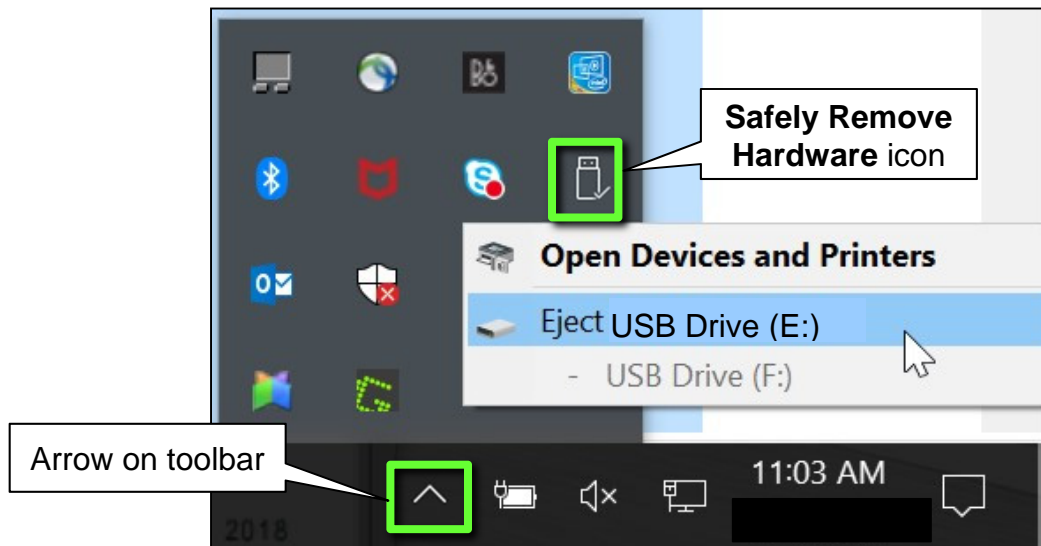
Figure 5

8. Once the transfer is complete, safely remove the USB drive from the CONSULT PC.
 - a. From the PC toolbar, select the **Safely Remove Hardware** icon.
 - o The icon is on the toolbar, or can be found after selecting the arrow.
 - b. Select the USB drive to be removed, and then remove the USB drive from the CONSULT PC.

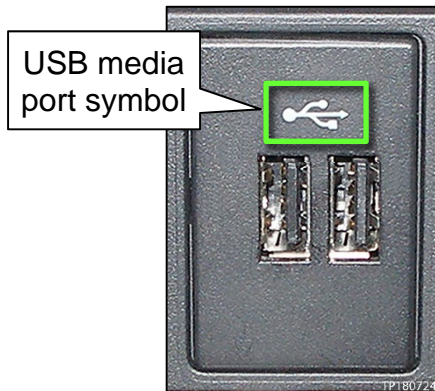
Figure 6

12. Insert the USB drive with the infotainment update-software into the vehicle's USB media port (Figure 6).

HINT: Charging ports are marked in the vehicle with a “lightning bolt” symbol.

Do not insert the USB drive into a charging port. If used, the update-software and/or USB drive may become damaged. Only insert the USB drive in a USB media port.

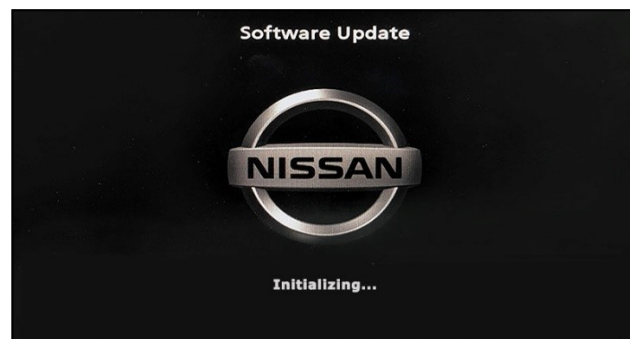
13. Wait approximately 10-30 seconds for the screen in Figure 8 to appear.

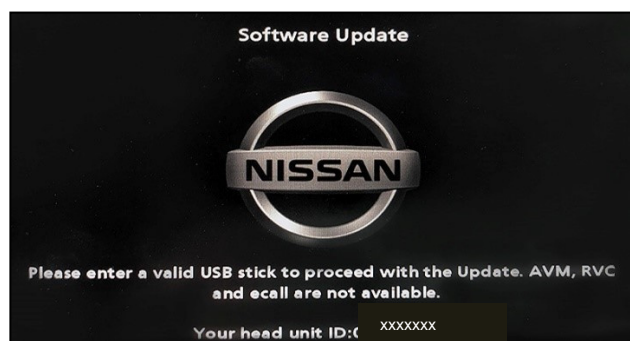
- The screen in Figure 9 may briefly appear. **Do not remove the USB drive.** The audio system will detect the USB and continue the update.

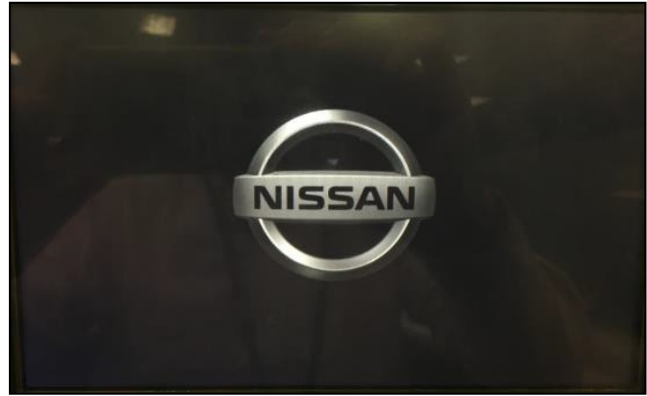
Figure 12

22. Turn the ignition ON (engine OFF) and wait for the Nissan logo to appear (Figure 12).
 - If the Nissan logo does not appear (this might take up to 30 seconds), start over from step 17.
23. After the Nissan logo appears, wait about 1 minute.
 - The MENU (Home) screen in Figure 13 will be displayed.
