# CAMPAIGN BULLETIN

## Passenger Knee Air Bag Dealer Inventory

Reference: PC858

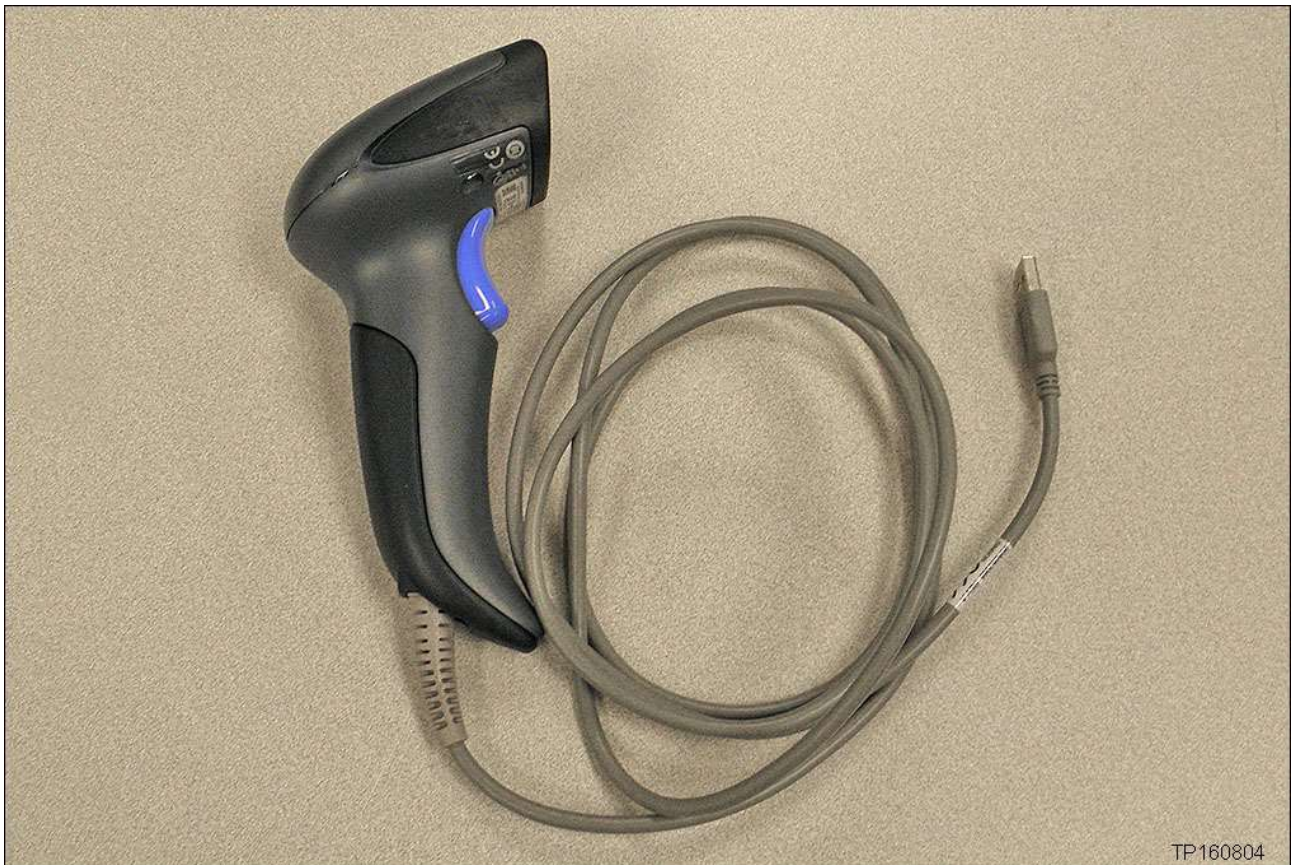
Figure A

Quick Scan Tool (J-52352)

- Each retailer has been shipped one Quick Scan Tool (J-52352).
- Additional tools can be obtained from Tech•Mate at 1-800-662-2001.

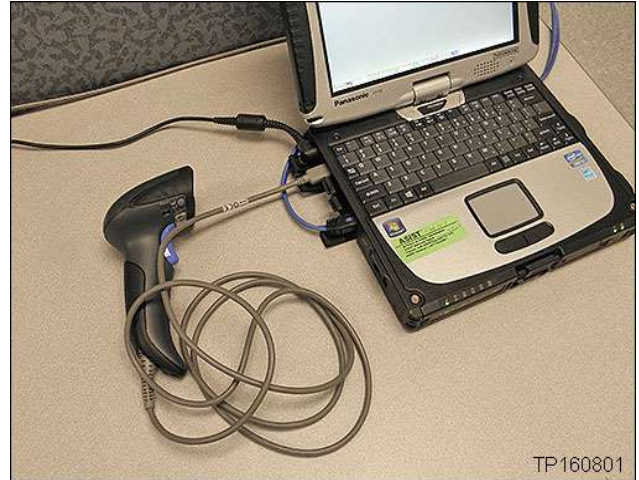
Figure 1

- a. Attach the quick scan tool (J-52352) to your CONSULT PC USB port.

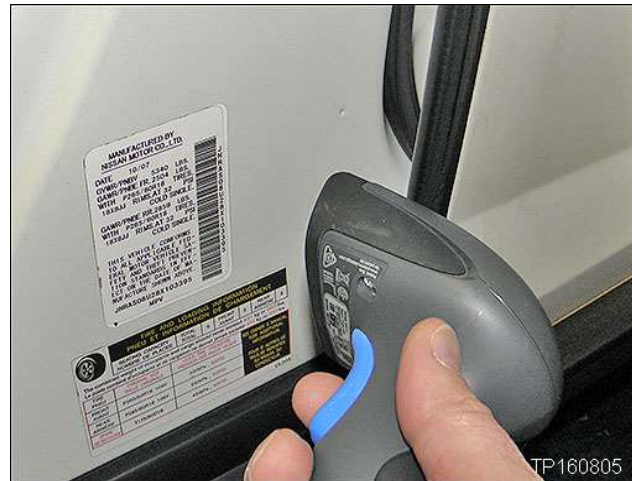
Figure 4

- d. Use the quick scan tool to scan the bar code (VIN) on the B-pillar label.
- Wipe any dirt/debris from bar code before scanning.

- Some labels may not scan quickly.
- Hold the scan tool approximately 6 inches away from the label.
- Hold the trigger down until the label is read (this may take several seconds).
- VIN will automatically populate (see Figure 5).
- If needed, VIN can be entered manually.
