P20EE (diagnostic troubleshooting code) SOLUTION - NOX CONVERSION EFFICIENCY

Prevost vehicles

B13R (9700 us/can)

SP18-35H

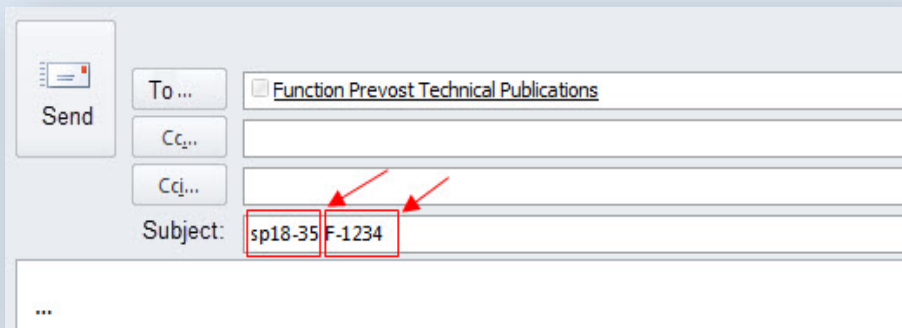
Please indicate in the "subject line": SP18-35 and the short V.I.N. as in the example below...
