Release Date	04/12/2022	Technical Service Bulletin
90T6 UPDATE

ConBox Software Update – (NVLW)		Audi

Release Date	04/12/2022	Technical Service Bulletin
90T6 UPDATE ConBox Software Update – (NVLW)

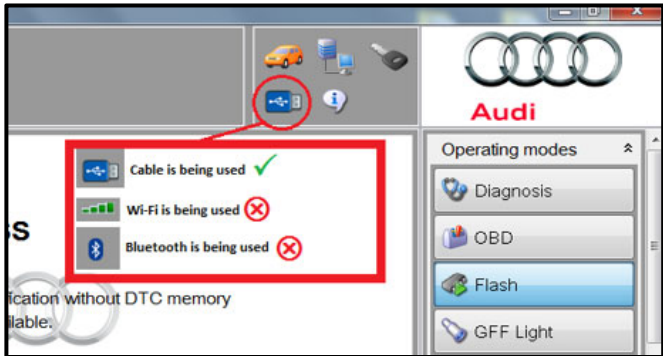
- Connect the VAS6150X/VAS6160X Diagnostic Tester to the vehicle.
- Start the ODIS program.

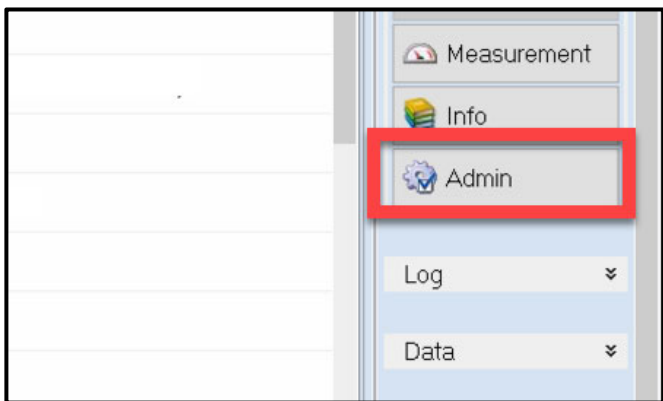
- Confirm that scan tool is communicating with the diagnostic head by USB cable.
 - If the Bluetooth or WiFi symbol is shown, then disconnect the diagnostic head from the vehicle and reconnect the USB cable to the diagnostic head and then reattach to the vehicle.

- ✓ **The VAS Diagnostics Interface MUST ONLY be connected to the tester with a USB cable.**
 - Performing a software update using a Bluetooth or WiFi connection increases the risk of losing connection during the update, which could result in damage to the control module. It also greatly increases the time required to perform the update. Requests for additional time or parts will be denied if the GFF log shows the update was performed using Bluetooth or WiFi.

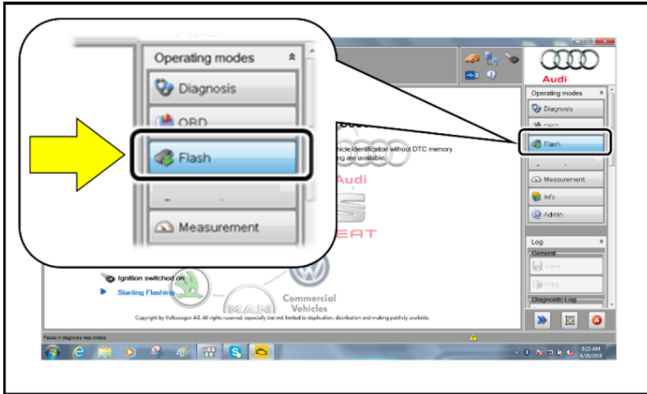
- Select “Yes” when prompted, “Do you really want to save?”
- Return to the home screen of the scan tool.

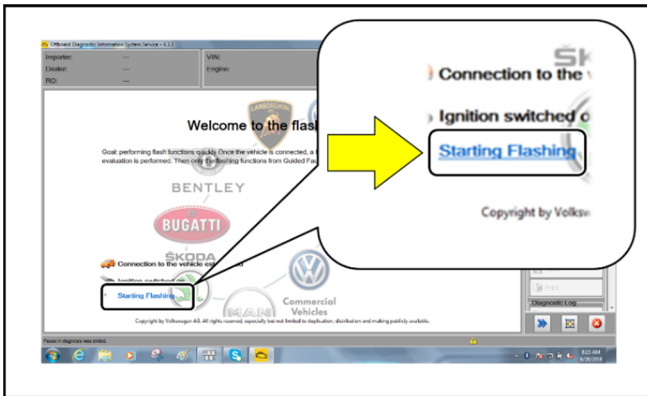
- From the home screen of the scan tool highlight “Flash” <1>.
- Follow the on-screen prompts.

Operating mode “Flash” must be used. Performing this software update using “Diagnosis” (Guided Fault Finding) could result in non-payment of the claim.

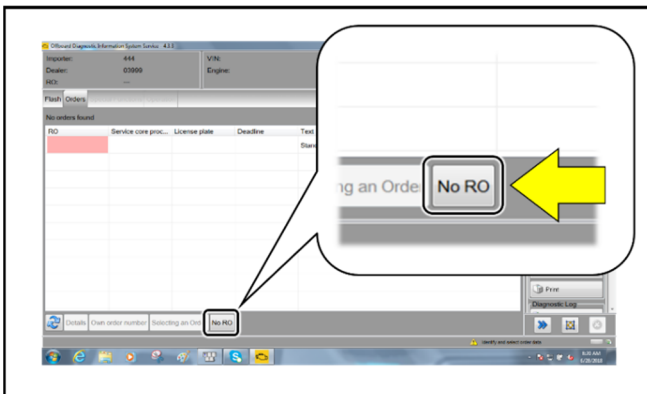
- Select “Starting Flashing” and follow the on-screen prompts.

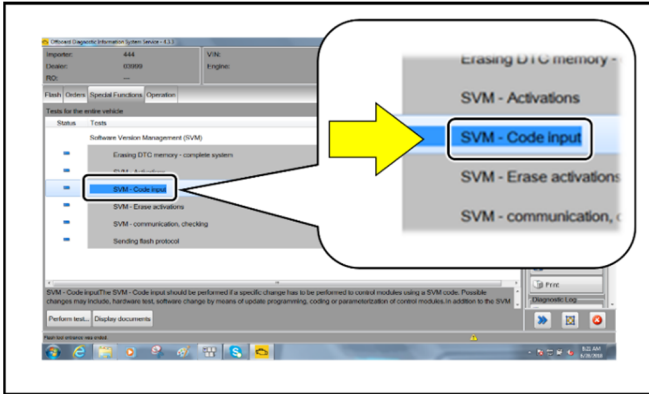
- Select “No RO”.

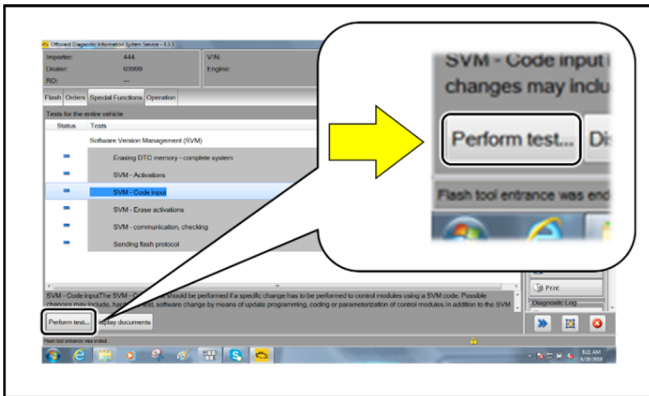
- Highlight “SVM – Code Input”.
