Release Date	4/26/2022	Technical Service Bulletin		
93N6 UPDATE				 
Software Update for Battery Modules Control Unit – (NVLW)

This Update has been proactively released to prevent the following condition(s) from occurring in the vehicle:	
Criteria	Technical Background
S1	A software update is necessary on Audi e-tron vehicles manufactured within a specific period. The battery system of an electric vehicle consists of a large number of individual battery cells. These cells have the same capacity and slightly different cell voltages. Without a balancing function, the capacity of the entire system would align itself with the capacity of the weakest cell. In addition, individual cells could be overloaded and age more rapidly. The efficiency of the balancing function may be affected by a possible error in the cell voltage measurement. This software update optimizes the function of the control unit with respect to balancing and stabilizes the cell voltage measurement.

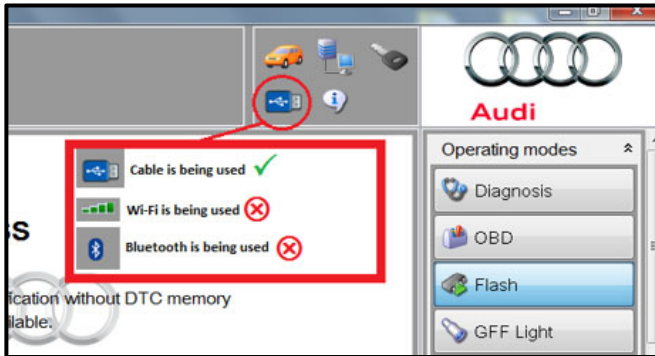
- Confirm that scan tool is communicating with the diagnostic head by USB cable.
 - If the Bluetooth or WiFi symbol is shown, then disconnect the diagnostic head from the vehicle and reconnect the USB cable to the diagnostic head and then reattach to the vehicle.

- ✓ **The VAS Diagnostics Interface MUST ONLY be connected to the tester with a USB cable.**
 - Performing a software update using a Bluetooth or WiFi connection increases the risk of losing connection during the update, which could result in damage to the control module. It also greatly increases the time required to perform the update. Requests for additional time or parts will be denied if the GFF log shows the update was performed using Bluetooth or WiFi.

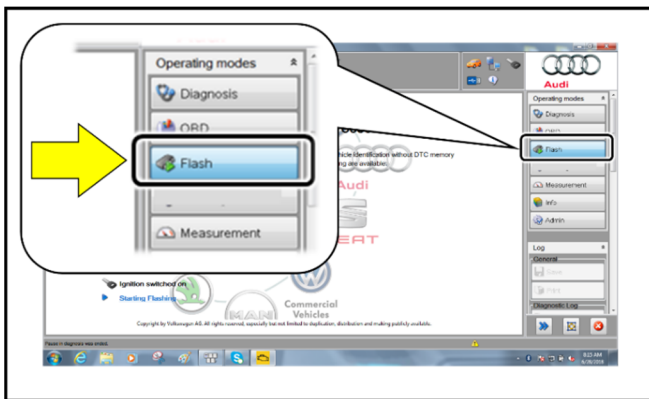
- From the home screen of the scan tool highlight “Flash” <1>.
- Follow the on-screen prompts.

Operating mode “Flash” must be used. Performing this software update using “Diagnosis” (Guided Fault Finding) could result in non-payment of the claim.

- ✓ **Flash process through “Audi Flashing” not Guided Fault Finding (GFF).**
 - DO NOT USE Guided Fault Finding (GFF) to perform this flash. Using GFF will cause the flash to take longer. Requests for additional time will not be considered.

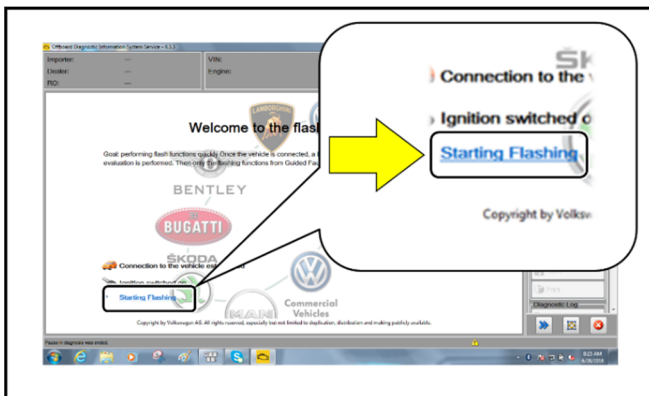
- Select “Starting Flashing” and follow the on-screen prompts.

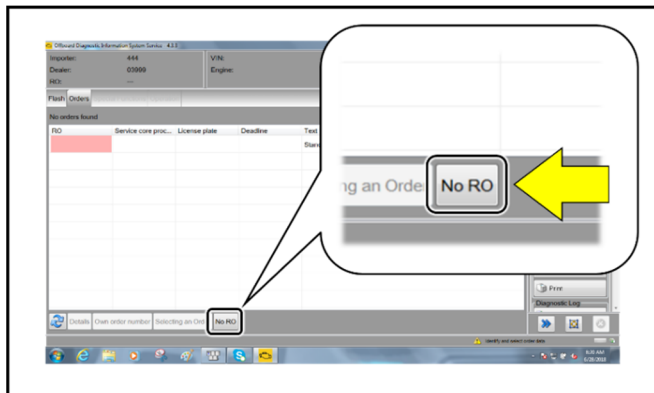
- Select "No RO".

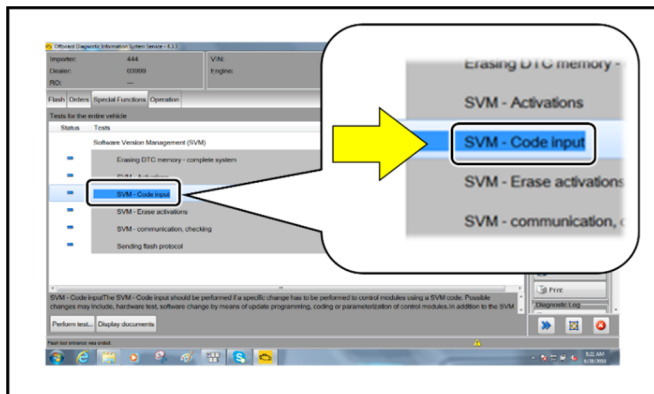
- Highlight "SVM – Code Input".

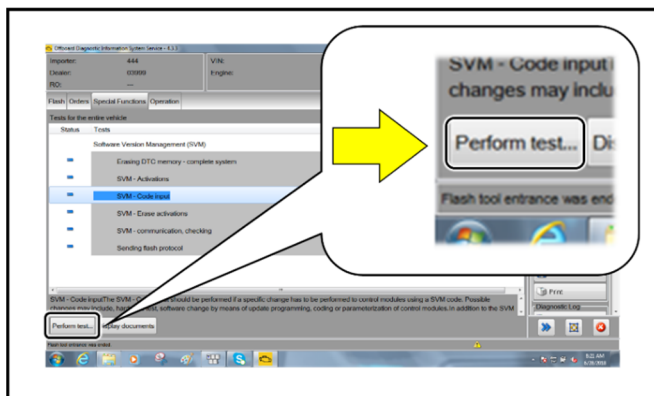
- Select "Perform test".

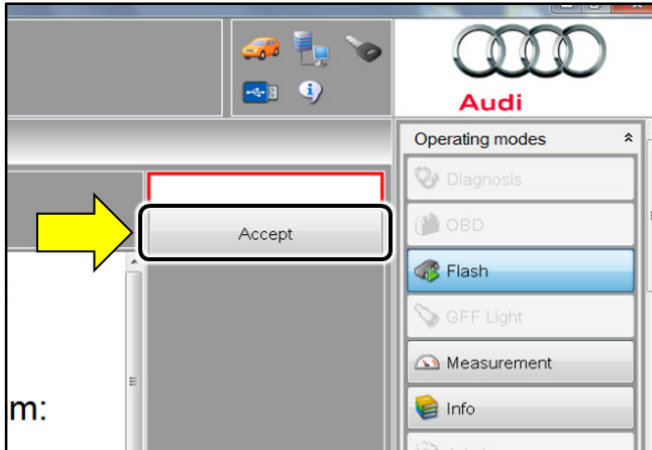
- Enter the corrective action code (SVM code) as listed below.

93N6A268

- Select "Accept" <arrow>.
- Follow the on-screen prompts.

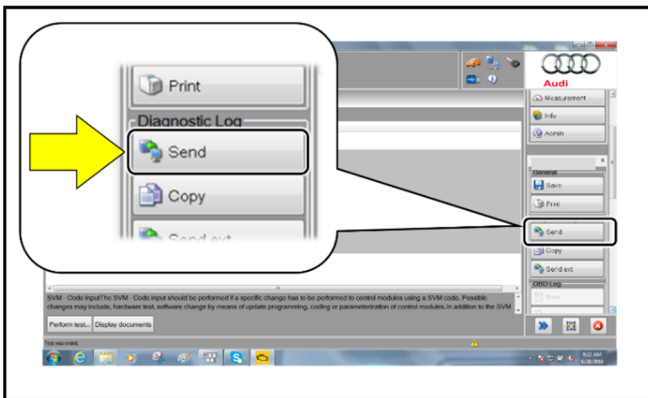
- After receiving confirmation that the flash completed successfully, select "Send" <arrow> to send the diagnostic protocol online.
- Follow the on-screen prompts.

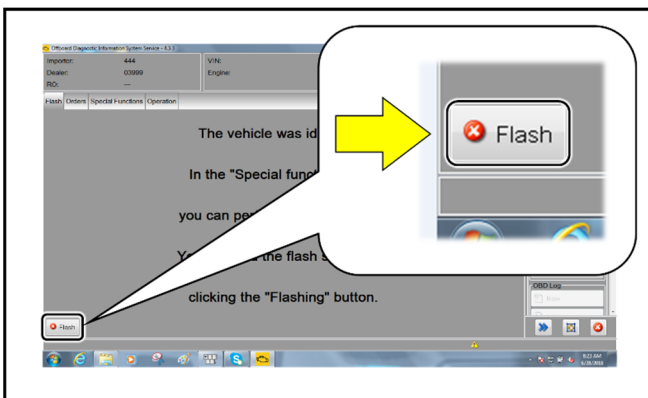
- Click "Flash" <arrow> to exit the flash session.
- Various event memory entries may be generated after the flashing procedure on some vehicles. Put the vehicle in a corresponding bus sleep mode after performing the update in order to clear the faults.
- To put the vehicle in bus sleep mode, disconnect the diagnostic tester, remove the key from the vehicle and lock the vehicle with the remote for 6 minutes.
