WARRANTY BULLETIN WARRANTY CAMPAIGN

Campaign no.: 2021-0004
2022-0006

Subject: **Engine Starting Issue - Low Compression**

No. **2022-4**

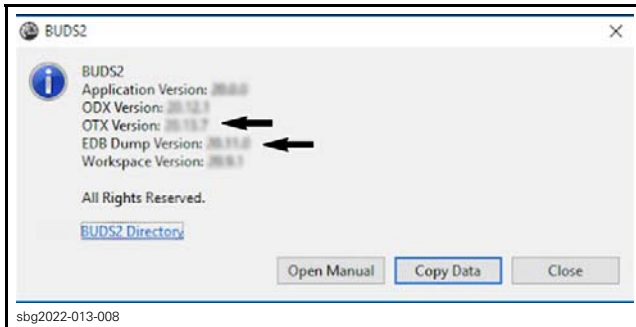
1. Start BUDS2 and logon.
2. In BUDS2, go to:
 - About page
3. Validate the following:
 - OTX Version: **22.7.0** or newer
 - EDB Dump Version: **22.7.0** or newer.

If the information is different, connect the computer to Knowledge Center to update BUDS2.

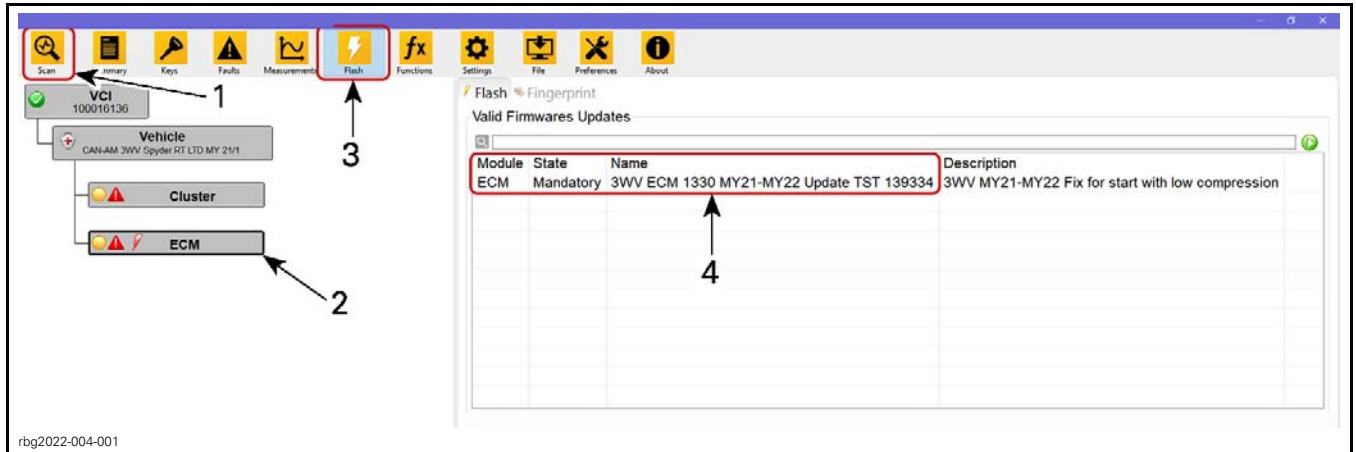
TYPICAL

1. Connect the vehicle to the BRP diagnostic software (BUDS2).
2. In BUDS2, go to:
 - Select **Scan** page
 - Select **ECM** button
 - Select **Flash** tab.
 - Double click on Mandatory Flash File to install.

1. Scan page
2. ECM button
3. Flash tab
4. File Name(s) to Update
