Product Update: 2015–20 TLX PGM-FI Idle Stop Software Update

AFFECTED VEHICLES

Year	Model	Trim	VIN Range
2015–20	TLX	V6 SH-AWD	Check the iN VIN status for eligibility.

Update the PGM-FI Software.

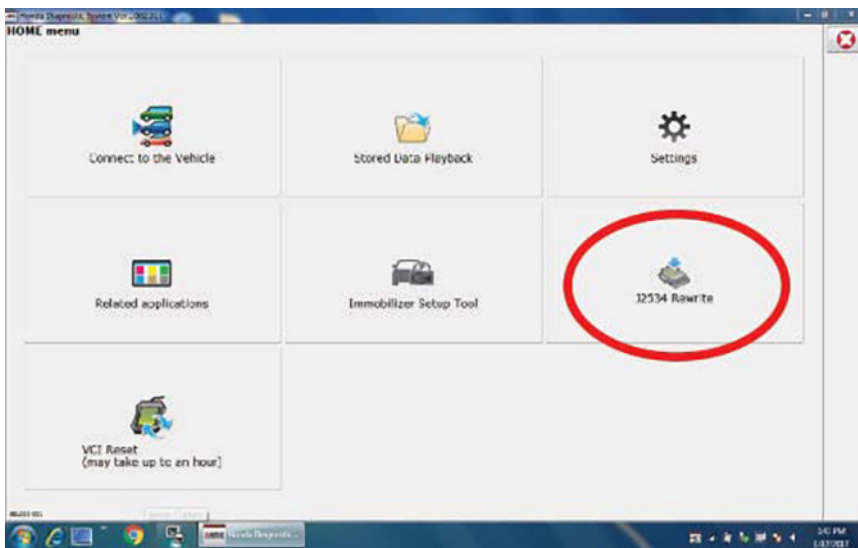
2. From the HOME menu, select the **J2534 Rewrite**.

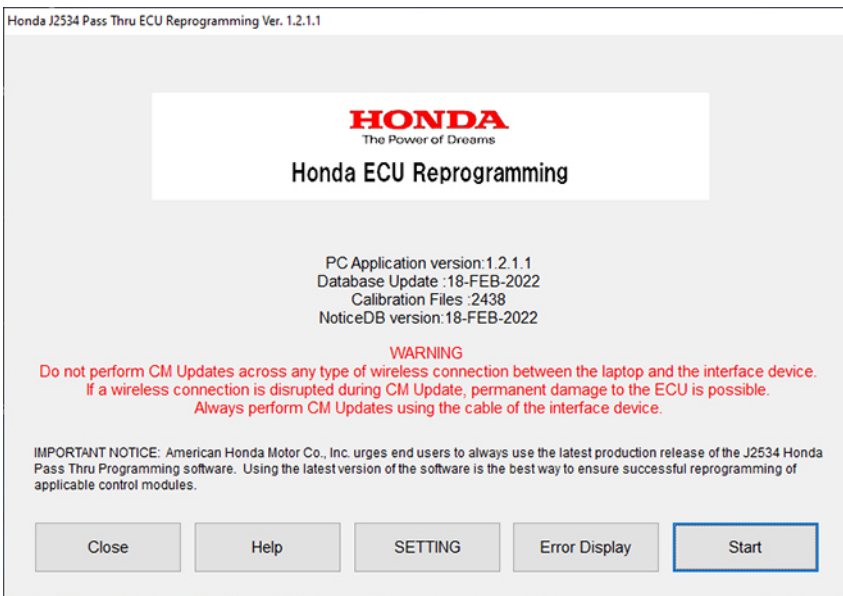
4. Connect the i-HDS to the vehicle and select **Start** to begin reprogramming.
