# TECHNICAL TOPICS

AJ20-P6 Overheat Warning on Highway

20-22MY Defender

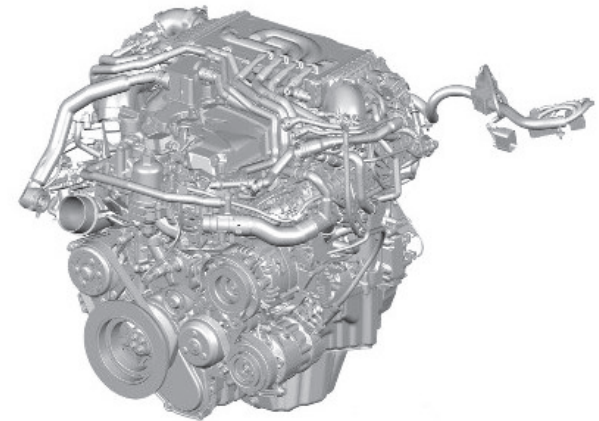
- Perform Diagnostics for Overheat (TOPIx 303-03C)
- PCM software has been released to resolve the issue. (OTX TBC)
- Verify coolant pump is stuck by verifying PCM DID 05DB (Coolant Pump Position Sensor Voltage) does not go below 3V when vehicle is fully warm (coolant temp 90C+).
