TECHNICAL INSTRUCTIONS

22LC01

DATA COMMUNICATION MODULE (DCM) REPROGRAMMING

2021 MODEL YEAR IS300, IS350, LC500, LC500h, LC500C, LS500, LS500h, NX300, NX300h, RC300, RC350, RC F

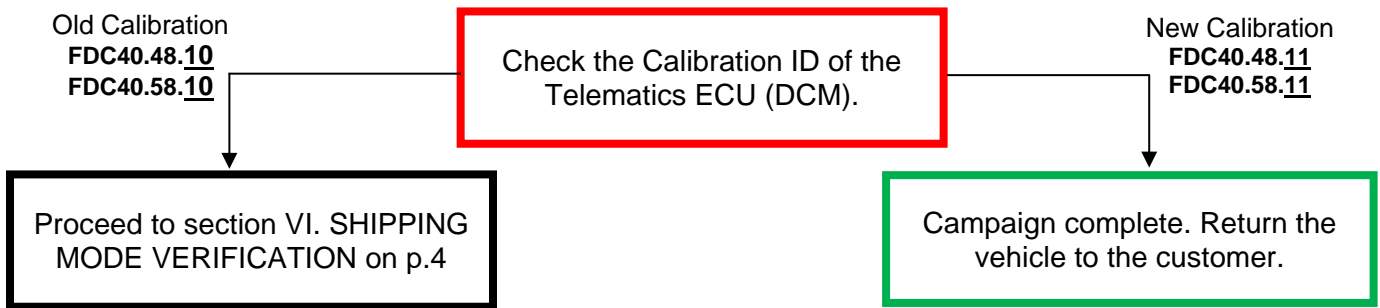
- Locate the Calibration column for the Telematics in the Stored Data tab for this vehicle.
- Check the Calibration ID of the Telematics ECU (DCM).

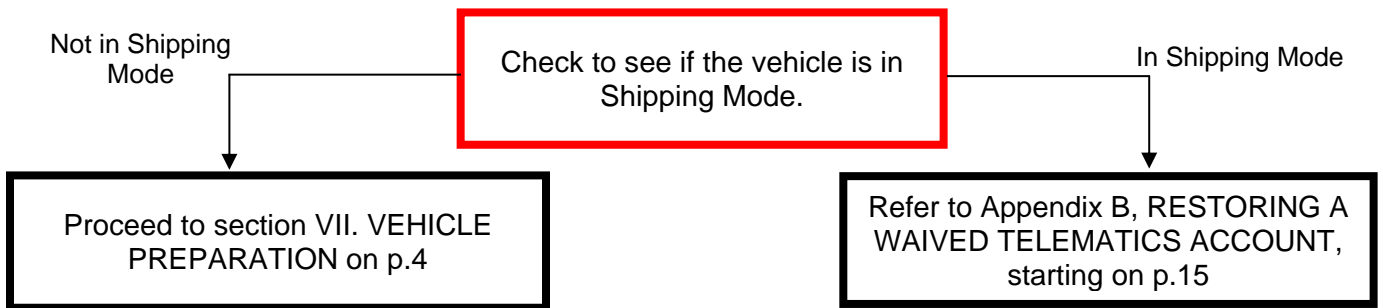
- Select the "System Select" tab at the top left of the screen, select "Telematics" and click the right-arrow.
- Select "Data List."
- Check to see if the Telematics Activation Status value is "Shipping."

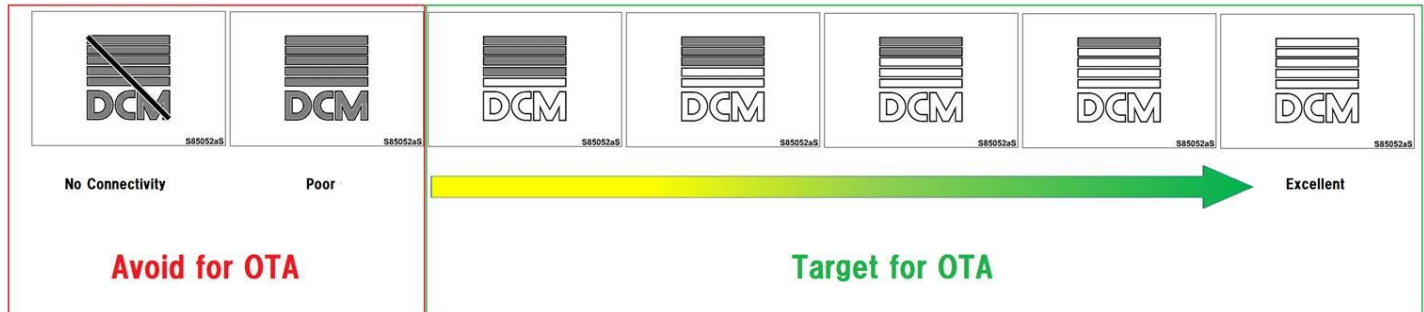
- Confirm that the DCM signal reception level shown in the upper right corner of the head unit display is not out of range. If the display shows poor or no connectivity, move the vehicle to another safe location with adequate signal reception.

- Refer to the image below for target signal reception.
- Full signal is not required but you must have at least one bar.

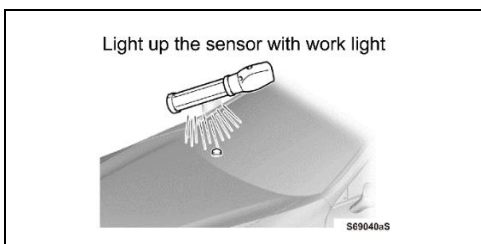
- Confirm the following conditions (Example):
 - Vehicle in the IG position (engine off).
 - Open the driver's door window.
 - Transaxle in P range.
 - Parking brake engaged.
 - Turn off all electrical accessories (i.e. air conditioning system, audio system, etc.)
 - Hedadlight switch in the DRL OFF position.(w/ DRL OFF position)
 - Windshield wiper switch in the OFF position.

- When the vehicle has no "off position" in the light control switch:
 - Turn the IG ON.
 - Set the light control switch to the AUTO position and make sure that the exterior lights are turned on.
 - Light up the automatic light control sensor with work light to keep the exterior lights turned off.

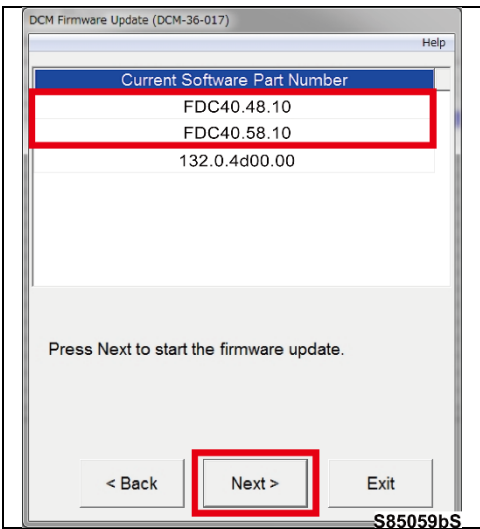
g) Confirm that the displayed software part number (Calibration ID) is the one to be reprogrammed, then click "Next".

Software Part Number to be reprogrammed	New Software Part Number
FDC40.48.10	FDC40.48.11
FDC40.58.10	FDC40.58.11
