Entune Audio Head Unit Software Update (Panasonic)

Service Category Audio/Visual/Telematics

Section Navigation/Multi Info Display **Market** USA and Mexico

Introduction

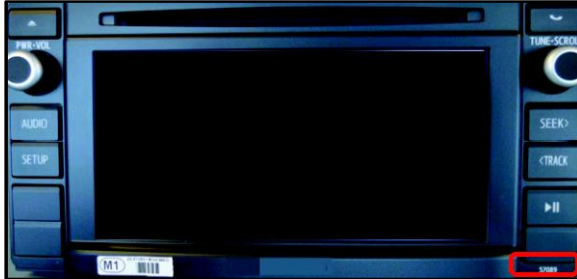
1. Confirm the audio system type by checking the faceplate ID printed on the bottom-right or bottom-center of the head unit. See Table 1 for the applicable model faceplate ID number.

Figure 1. Avalon, Avalon HV, Highlander, Highlander HV, Prius, Prius Prime, Prius V, Sienna, Sequoia, Tacoma, Tundra, Yaris

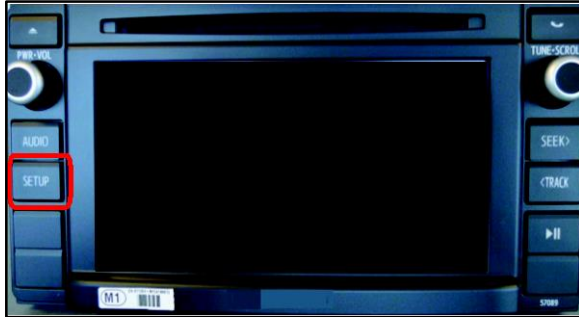
4. Go to the Setup screen.
 - A. For Entune™ Audio: Press the Setup button on the panel.

Figure 3. Tacoma, Prius, Prius Prime, Prius V, Yaris

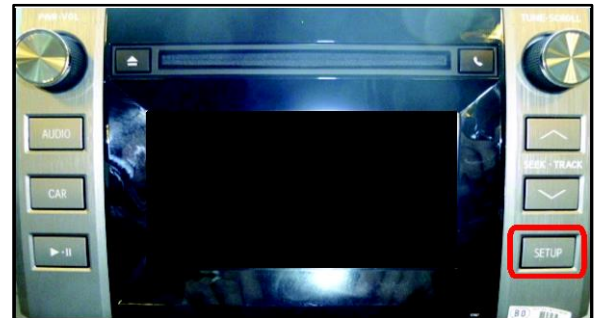
Figure 4. Tacoma, Prius, Prius V

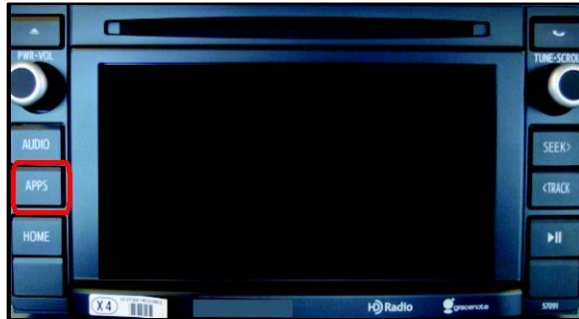
- B. For Entune™ Audio Plus and Entune™ Premium Audio: Press the Apps button on the panel.

Figure 5. 4Runner, Avalon, Avalon HV, Highlander, Highlander HV, Prius, Prius Prime, Prius V, Sienna, Sequoia, Tacoma, Yaris

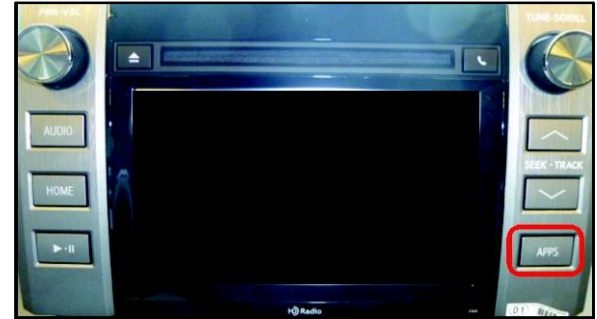
Figure 6. Tundra

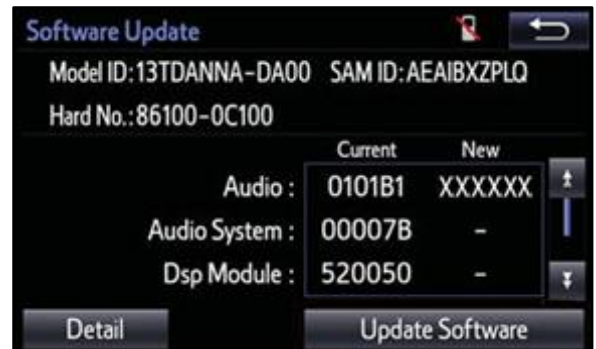
Figure 13.

9. Verify that the NEW software is up to date on the Software Update screen.

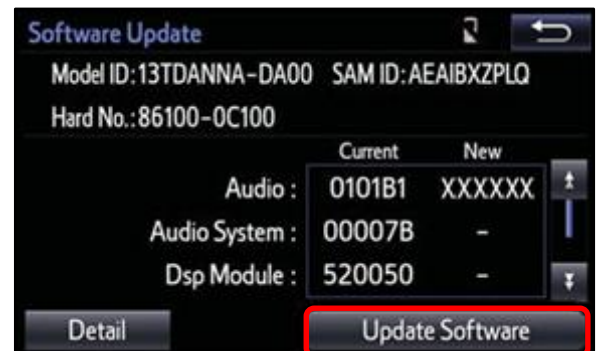
Figure 14.

10. Select Update Software on the Software Update screen.

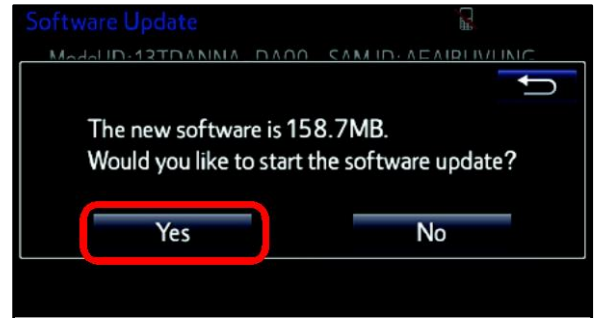
Figure 15.

11. Select Yes on the “Would you like to start the software update?” pop-up.

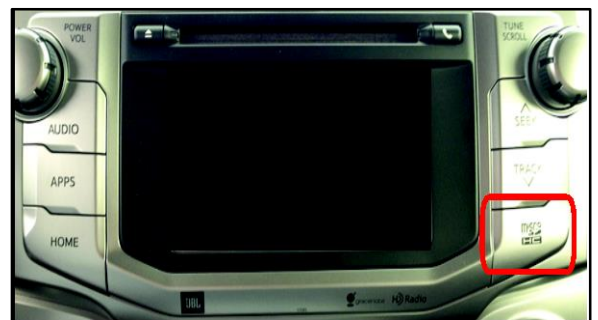
Figure 17.

- If the update fails and the error message “New software is not compatible with the system” displays, cycle the ignition OFF, remove the map micro SD card from the head unit, then repeat steps 3 – 12.
- A software update error is more likely to occur in areas with more traffic information.

Once the update is completed, reinsert the map micro SD card into the head unit, cycle the ignition OFF, then continue to step 13.
