GROUP	MODEL
ENG	2023MY Sportage (NQ5/NQ5a)
NUMBER	DATE
238	May 2022

## TECHNICAL SERVICE BULLETIN

### SERVICE ACTION: ECM LOGIC IMPROVEMENT FOR DTC P0456/P013E (SA498)

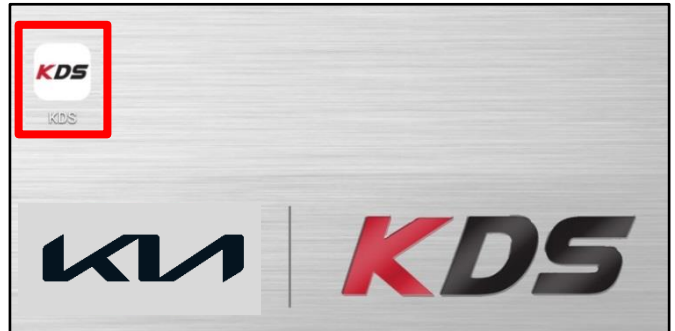
3. Confirm communication with VCI (A) and then configure the vehicle (B) using the 'AUTO VIN' (C) feature.

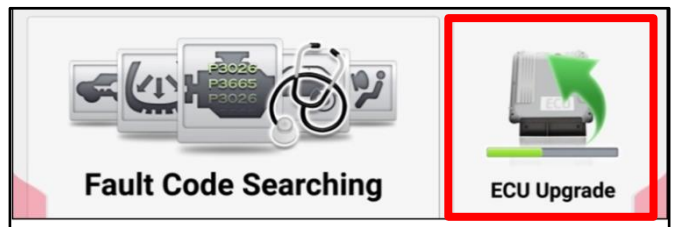
- The KDS will check the server for recently uploaded Events and then automatically download Upgrade Event #617.

After the download is complete, the program will shut down to install. Please wait until the program restarts.

KDS screenshot shown above is for demonstration purposes only. Events shown in screenshot are not applicable to this bulletin.
