## CAMPAIGN BULLETIN Audio Amplifier

Reference: PC870

INFINITI is conducting a quality action on **18** specific 2022 QX60 (L51) vehicles to inspect the Audio Amplifier and, if necessary, reprogram or replace the audio amplifier. Due to an internal software concern, the audio amplifier may stop producing sound.

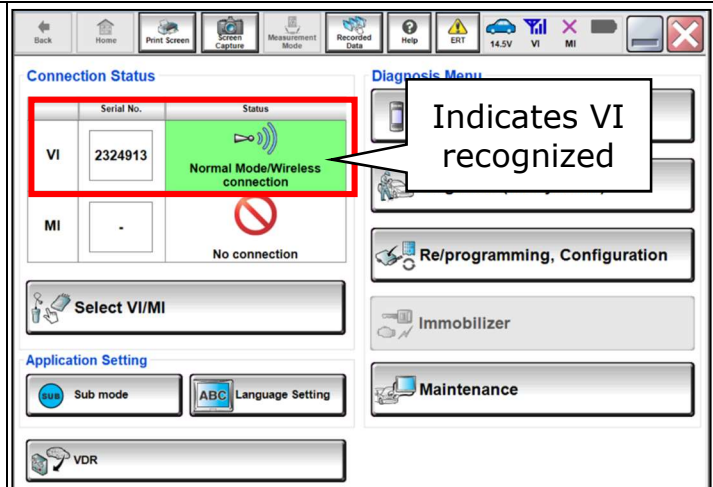
Figure 1

5. Prepare CONSULT 3+ (C3+) for reprogramming.
  - Connect the C3+ VI to the DLC
  - Turn the ignition on
  - Open the C3+ program
  - Turn the Hazard lamps on to prevent the ignition from turning off
  - Allow the VI to be recognized (Figure 1)

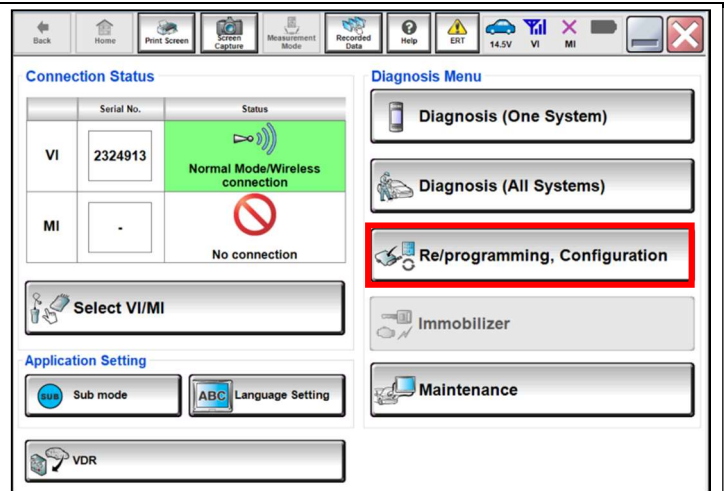
Figure 2

6. On the C3+ Home page, select **"Re/programming, Configuration"**. (Figure 2)

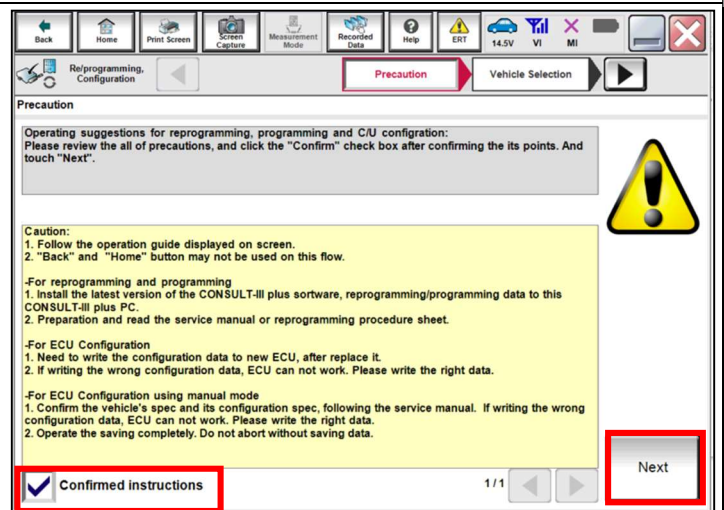
Figure 3

7. Review Precaution. (Figure 3)

- Check the **"Confirmed Instructions"** box
- Select **"Next"**

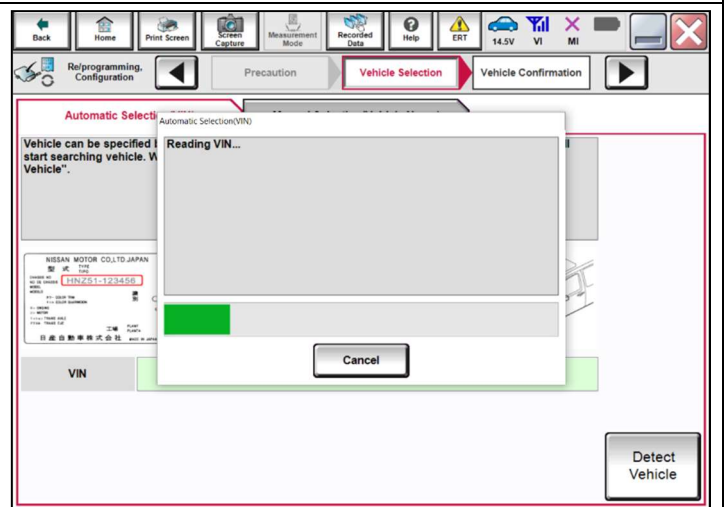
Figure 4

8. Perform Automatic VIN selection. (Figure 4)

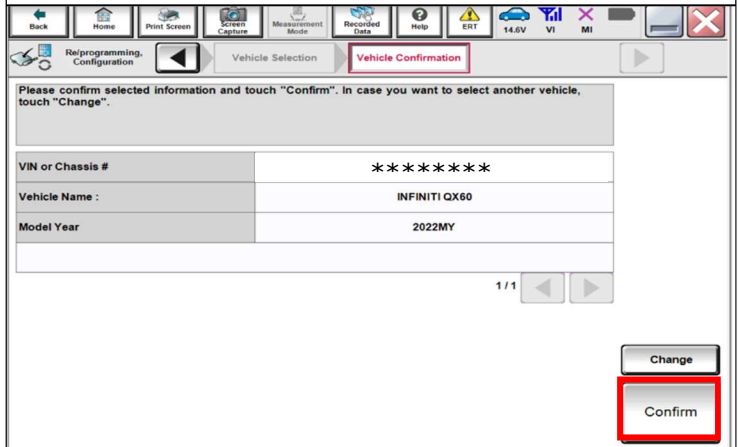
Figure 5

9. Confirm VIN, Model, and year are correct. (Figure 5)

- Select **"Confirm"**

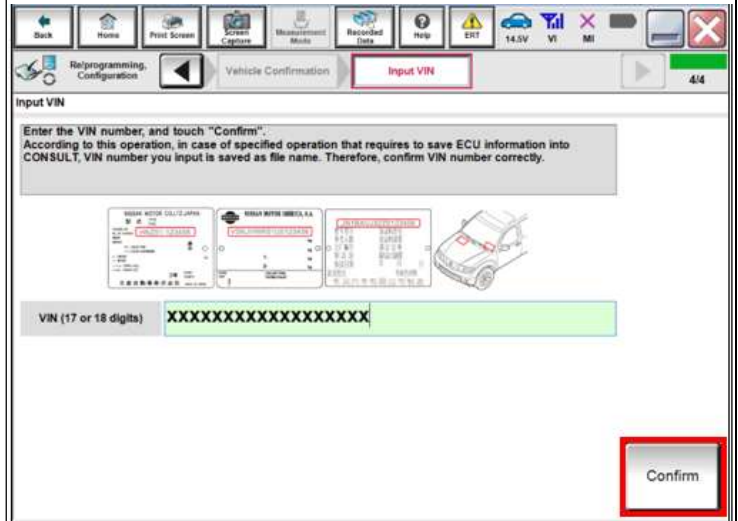
Figure 6

10. Confirm VIN. (Figure 6)

- Select **"Confirm"**

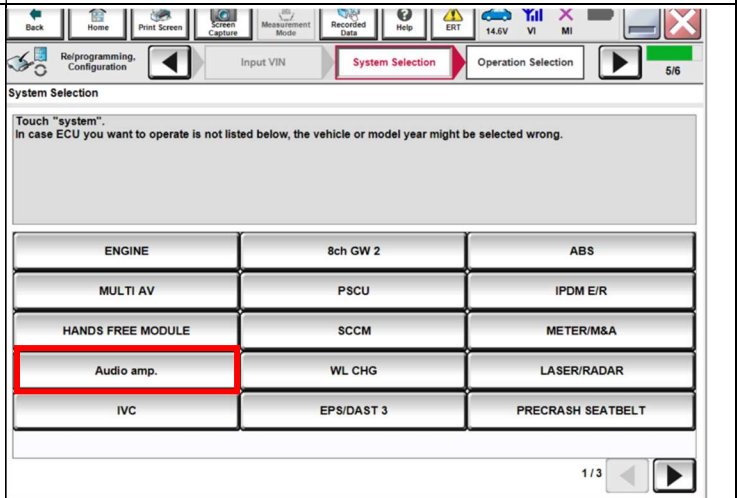
Figure 7

11. Locate and select **"Audio Amp."** from the available systems on Page 1. (Figure 7)

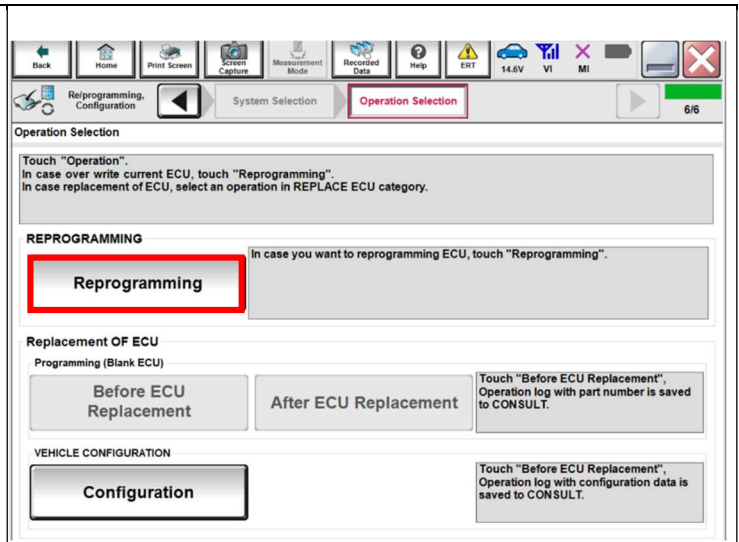
Figure 8

12. Select **“Reprogramming”**. (Figure 8)

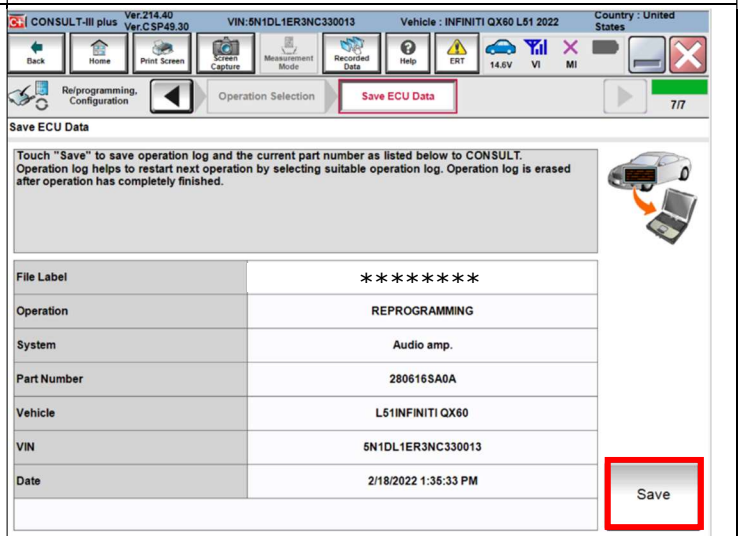
Figure 9

13. Select **“Save”**. (Figure 9)

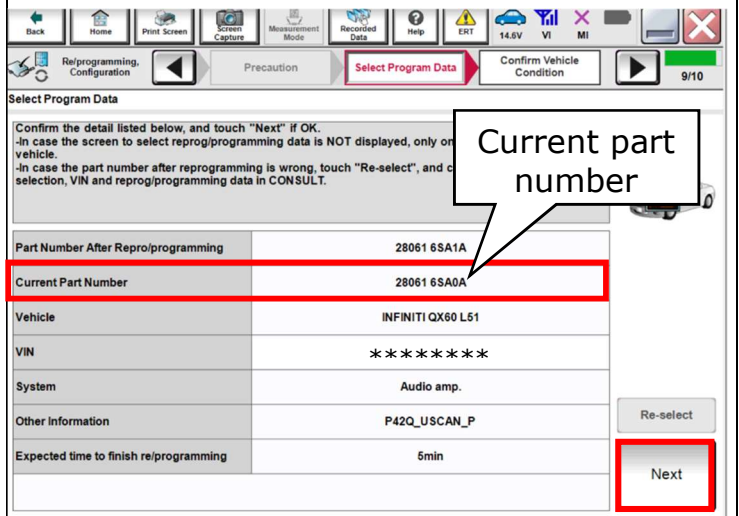
Figure 10

14. Verify Amplifier part number. (Figure 10).

- If the current part number is 28061-6SA0A, select **“Next”**
- If current part number is **NOT** 28061-6SA0A, reprogramming is NOT needed, Continue to Step 24

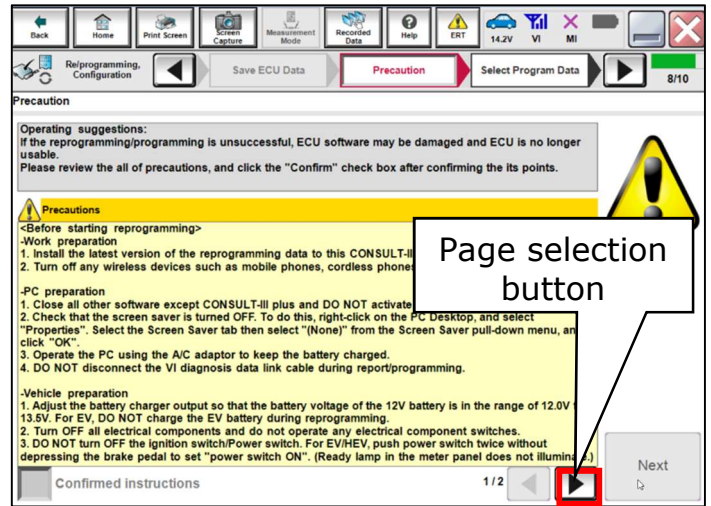
Figure 11

15. Review both pages of Precautions.  
(Figure 11)

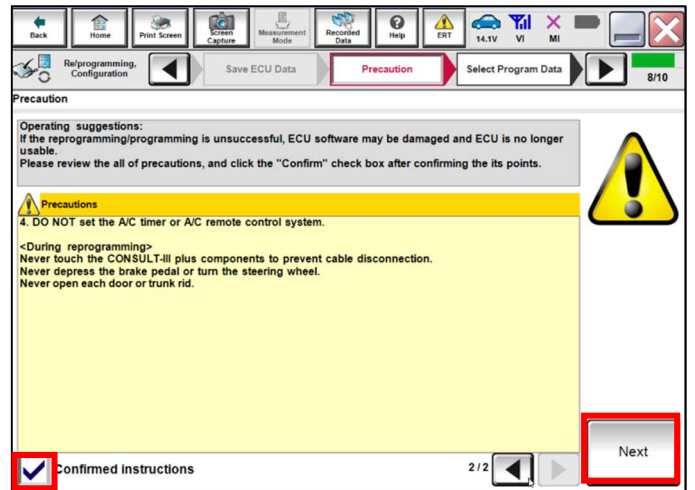
Figure 12

16. Check the "Confirmed Instructions" box.

- Select "Next" (Figure 12)

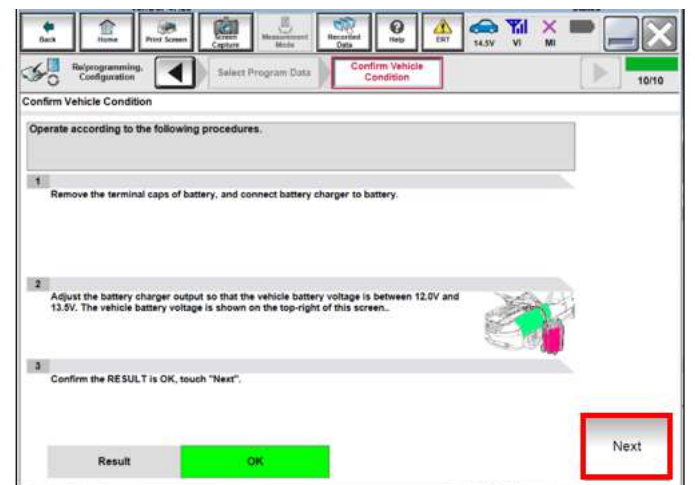
Figure 13

17. Confirm the battery charger condition is "OK". (Figure 13)

- Select "Next"

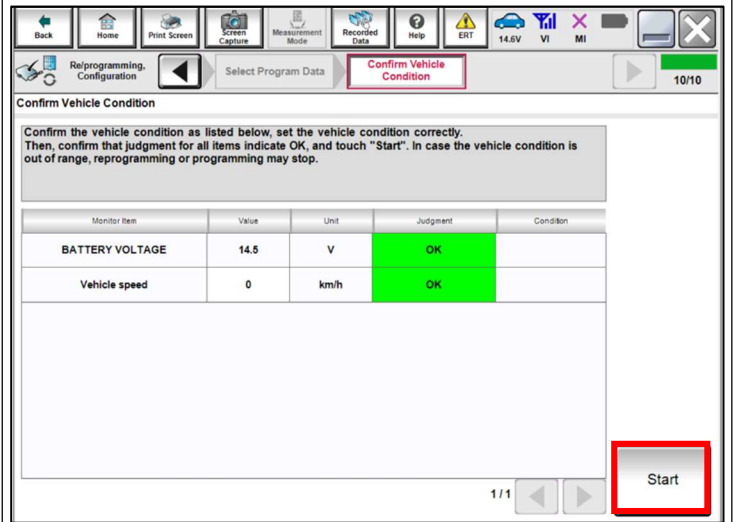
Figure 14

18. Confirm vehicle conditions are "OK".  
(Figure 14)

- Select "**Start**"

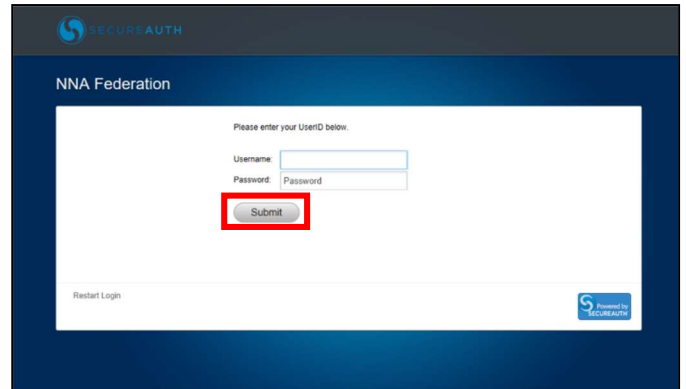
Figure 15

19. Enter login information. (Figure 15)

- Select "**Submit**"

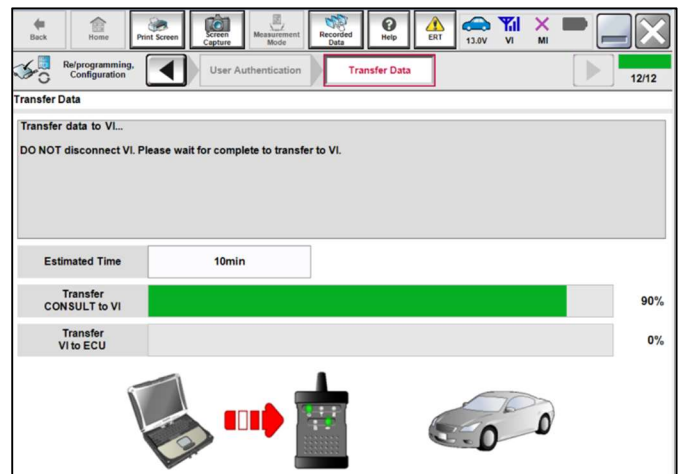
Figure 16

- Reprogramming will start after successfully logging in. (Figure 16)
- See your service manager if login information is needed

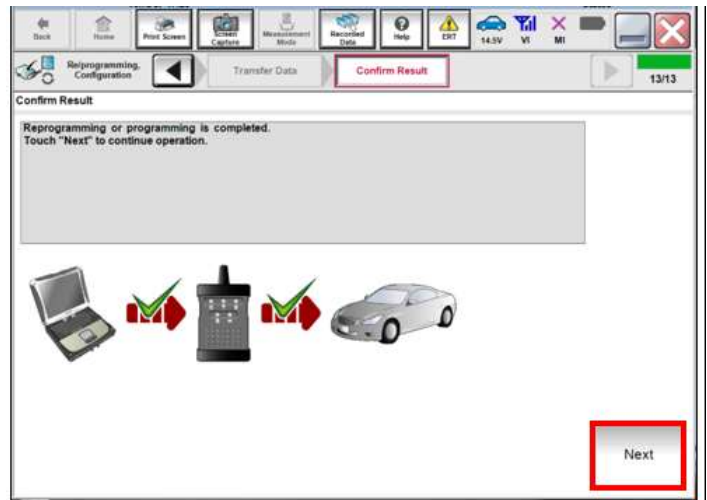
Figure 17

20. Select "Next". (Figure 17)

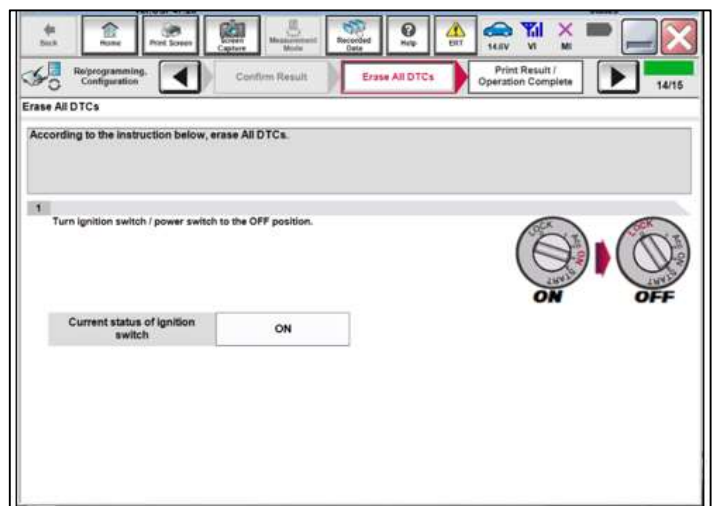
Figure 18

21. Cycle the ignition. (Figure 18)

- Turn the ignition OFF
- Turn the ignition ON
- DTC's will be erased

**Note:** If the ignition does not turn off when pressing the ignition button, press and hold the ignition button until the ignition powers off.

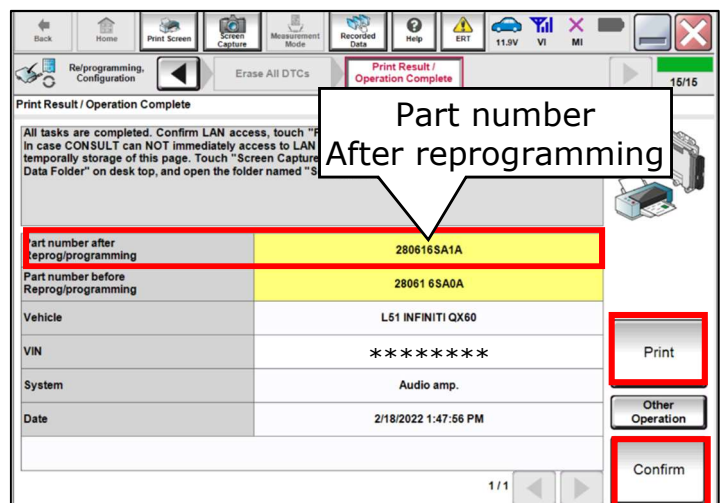
Figure 19

22. Reprogramming complete.

- Verify the Part number after reprogramming is 28061-6SA1A
- Print reprogramming results and attach to repair order
- Select Confirm to return to C3+ Homepage (Figure 19)
