**NUMBER:** 08-049-22

UBE, UEE, UBU, UEU, UFE, UPE, UFU and UPU Radio Enhancements

This bulletin involves updating the radio with the latest available software.

2022 (MP) Jeep Compass

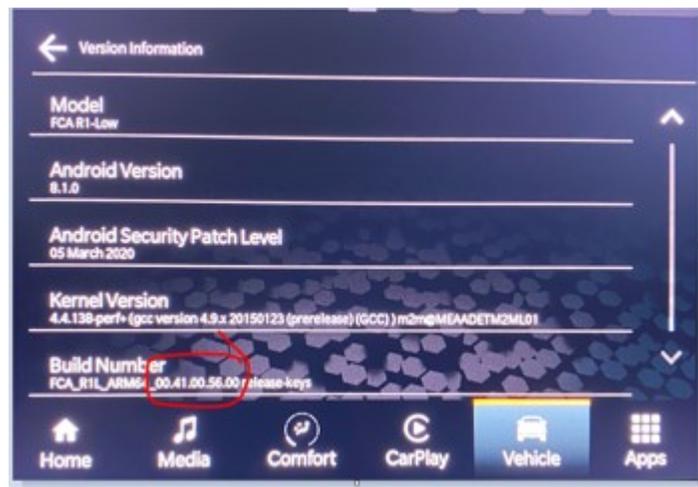
- On the radio display screen go into "Vehicle Settings".
- Select "System Information".
- Select "Version Information".
- Under the "Build Number", radio software version is listed. For example, the software version here is 00.41.00.56.00 (Fig. 1) .

Fig. 1  
Software Version

- YES>>> The software version is below R41.00.56. Proceed to [Step 1](#) of the repair procedure below.
- NO>>> If the software version is at or above R41.00.56, the radio is already at updated software. This bulletin has been completed.

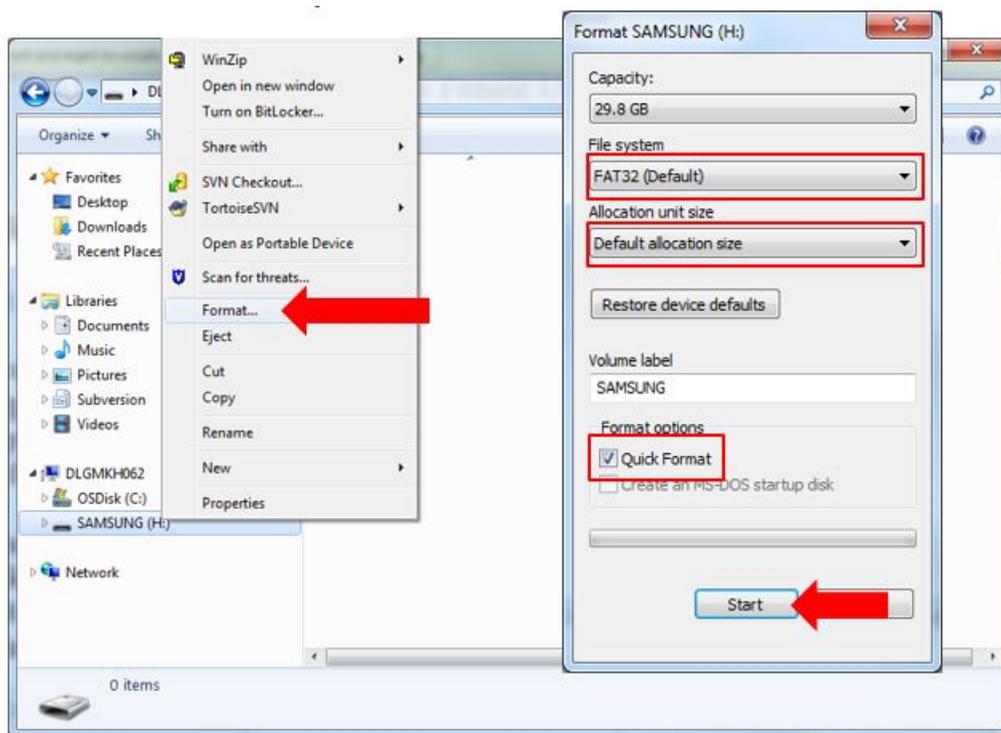
1. Is the vehicle on the RSU VIN list?
  - YES >>> Proceed to [Step 2](#).
  - NO >>> This bulletin does not apply.
2. Reprogram the radio with the latest software R41.00.56 via USB.
3. Has a **4 GB** USB flash drive been created?
  - YES >>> Proceed to [Step 15](#).
  - NO >>> Proceed to [Step 4](#).
4. Perform the following steps to format the USB flash drive ([Fig. 2](#)) .
  - a. Select “FAT32” format.
  - b. Select “Default allocation size” under Allocation Unit Size.
  - c. Select “Quick Format” under Format Options.
  - d. Click “Start”.

**Fig. 2**  
**Formatting The USB Flash Drive**

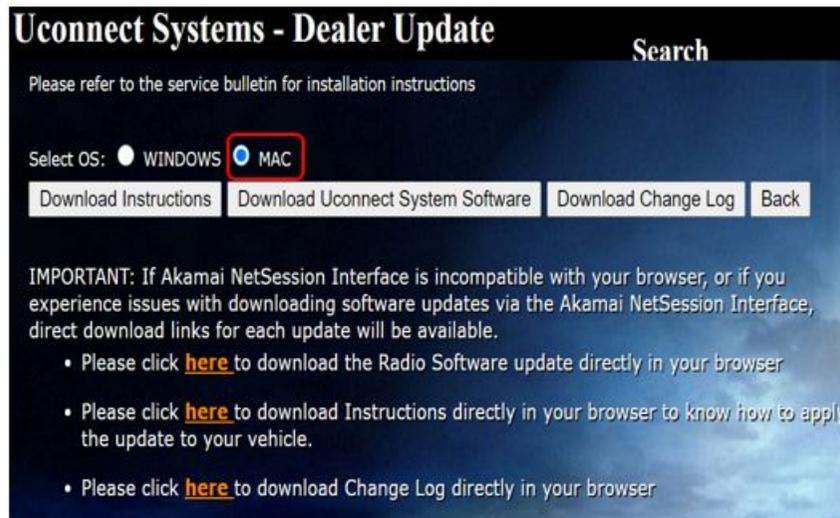
7. Use a blank USB flash drive with at least 4 GB of space. Follow the on-screen instructions to download the software files.
8. Download the software update file to your local PC’s desktop. Make sure to select the “MAC” radial button for all downloads (Fig. 4) .

Fig. 4  
MAC Download Steps

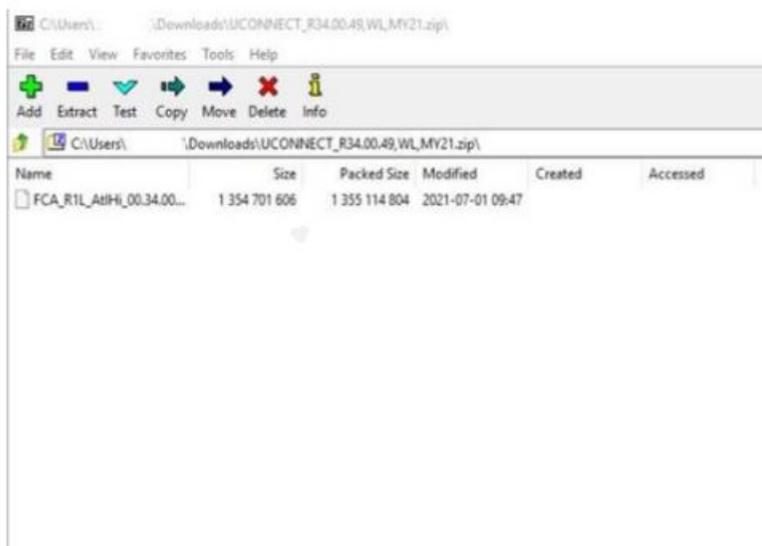
9. Be sure to download the file to your designated folder before extracting the zip file to the blank USB flash drive (Fig. 5).

**Fig. 5**  
**Zip File**

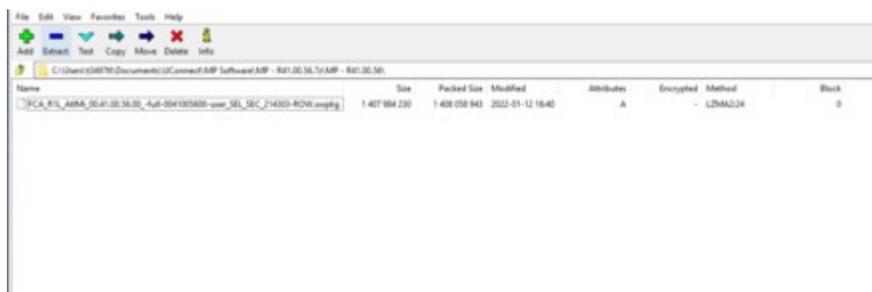
10. Unzip the file to the root folder of USB flash drive. File should not be within a zip folder. Your USB file should look like when you open it. Unzip the file to the root folder of USB flash drive. File should not be within a zip folder. Your USB file should be look like when you open it (Fig. 6).

**Fig. 6**  
**Extract File To USB**

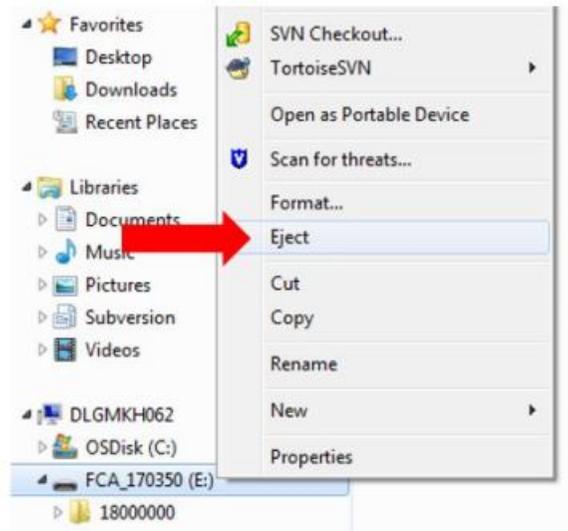
12. Perform the following steps to properly eject the USB flash drive (Fig. 7) :
  - a. Right click on the location of the USB flash drive.
  - b. Click “Eject” to avoid data corruption.
  - c. Remove the USB flash drive from the PC.

Fig. 7  
Ejecting The USB Flash Drive

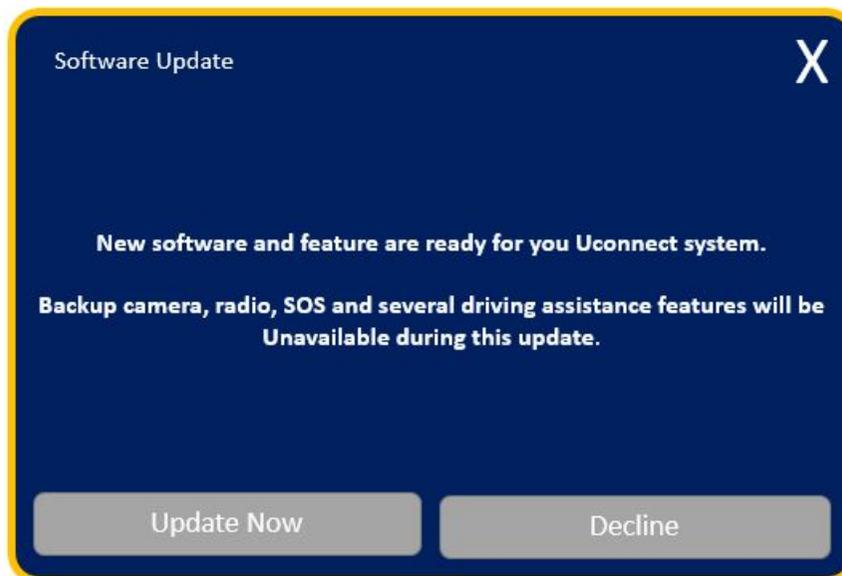
18. The radio will prompt you if you want to update to the newest software version (Fig. 9) .

Fig. 9  
Software Update Screen

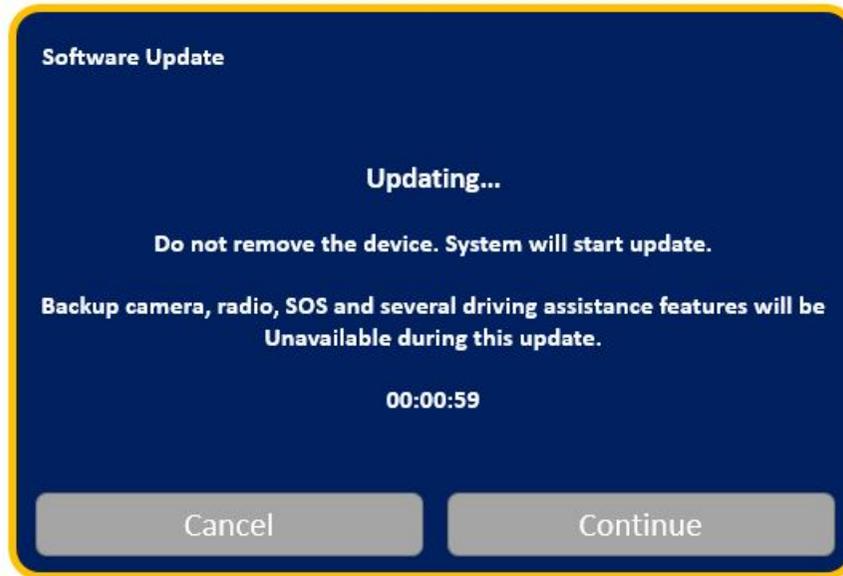
20. The radio will prompt you if you want to continue updating to the newer software (Fig. 10) .

Fig. 10  
Software Updating Screen

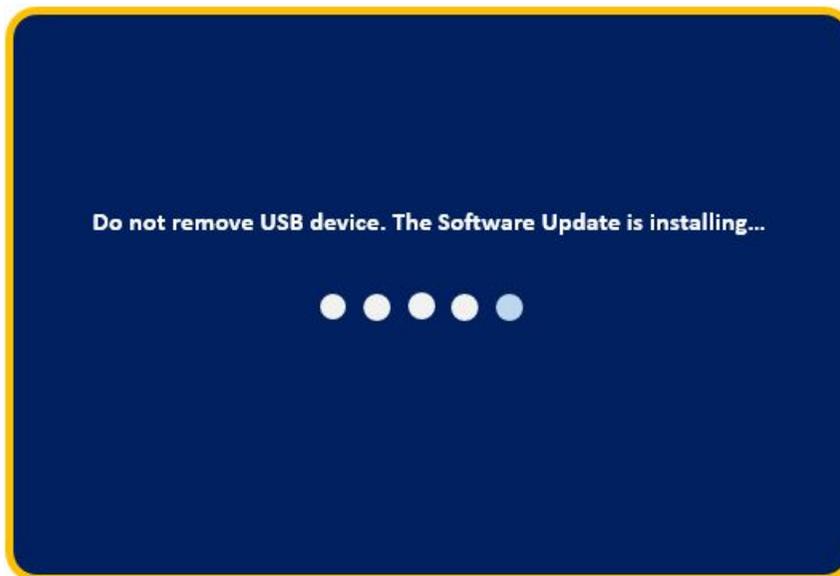
21. Select "Continue" (Fig. 11) .

Fig. 11  
Installing Update Screen

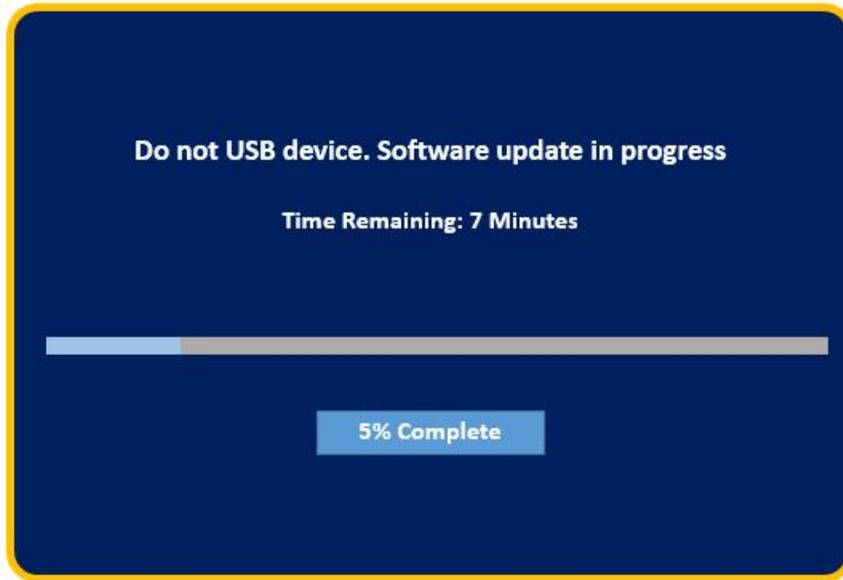
22. The update will take approximately 15-20 minutes (Fig. 12) .

Fig. 12  
Update In Progress Screen

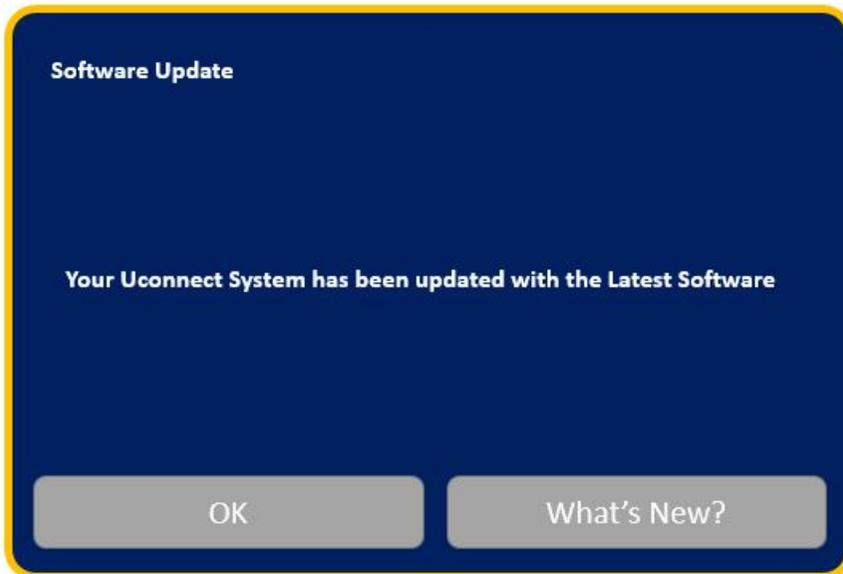
23. The radio will reboot and you will observe the update screen after the splash screen once the update has been successful (Fig. 13) .

Fig. 13  
Software Updated Screen

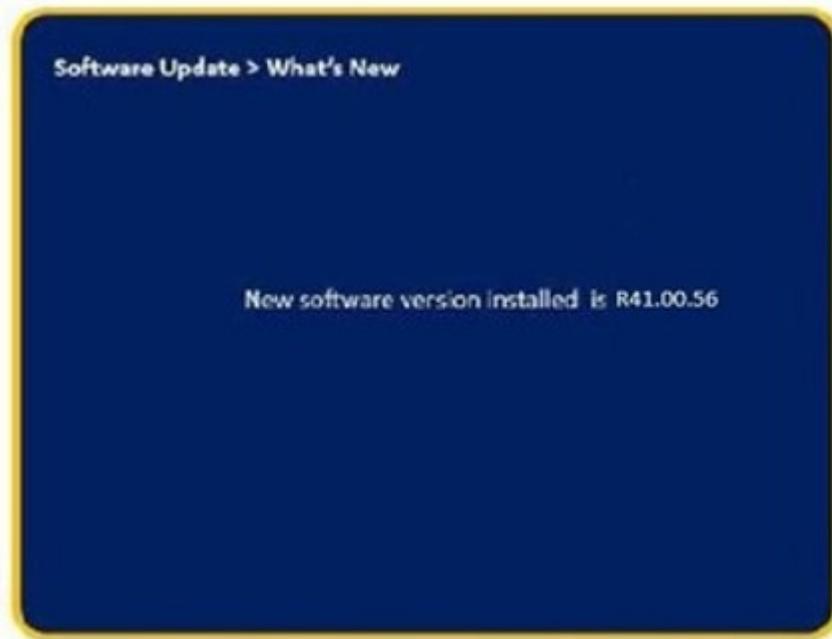
24. Select “What’s new” to confirm the software has been updated to R41.00.56 (Fig. 14) .

**Fig. 14**  
**What's New Screen**
