NUMBER: 08-048-22

UBR UER and UFR Radio Enhancements

****This bulletin involves updating the radio (UBR and UER) software level from the current level R34.00.49 or R37.03.58 to R41.00.56****

2021 - ****2022**** (WL) Jeep Grand Cherokee

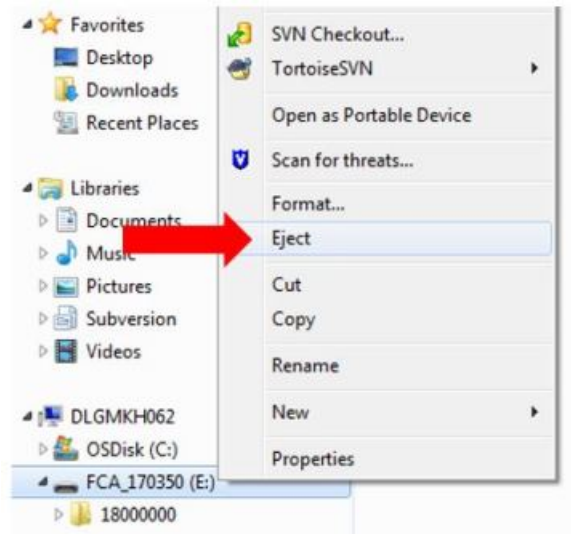
10. Perform the following steps to properly eject the USB flash drive (Fig. 6) .
 - a. Right click on the location of the USB flash drive.
 - b. Click “Eject” to avoid data corruption.
 - c. Remove the USB flash drive from the PC.

Fig. 6
Ejecting The USB Flash Drive

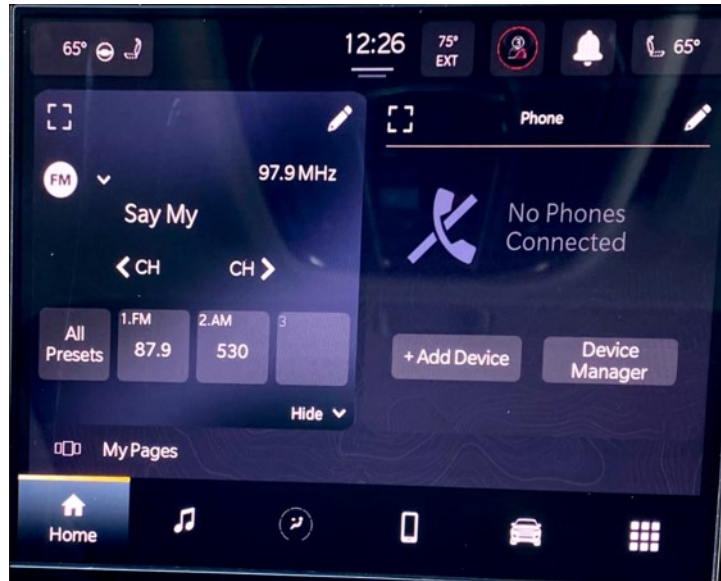
14. Vehicle must be out of “Ship Mode”. Starting at the radio ‘Home’ screen (Fig. 7) .

Fig. 7
Home Screen

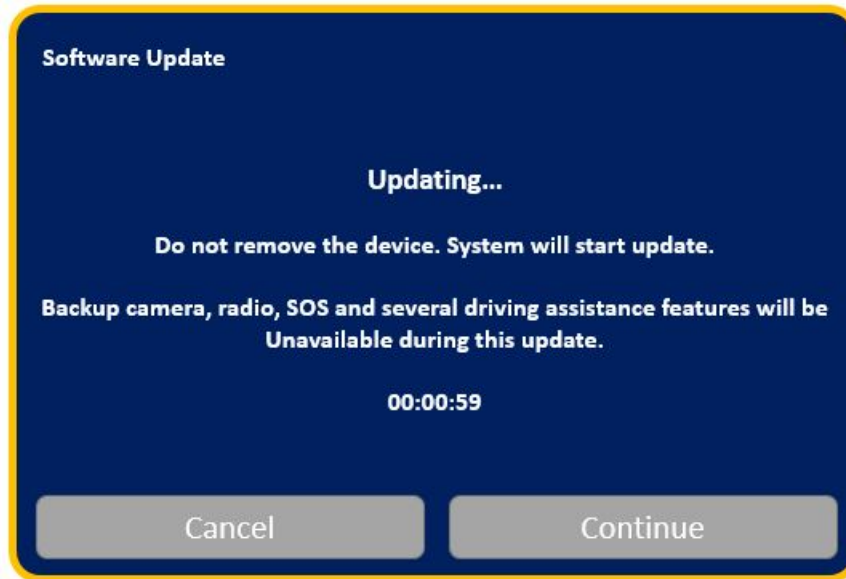
18. The radio will prompt you if you want to continue updating to the newer software (Fig. 9) .

Fig. 9
Software Updating Screen

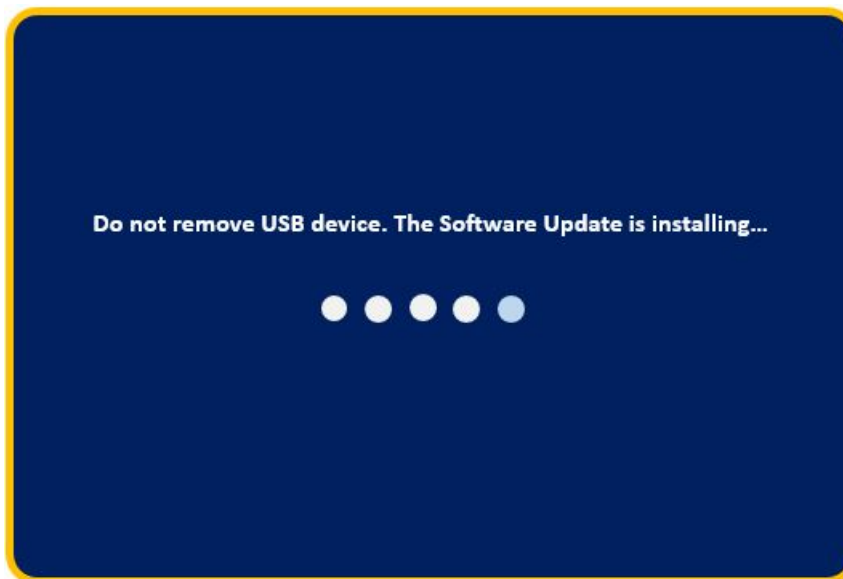
19. Select "Continue" (Fig. 10) .

Fig. 10
Installing Update Screen

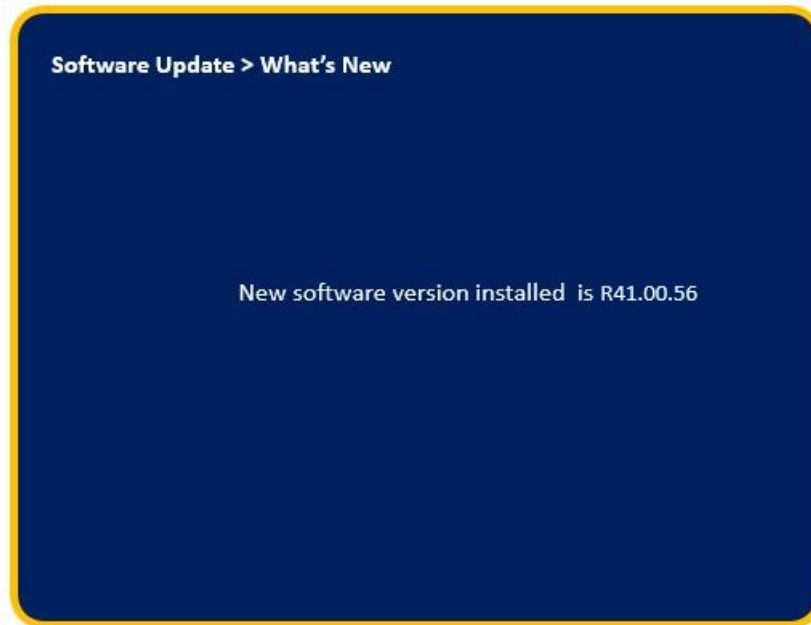
22. Select “What’s new” to confirm the software has been updated to:

- ****UER or UBR - R41.00.56****
- UFR - R34.00.49 (Fig. 13) .

Fig. 13
What's New Screen
