AJ20-P6 Turbo Coolant Pipe O Ring Repair

20-23MY Defender
19-22MY Range Rover, Range Rover Sport

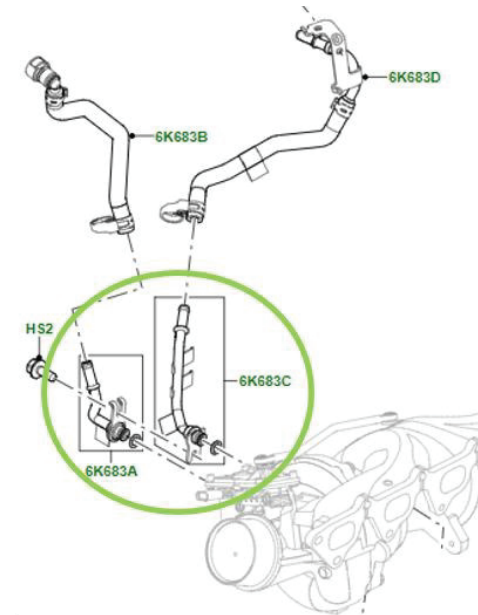
After replacing both pipes it is requested to please inspect the heater hose referring to "Image_2" in the SSM.

If the heater hose is not in the correct position, please replace the heater hose. Make sure the new heater hose is orientated correctly.
