WNE2 - Re-Programming Instrument Cluster (Stop Delivery)

Model Line: Panamera (971)

Concerns: Instrument cluster

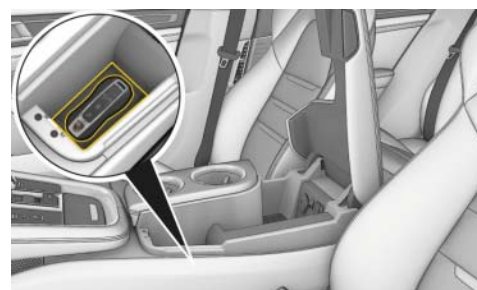
- 4 Place the driver's key with the back facing down in the front left storage compartment in the center console ⇒ *Driver's key in storage compartment*. This will guarantee an uninterrupted radio link between the vehicle and the driver's key.

Driver's key in storage compartment
