# Service Alert

MAZDA CONNECT SYMPTOM TROUBLESHOOTING (7TH GENERATION VEHICLES)

Service Alert No.: SA-004/22

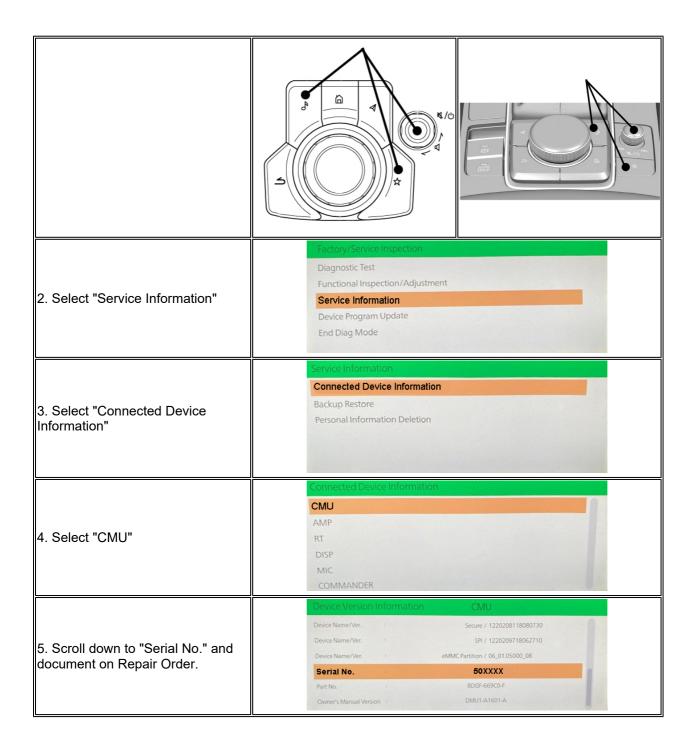
#### CMII Serial Number Retrieval

| Cino Serial Nulliber Retrieval | | | | |
|---|---|---|--|--|
| 1. Press and hold the Volume knob, then press and hold the Entertainment and Favorites buttons at the same time for 3-5 seconds and the Factory /Service Inspection screen will appear. | CX-5 and CX-9 | Mazda3, CX-30, MX-30 | | |

6. Return to Factory/Service Inspection main screen and select End Diag Mode
