Sport Tailpipe, Single-Branch – Silver (0P3)/Black (0P6)

Vehicle Type: **Macan (95B)**

Model Year: **As of 2019 up to 2021**

Concern: **Retrofitting**

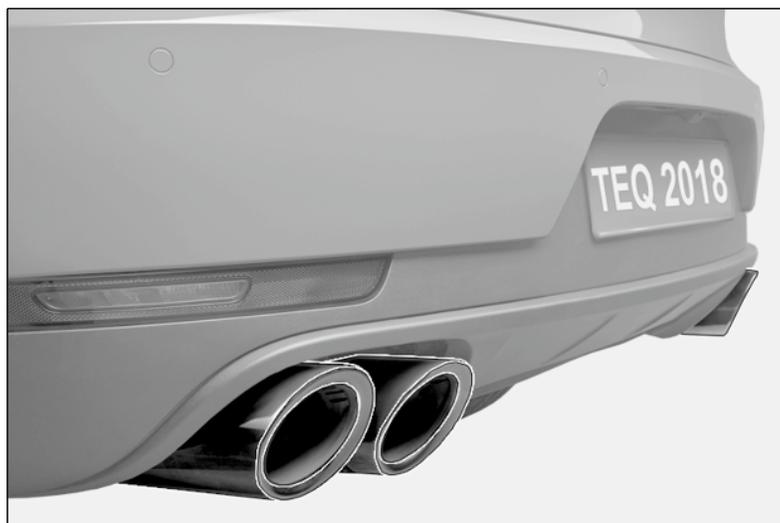
Figure 1

Notes: The standard exhaust system tailpipes can be replaced with sport tailpipes (⇒ Figure 1) on the vehicles specified above.

The tailpipes can be retrofitted worldwide and are also available for new vehicles from the factory by requesting optional equipment "I-no. OP3" = Silver or "OP6" = Black.

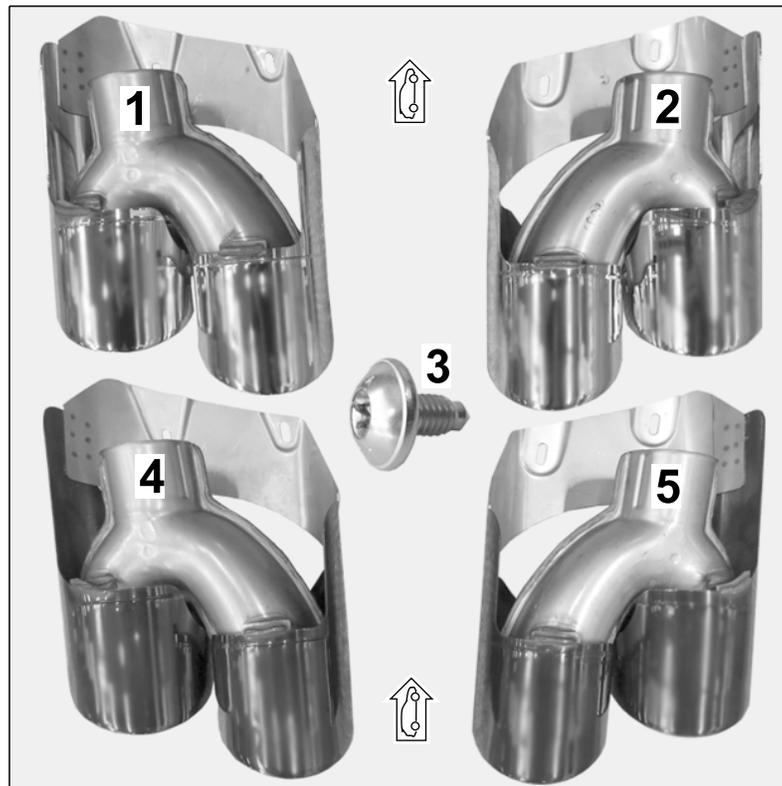
Figure 2

Sport tailpipe – silver chrome-plated (OP3), set:

| 95B.253.681.AK ¹ | 1 x | Sport tailpipe – left ⇒ Figure 2-1- |
| 95B.253.682.AG ¹ | 1 x | Sport tailpipe – left ⇒ Figure 2-2- |
| 999.073.594.01 | 4 x | Countersunk screw, M6 x 12 PA ⇒ Figure 2-3- |

Sport tailpipe – black chrome-plated (OP6), set:

| 95B.253.681.AO ¹ | 1 x | Sport tailpipe – left ⇒ Figure 2-4- |
| 95B.253.682.AH ¹ | 1 x | Sport tailpipe – left ⇒ Figure 2-5- |
