INFINITI

VOLUNTARY SERVICE CAMPAIGN

VOLUNTARY SERVICE CAMPAIGN 2022 QX60; AUDIO AMPLIFIER REPROGRAM

CAMPAIGN ID #: PC883
APPLIED VEHICLES: 2022 QX60 (L51)

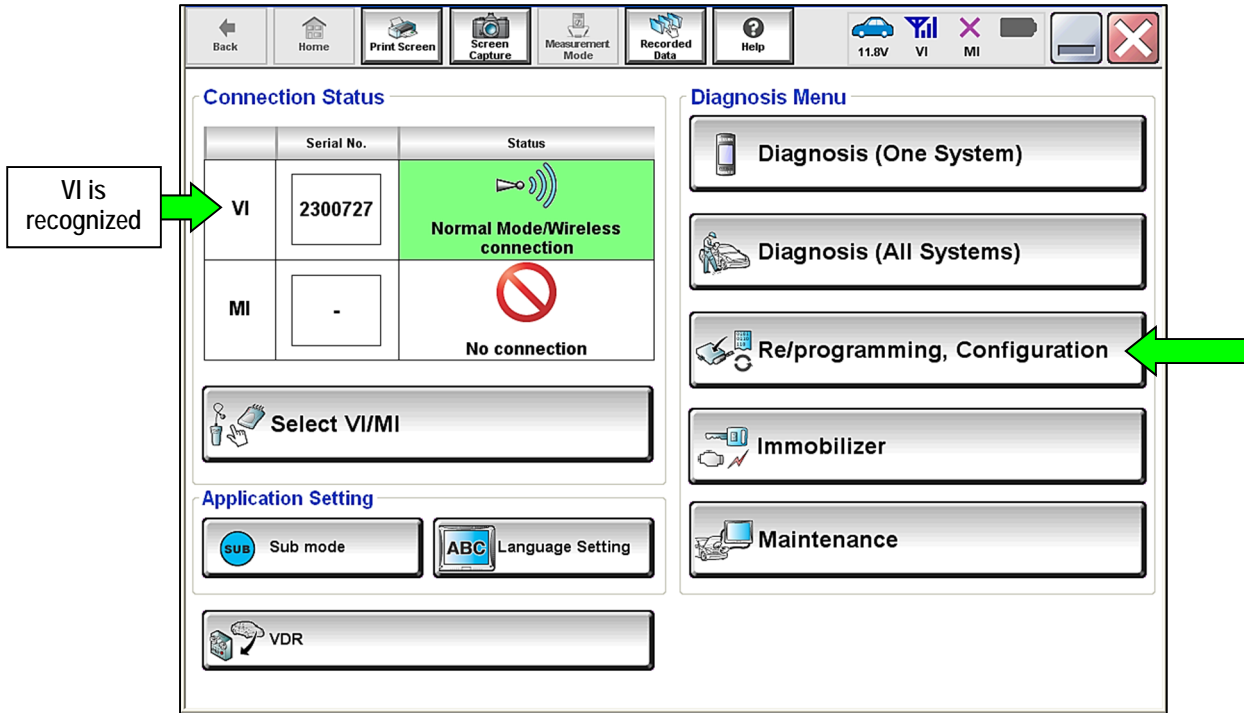
Figure 1

4. Connect the Vehicle Interface (VI) to the vehicle.
5. Start CONSULT-III plus (C-III plus) on the CONSULT PC.
 - The serial number will display when the VI is recognized (Figure 1 on page 3).

6. Select Re/programming, Configuration.

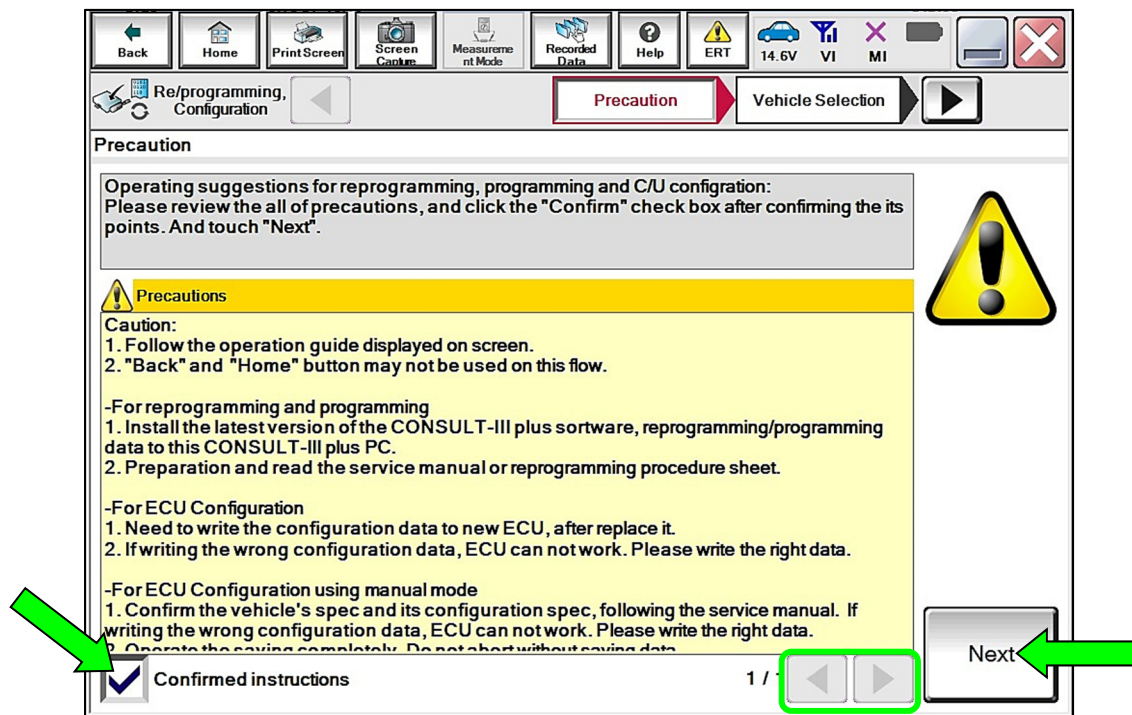
Figure 2

7. Check the box to confirm the precaution instructions have been read, and then select Next.

NOTE: Use the arrows (if needed) to view and read all precautions.

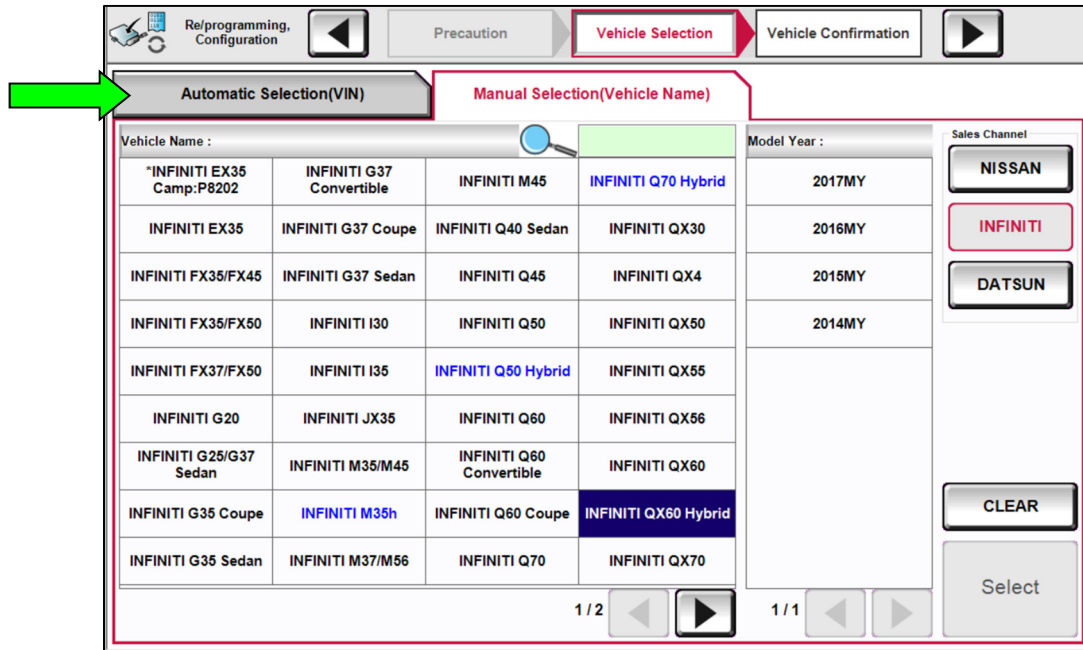
Figure 3

8. Select Automatic Selection(VIN).

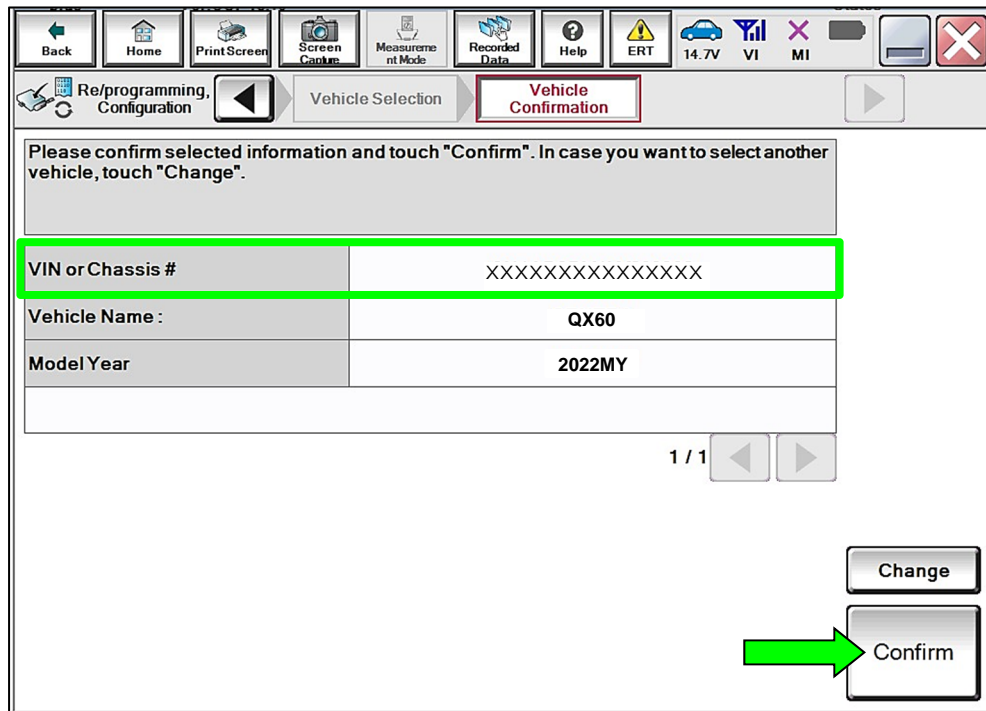
Figure 4

9. Confirm the VIN or Chassis # is correct, and then select Confirm.

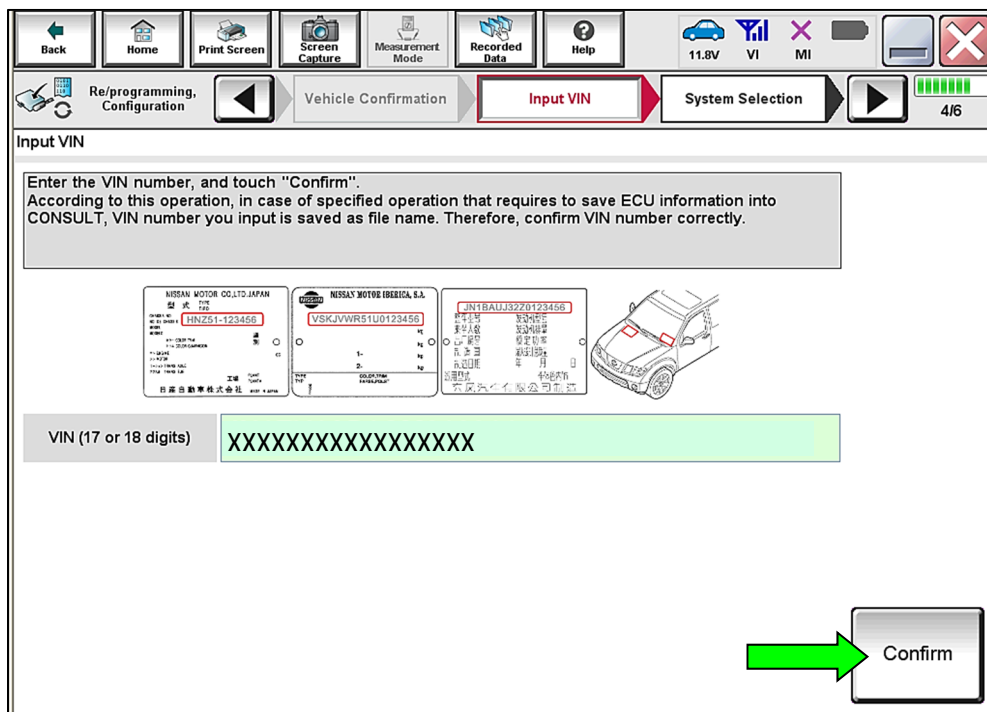
Figure 5

- Confirm the VIN is correct for the vehicle, and then select **Confirm**.

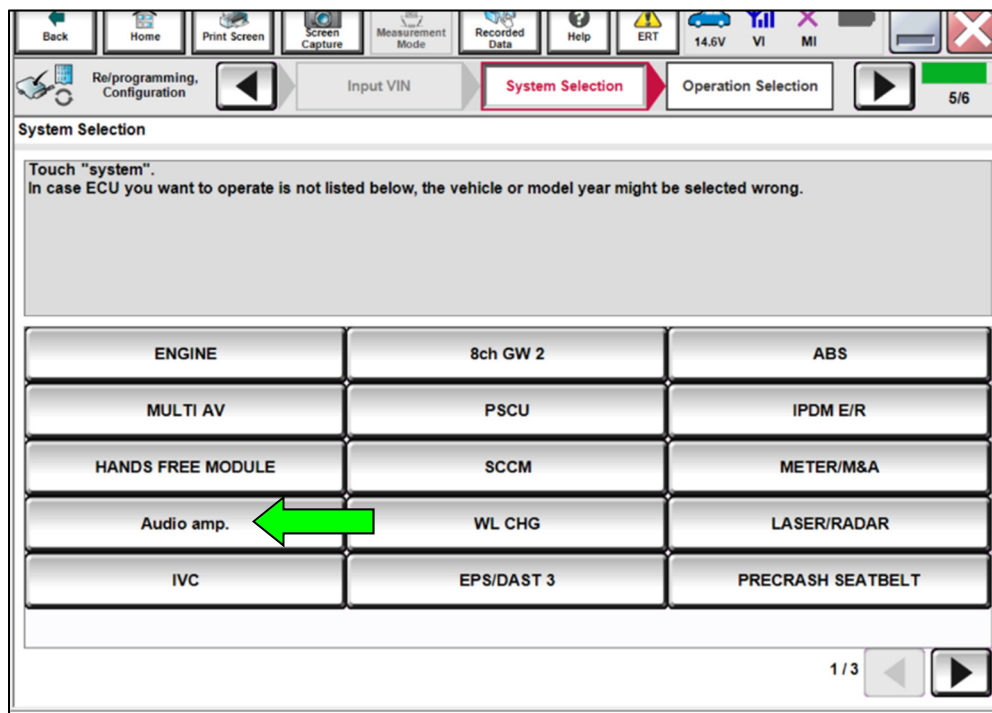
Figure 6

- Select **Audio amp**.

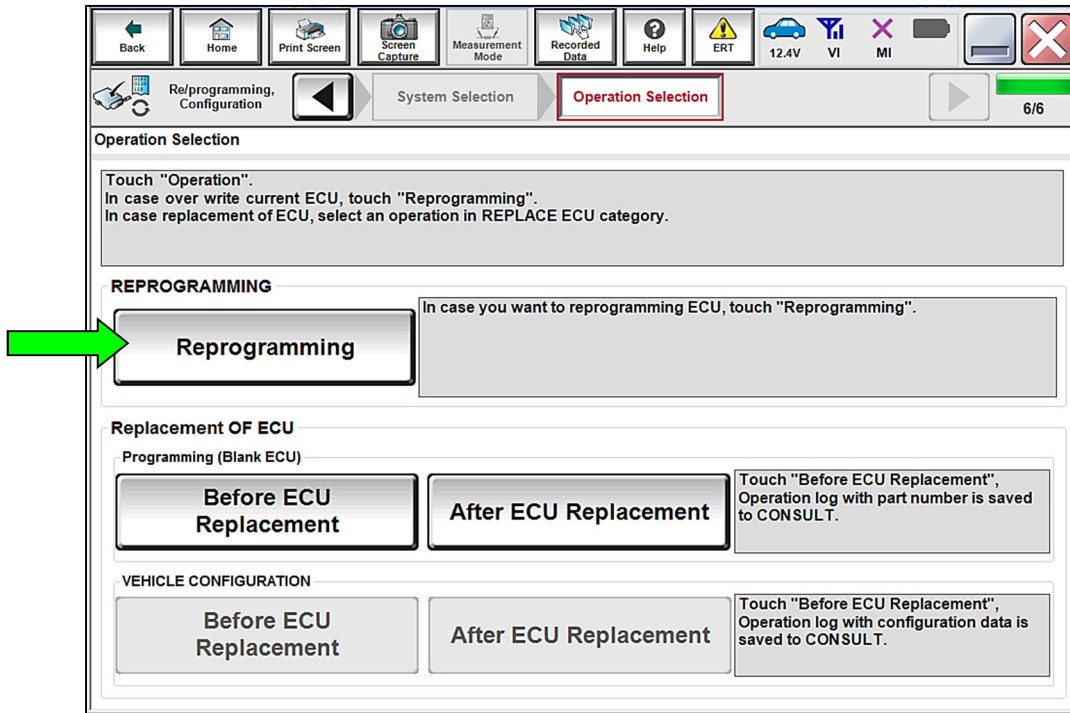
Figure 7

12. Select Reprogramming.

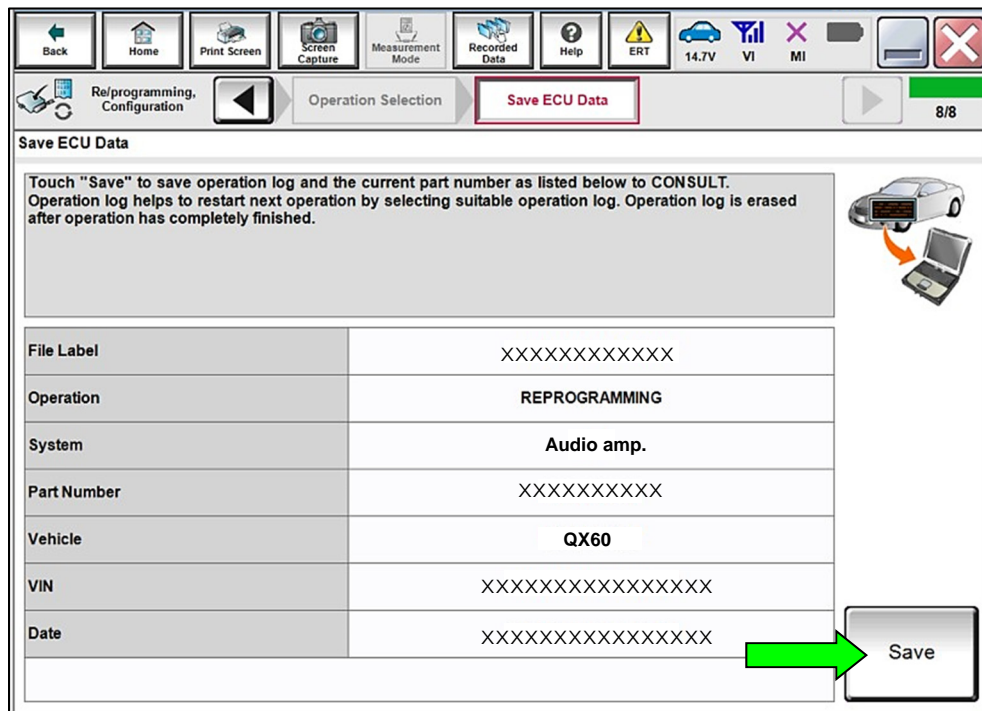
Figure 8

13. Select Save.

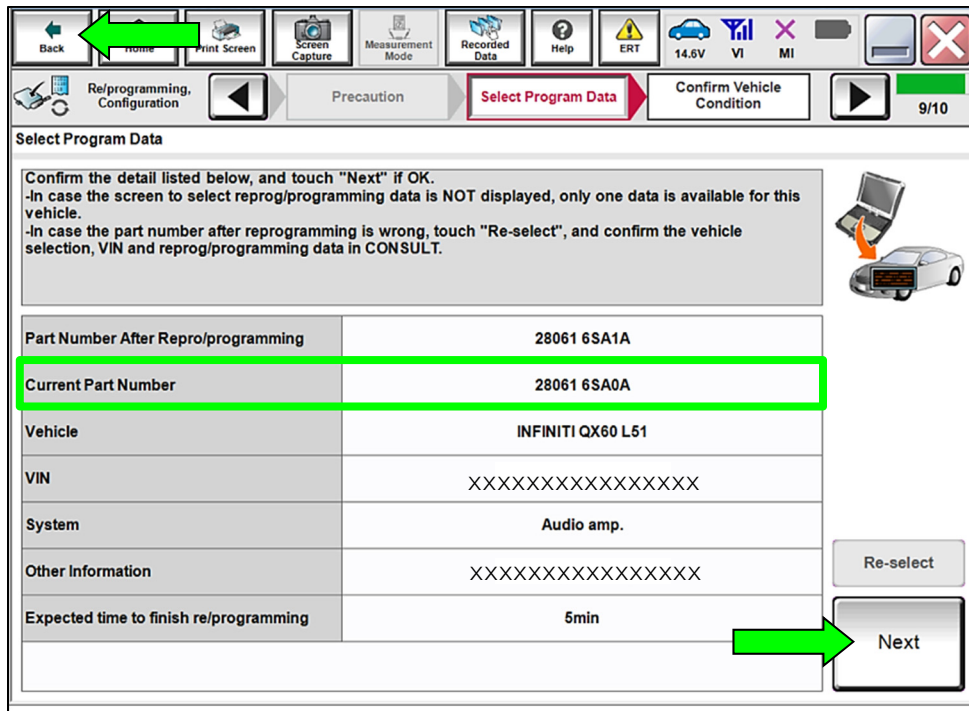
Figure 9

14. Verify the Current Part Number.

- If the **Current Part Number** is "28061 6SA0A", select **Next** and continue to step 15 on page 8 to continue the reprogramming procedure.
- If the **Current Part Number** is not "28061 6SA0A", reprogramming is not needed.
 - Select the back button in the top left corner of the screen, and then skip to step 27 on page 14 to remove the battery maintainer/smart charger.

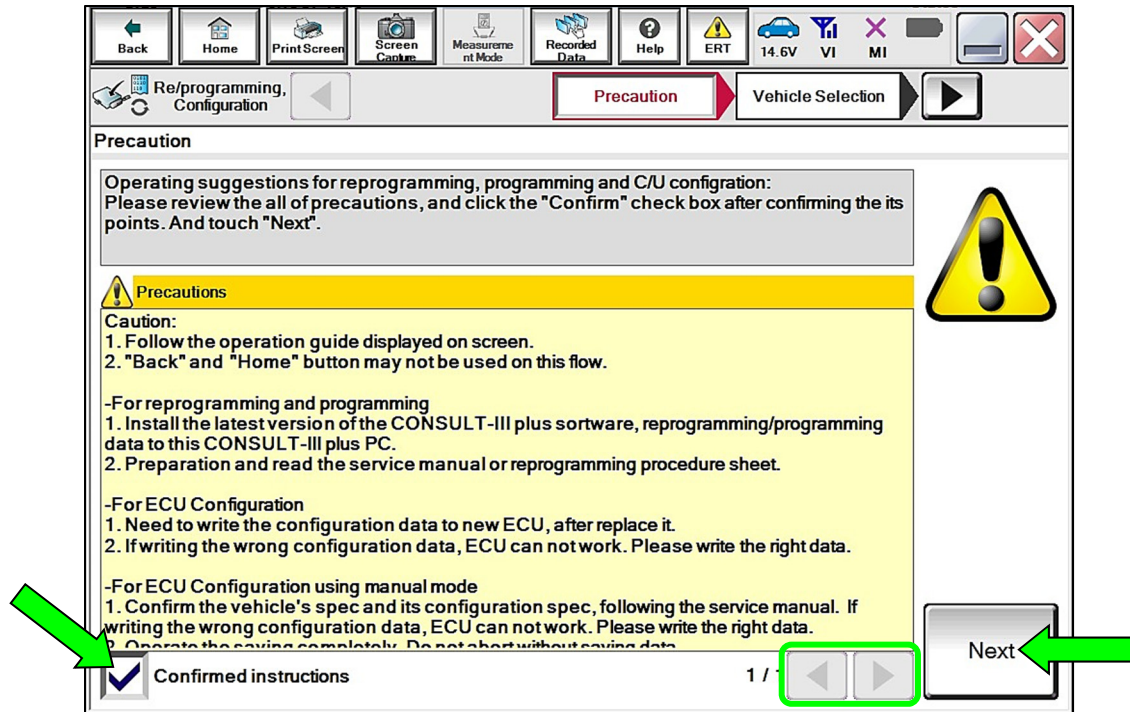
Figure 10

15. Check the box to confirm the precaution instructions have been read, and then select **Next**.

NOTE: Use the arrows (if needed) to view and read all precautions.

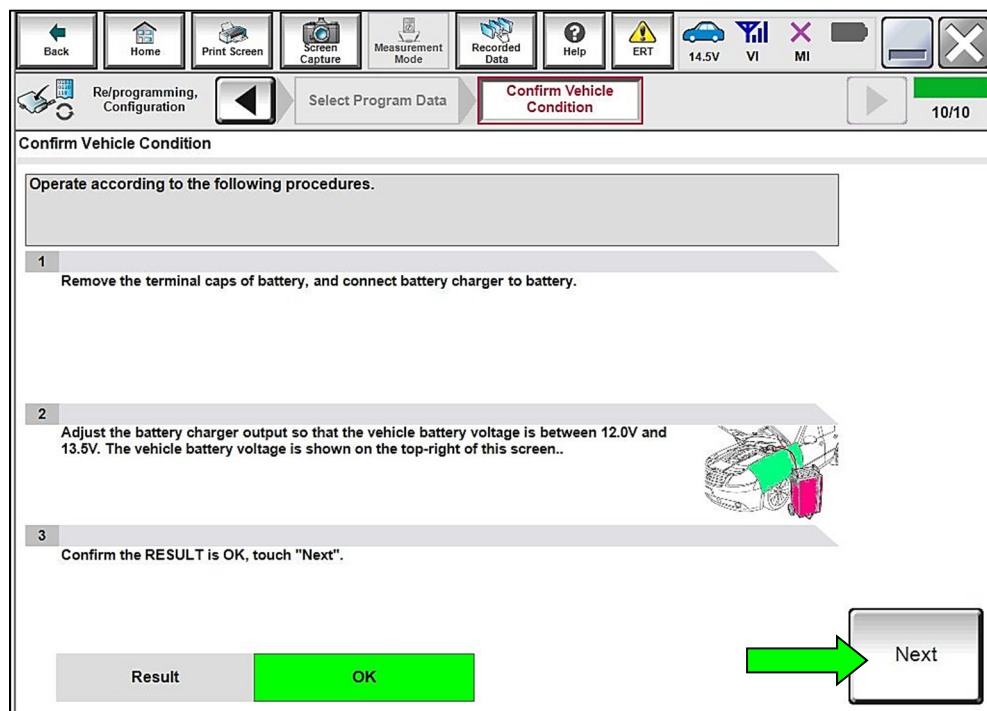
Figure 11

16. Confirm the battery charger is ON and the battery voltage is between 12V-15.5V, and then select **Next**.

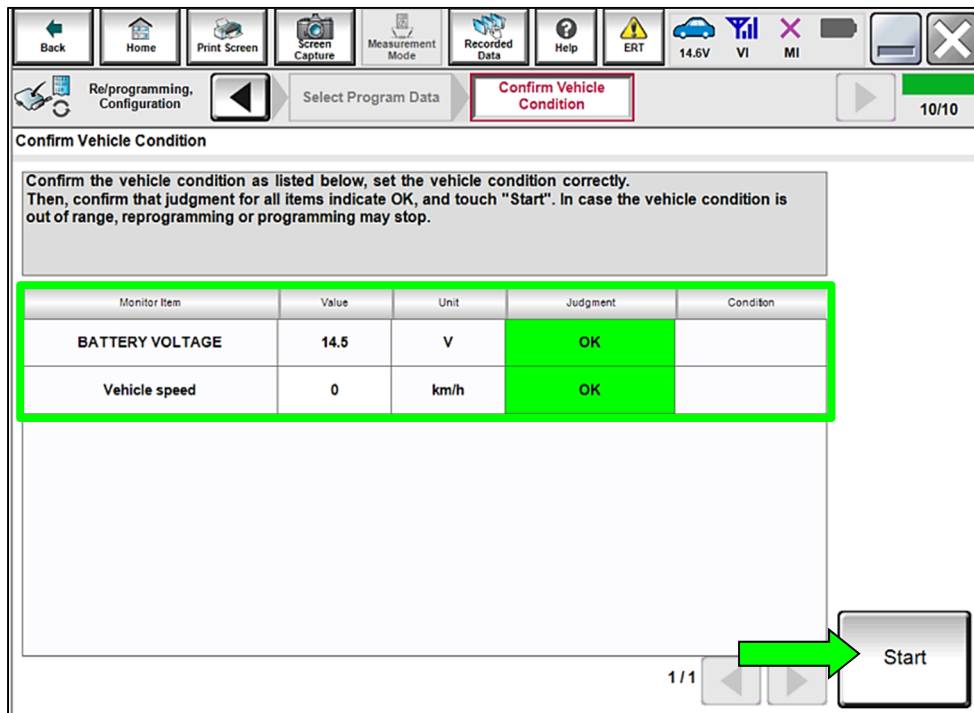
Figure 12

17. Confirm the **Judgement** for all the **Monitor Items** are "OK", and then select **Start**.

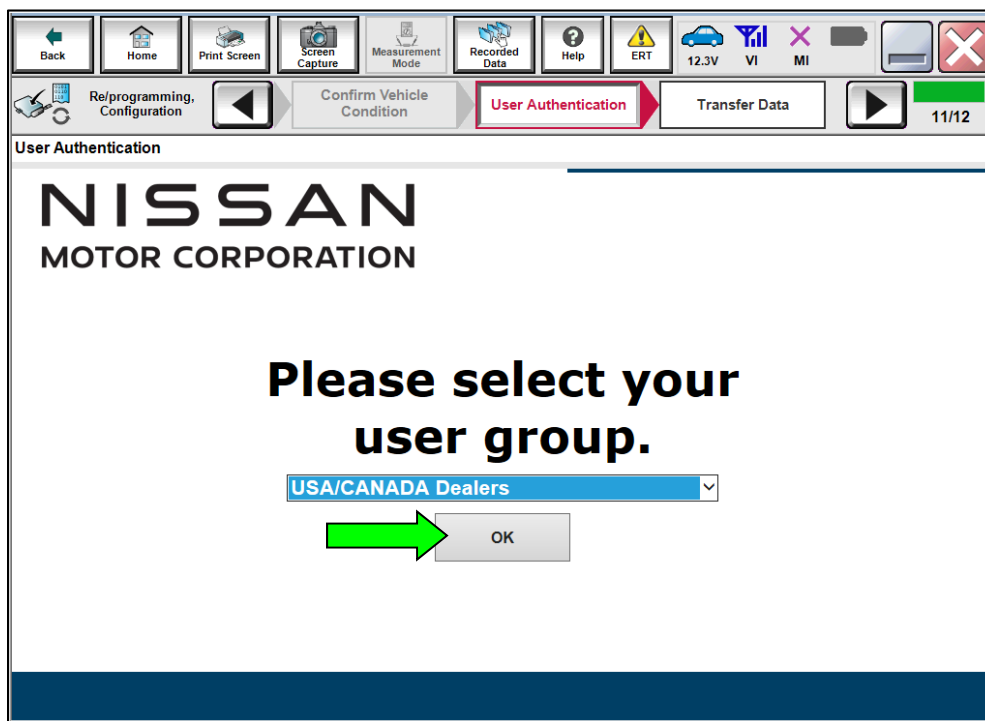
Figure 13

18. Select **USA/CANADA Dealers** from the drop down menu, and then select **OK**.

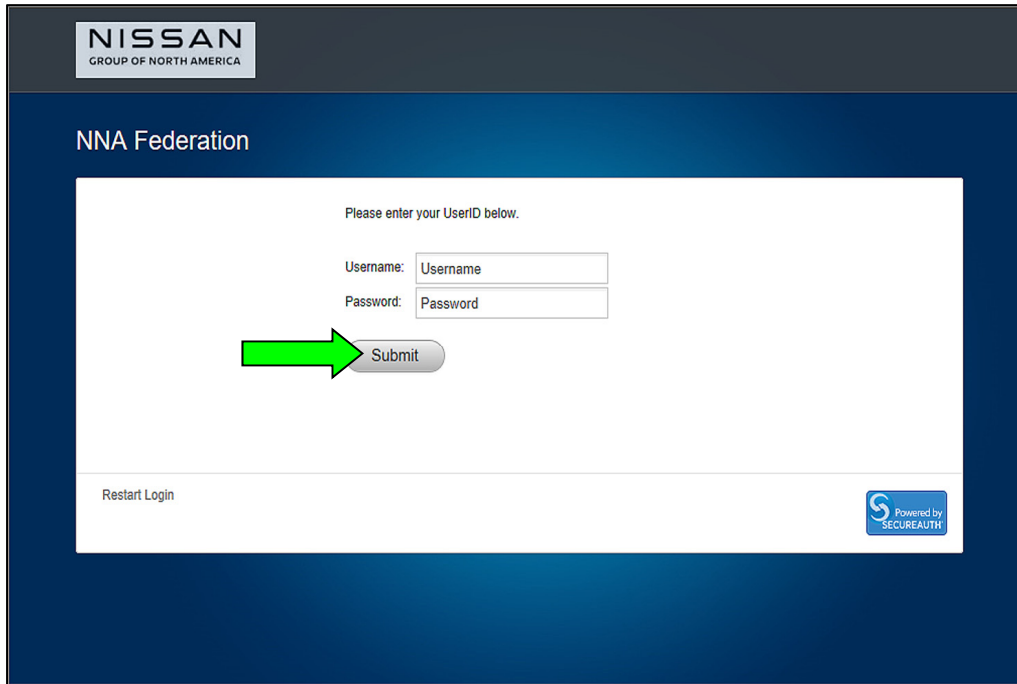
Figure 14

19. Login using your NNAnet credentials, and then select **Submit**.

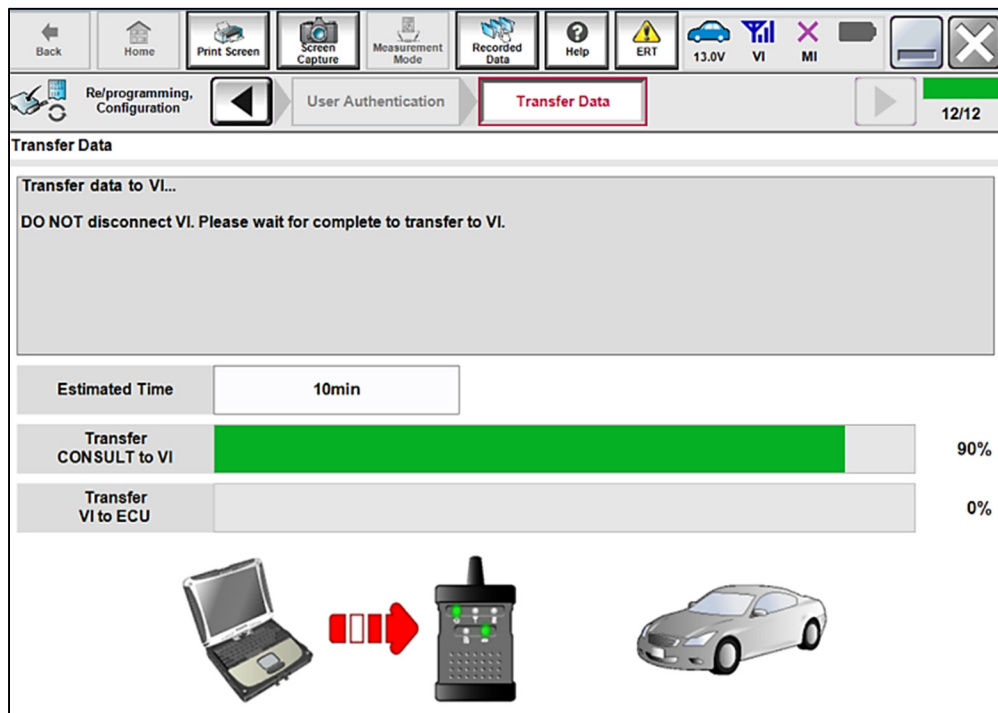
Figure 15

20. Allow **Transfer Data** to complete.

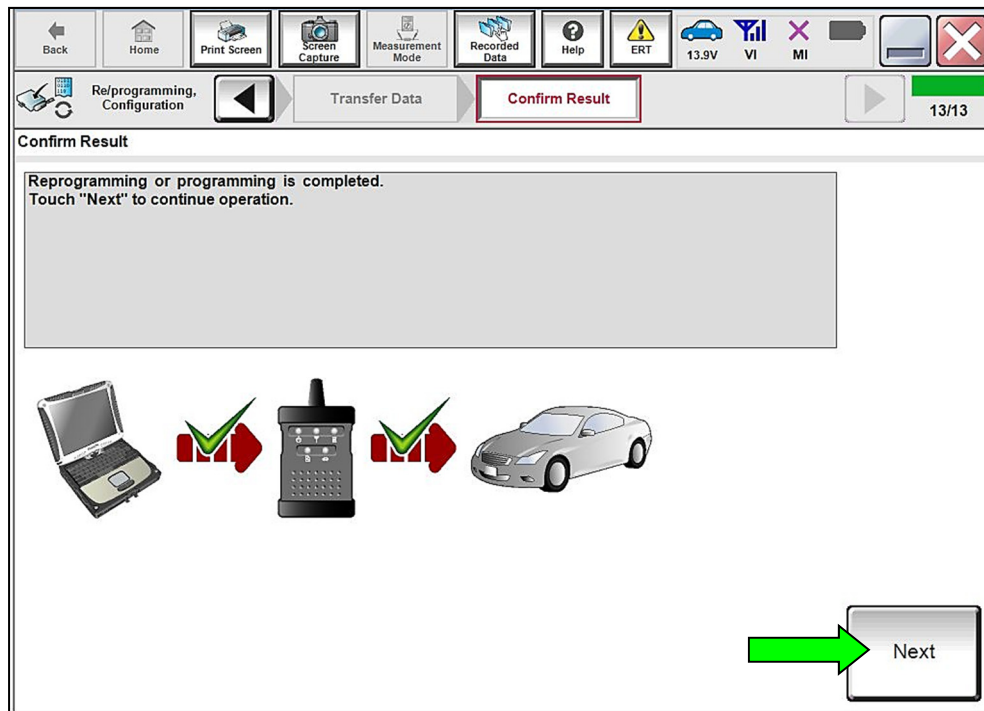
Figure 16

21. Once the reprogramming completes, select **Next**.
- Additional steps/operations are required before CONSULT will provide the final reprogramming confirmation report. Continue with the reprogramming procedure on page 12.

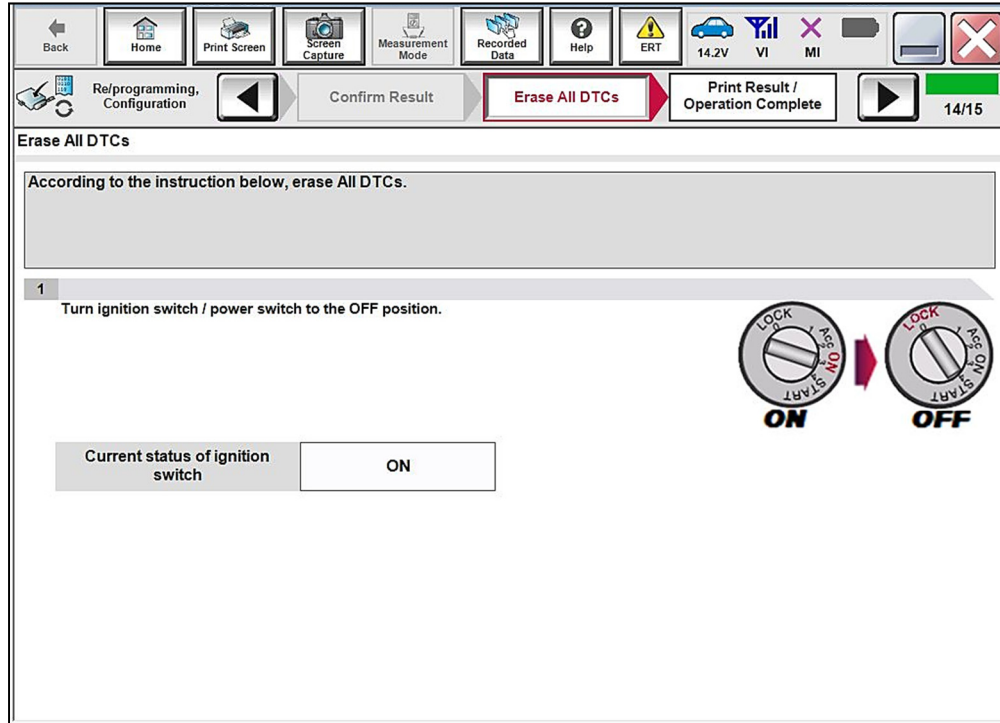
22. Perform Erase All DTCs.

- Follow the on-screen instructions as shown in Figure 17 and Figure 18.

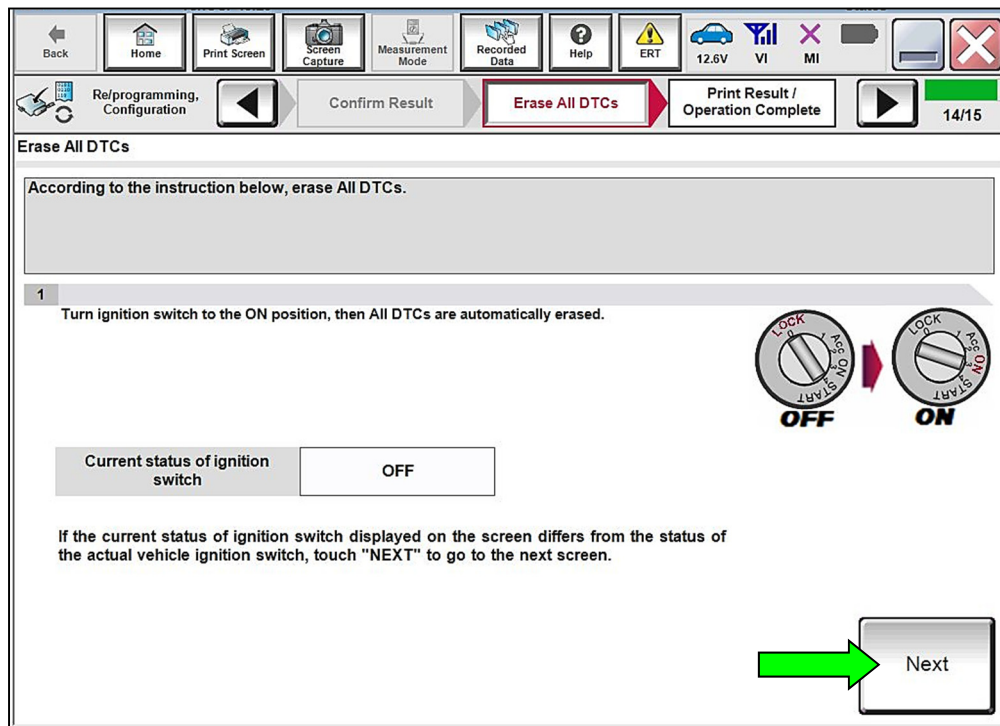
Figure 18

- Select Next.

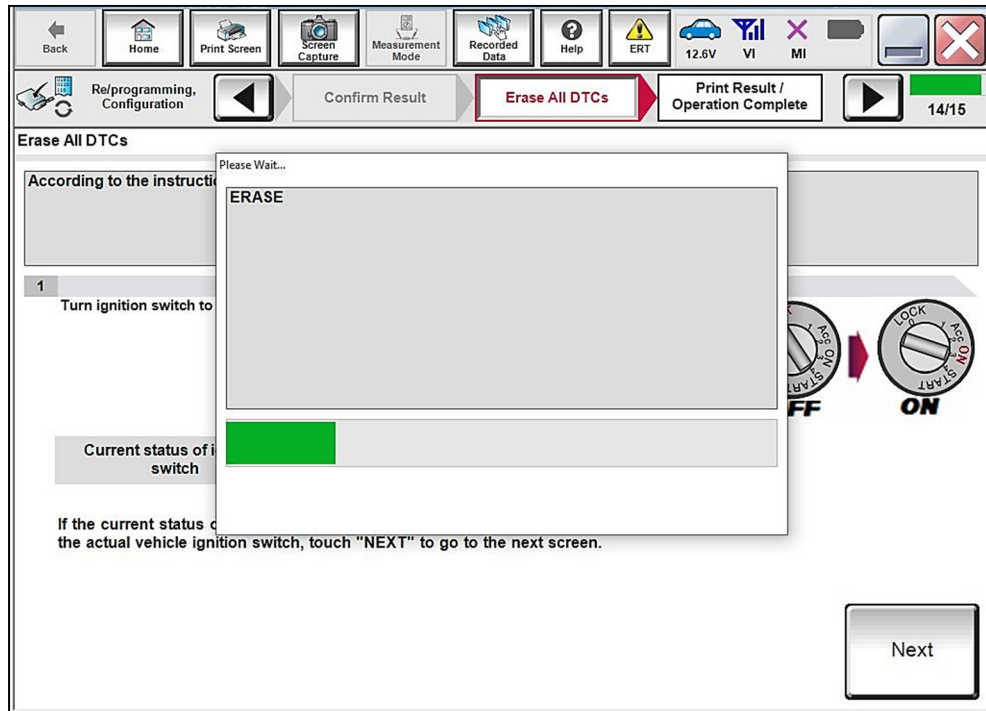
Figure 19

23. Allow Erase All DTCs to complete.

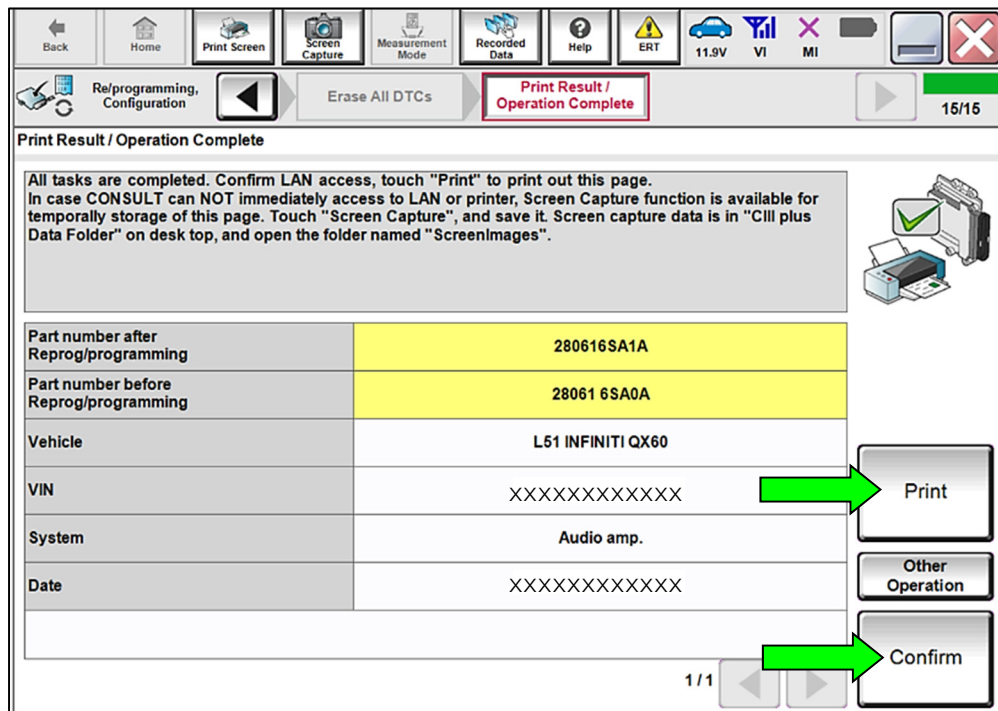
Figure 20

24. Select **Print** and attach the reprogramming results to the repair order, and then select **Confirm**.

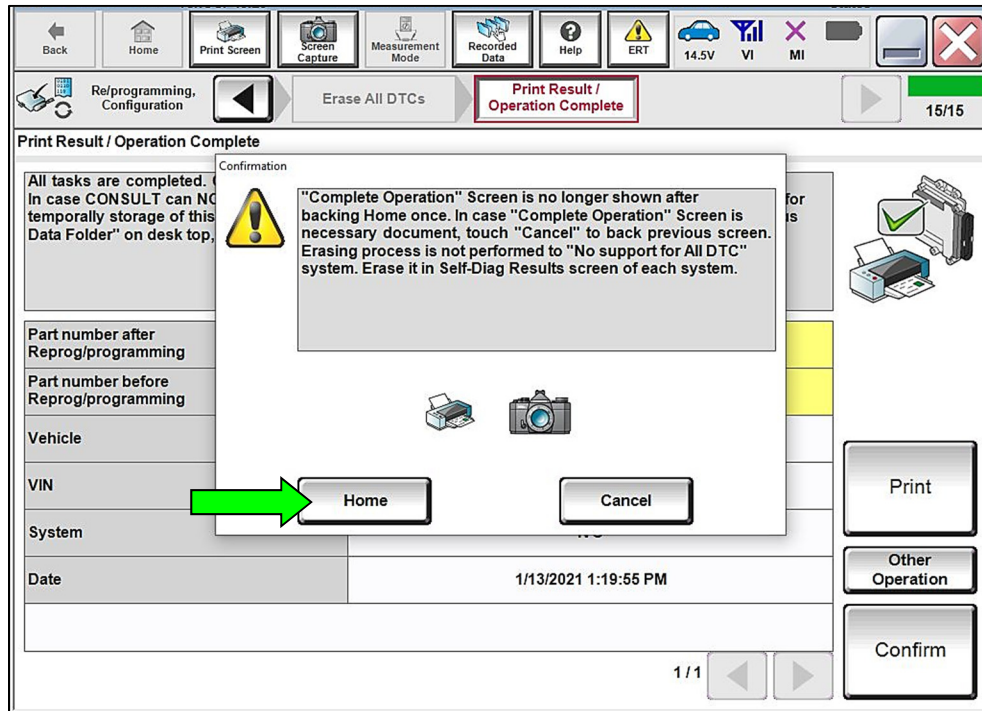
Figure 21

25. Select Home.
