October 2020  
SF611DE  
2ND REVISED NOTICE

## **Subject: Cascadia CTP Reset**

**Models Affected: Specific Freightliner Cascadia vehicles manufactured January 16, 2017, through March 27, 2020, and equipped with DTNA CTP proprietary telematics.**

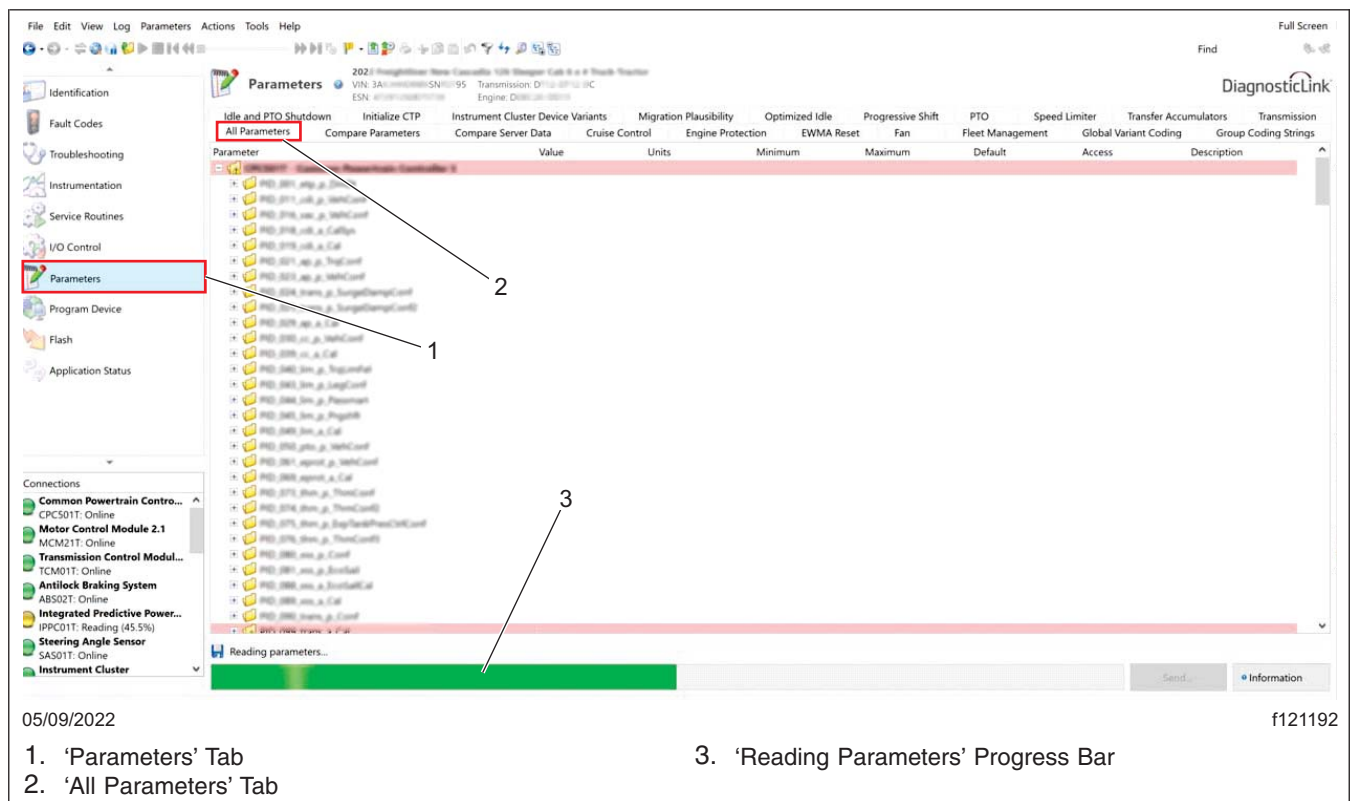
**Fig. 15, Reading ECU Parameters**

21. Go to the 'Parameters' tab, then select 'All Parameters,' as shown in **Fig. 15**.

DiagnosticLink will read the parameters of the connected ECUs. Wait until the 'Reading parameters' bar indicates this process is complete.

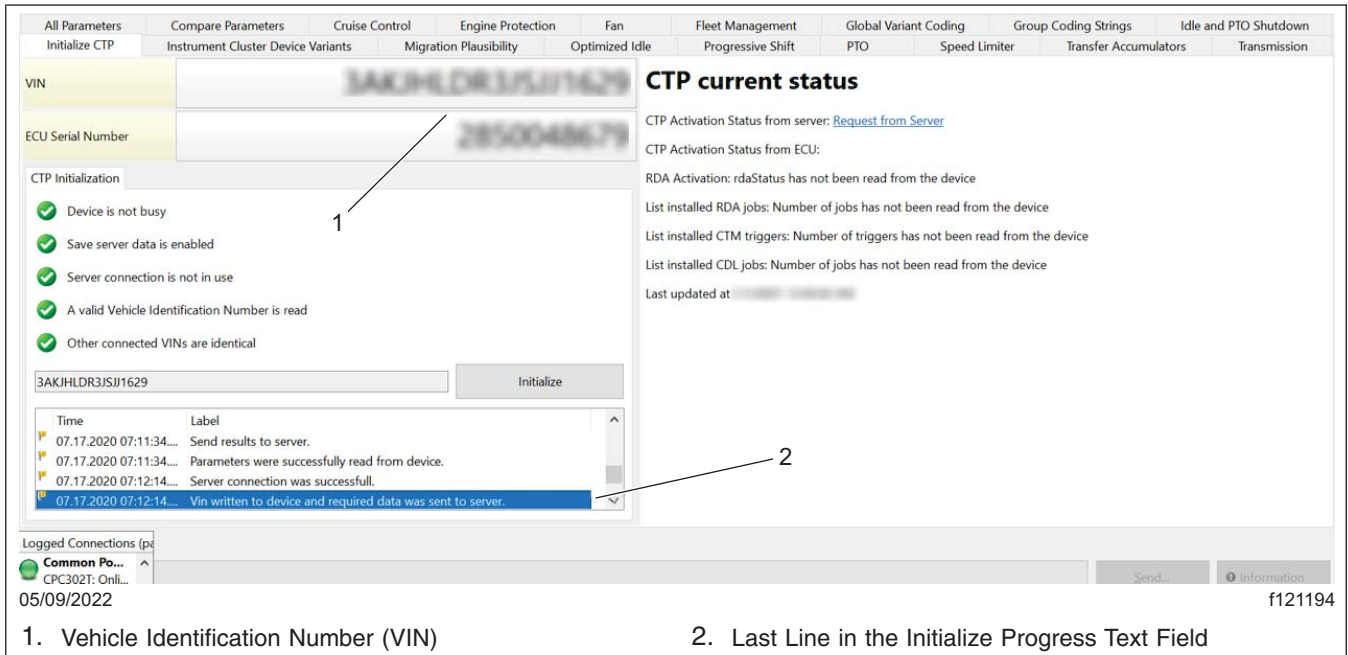
**Fig. 17, Initialization Successful**

25. Wait until the Initialization procedure finishes and the last line in the Initialize Progress Text Field reads 'VIN written to device and the required data was sent to the server,' as shown in **Fig. 17**.

Take a screenshot of the DiagnosticLink window and make sure the VIN and the last line in the Initialize Progress Text Field saying 'VIN written to device and the required data was sent to the server.' are visible in the capture.
