TECHNICAL SERVICE BULLETIN

| Classification: AN22-001 | Reference: NTB22-028 | Date: April 13, 2022 |

SOFTWARE UPDATE FOR INFOTAINMENT ISSUES

- APPLIED VEHICLES:** 2021 Kicks (P15)
2021 Sentra (B18)
- APPLIED DATES:** 2021 Kicks built before October 5, 2021
2021 Sentra built on or between March 18 and Sept 23 of 2021
- APPLIED GRADES:** SR and SV

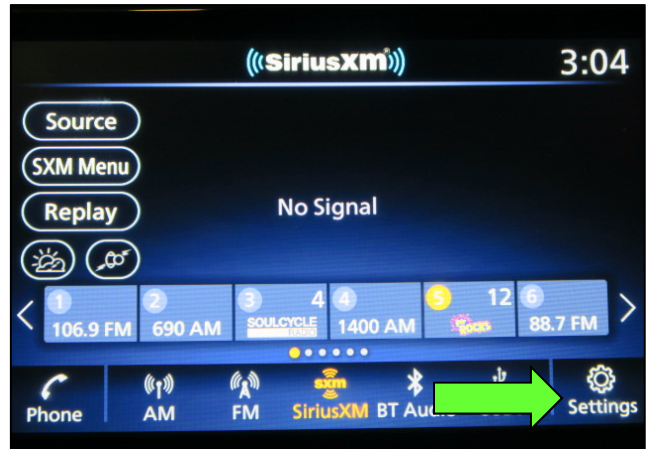
Figure 2

1. Select **Settings**, located in the lower right hand corner of the Audio Control Unit display (Figure 2).

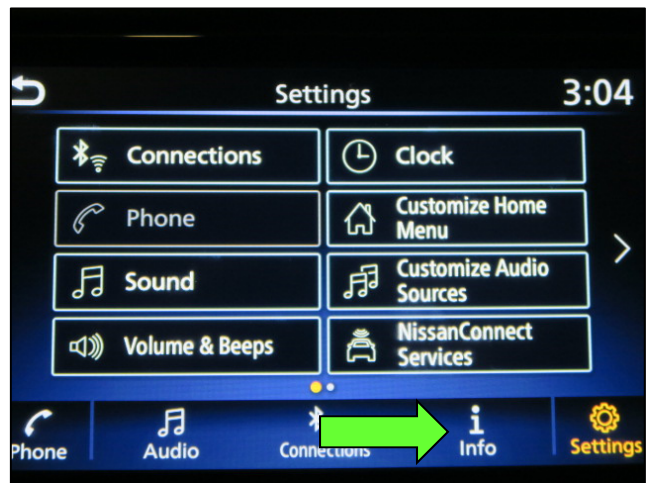
Figure 3

2. Select **Info**.

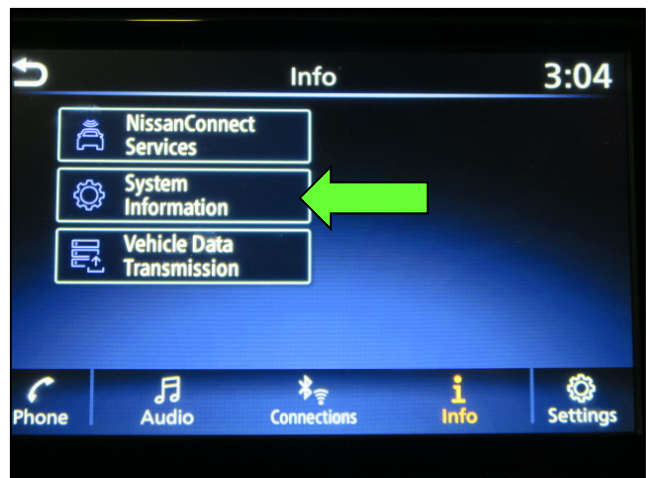
Figure 4

3. Select **System Information**.

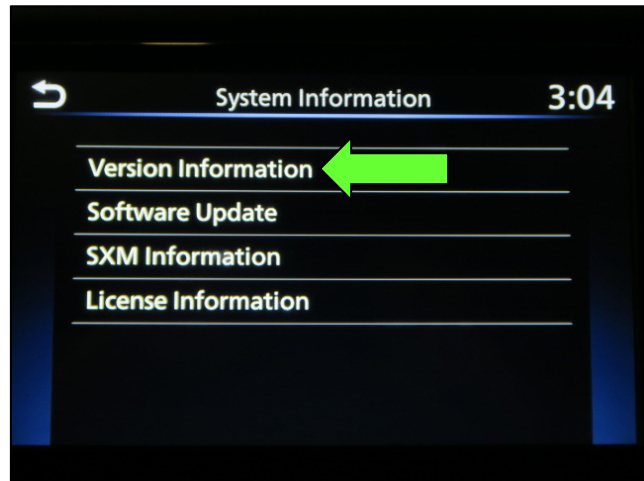
Figure 5

4. Select **Version Information**.

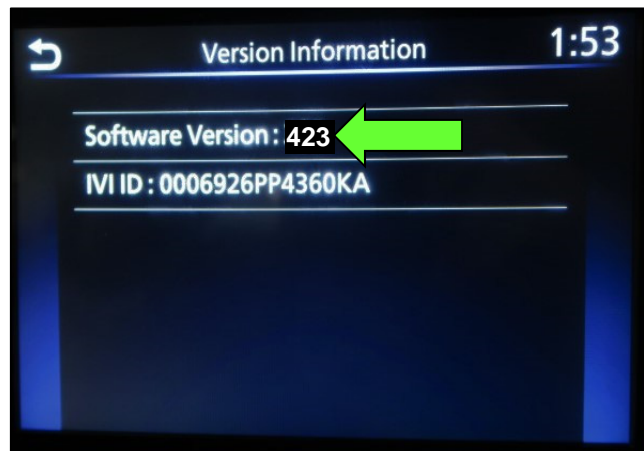
Figure 6

5. Verify the **Software Version** is numerically below 423.
- If the **Software Version** is below 423, proceed to step 6 on page 5.
 - If the **Software Version** is not below 423, the **SERVICE PROCEDURE** is complete. Proceed to **CLAIMS INFORMATION** on the last page of this bulletin.

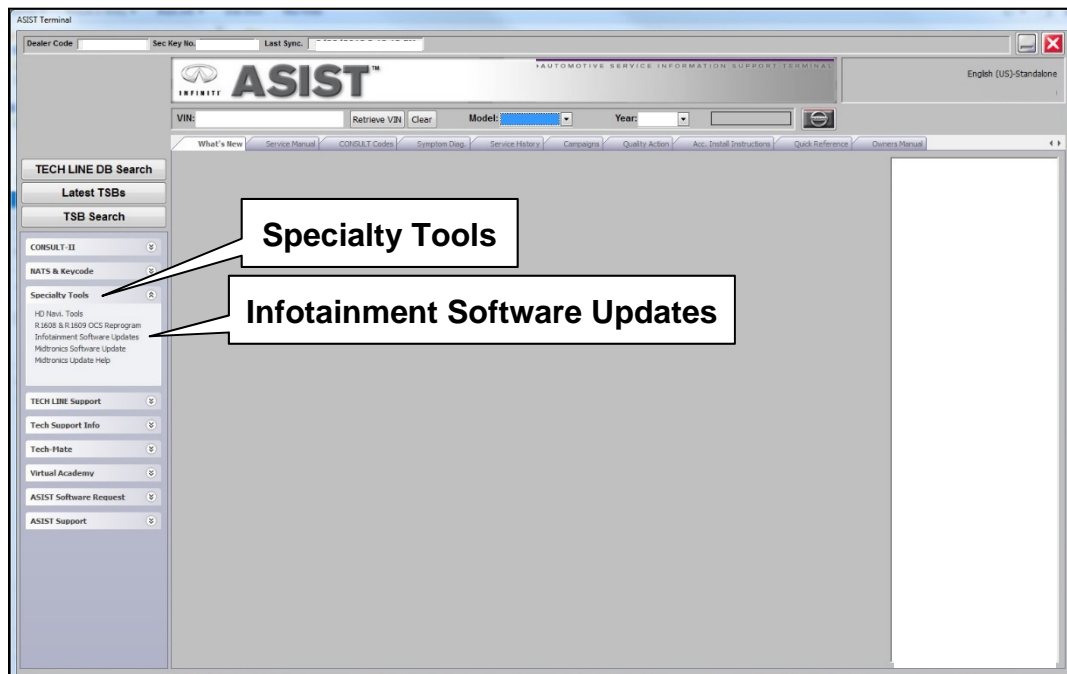
Figure 7

8. Select **Specialty Tools**, and then select **Infotainment Software Updates**.

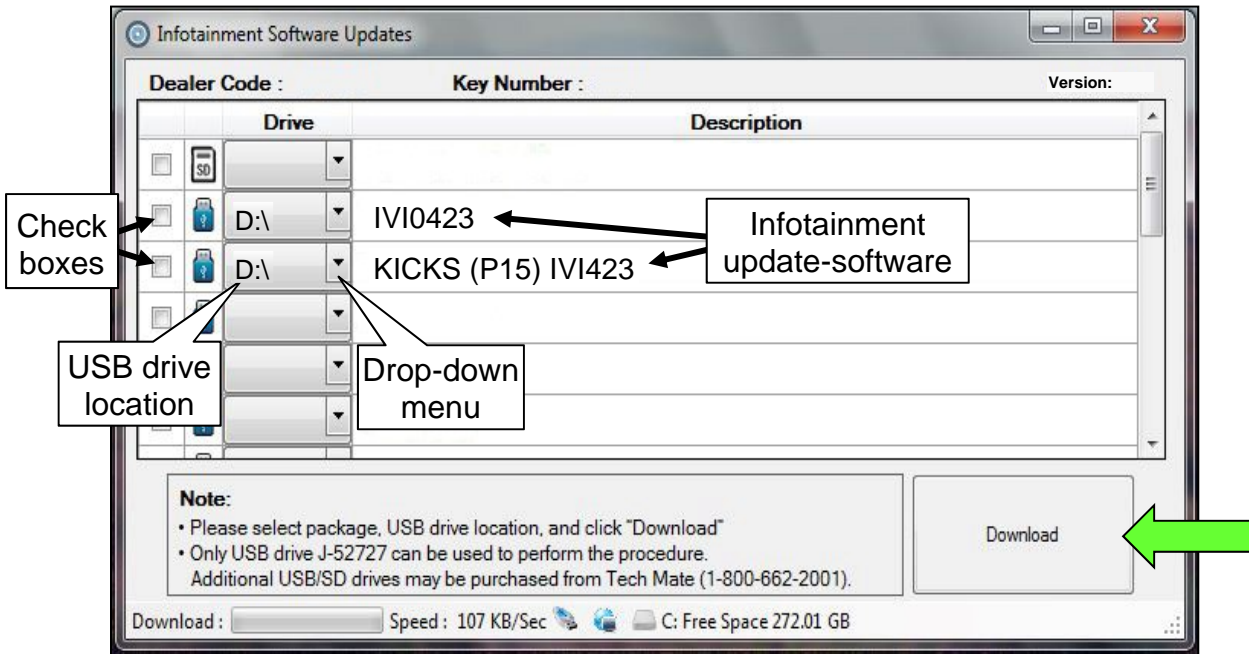
Figure 8

9. Select the check box next to one of the following model specific infotainment update-software descriptions:
 - For Sentra – **IVI0423**
 - For Kicks – **KICKS (P15) IVI423**
10. Use the drop-down menu and select the location of the USB drive that was inserted in step 6 on page 5.

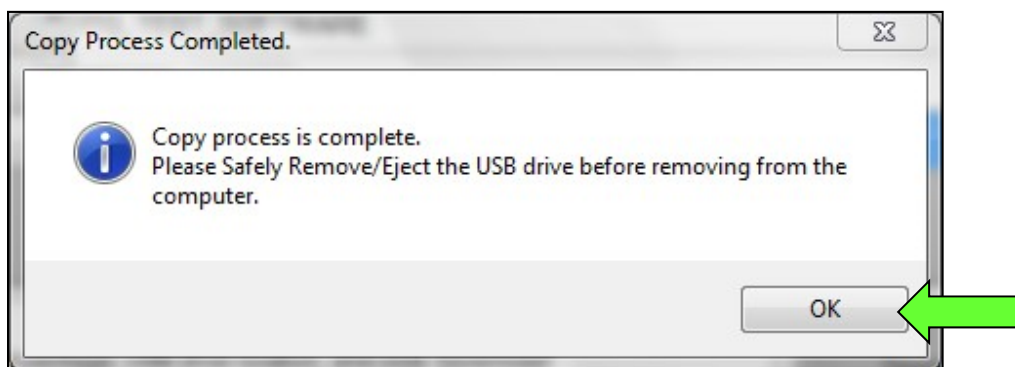
11. Select **Download**, and then wait for the download to complete.
HINT: The update-software is estimated to take 10-15 minutes to download to the USB drive.
12. Select **OK** when the message in Figure 9 is displayed.

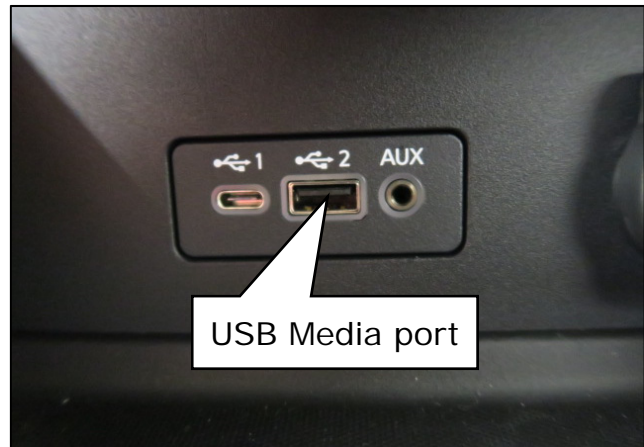
Figure 11

17. Insert the USB drive with the infotainment update-software into the vehicle's USB media port (Figure 11).
 - Do not remove the USB drive during the update to the vehicle until instructed to do so.

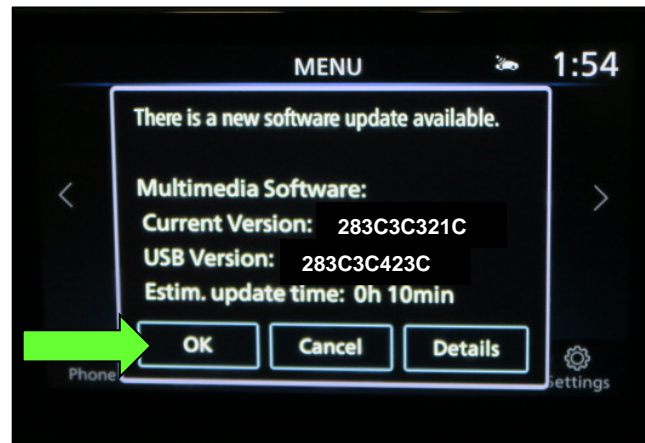
18. Wait approximately 10-30 seconds for the screen in Figure 12 to appear, and then select **OK**.

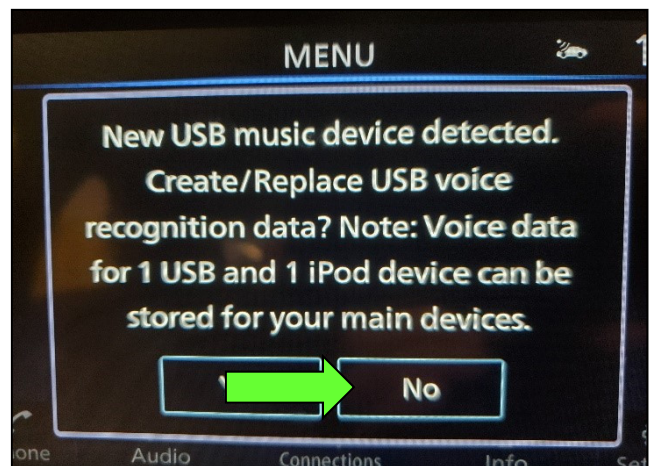
- If the screen in Figure 13 is shown, select **No**.

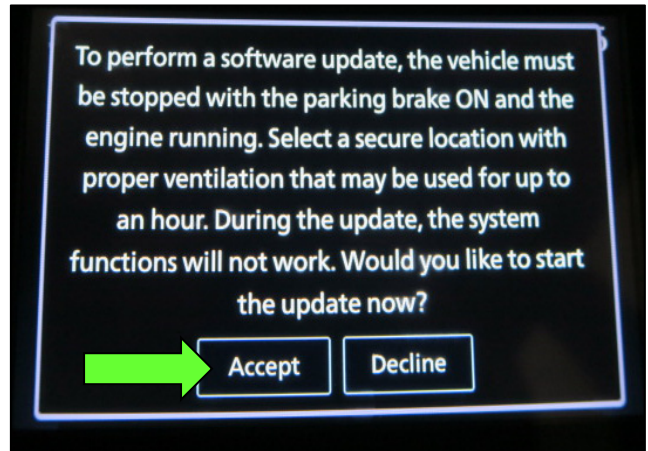
Figure 14

19. Review the software update requirements, shown in Figure 14, and then select **Accept** to start the reprogramming.

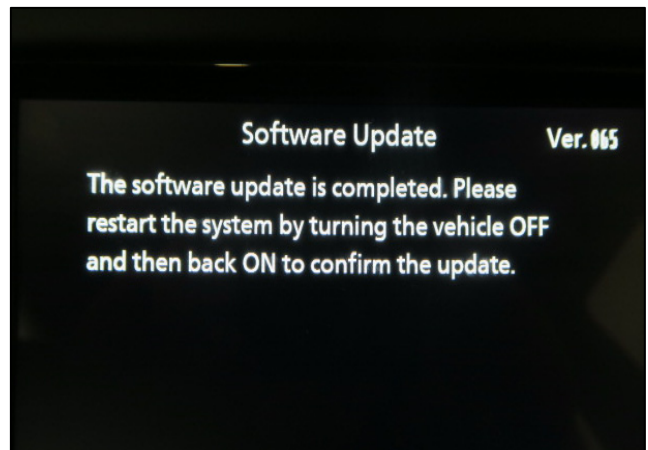
20. When the message shown in Figure 15 is displayed, remove the USB drive from the USB media port.

Do not remove the USB drive until the screen in Figure 15 is displayed. If removed prior to this screen being displayed, the Audio Control Unit may be damaged.

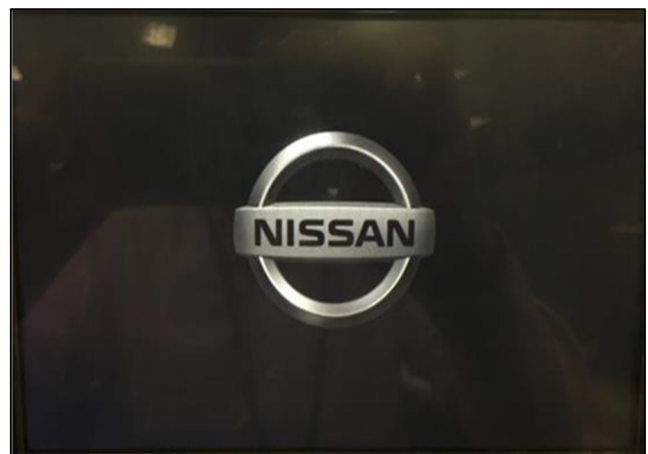
Figure 16

21. Turn the ignition OFF.
22. Open and close the driver door.
23. Restart the engine.
24. Allow the system to boot up completely (approximately 30 seconds).
 - The Nissan logo will be displayed during the reboot (Figure 16).

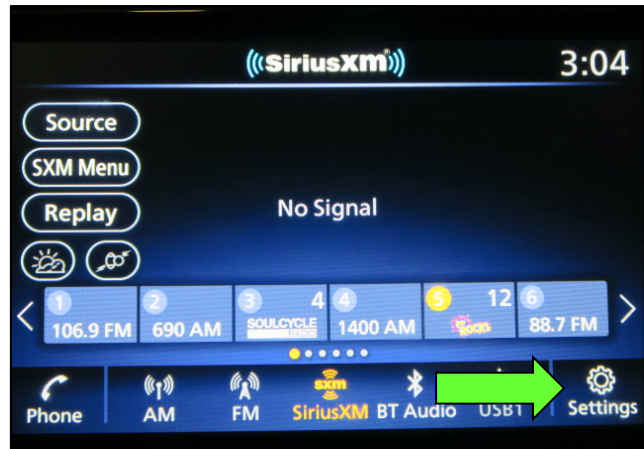
Figure 17

25. Select **Settings**, located in the lower right hand corner of the Audio Control Unit display (Figure 17).

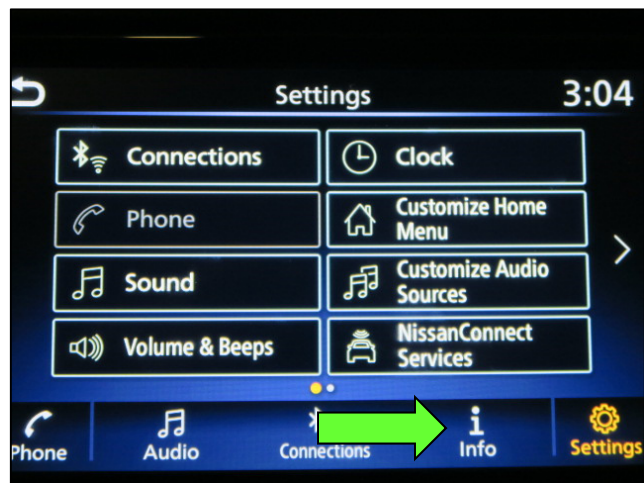
Figure 18

26. Select **Info**.

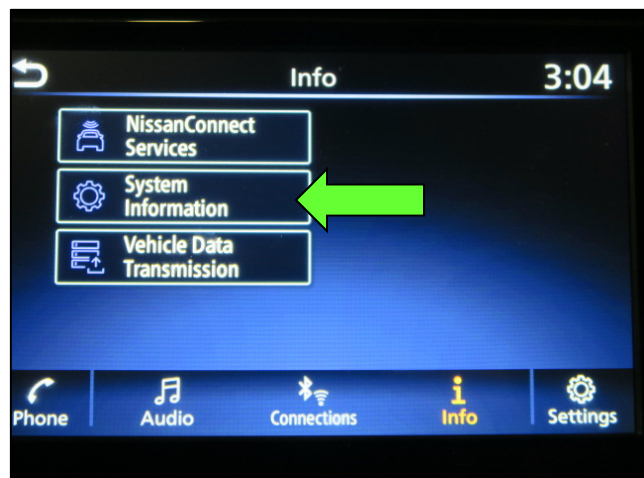
Figure 19

27. Select **System Information**.

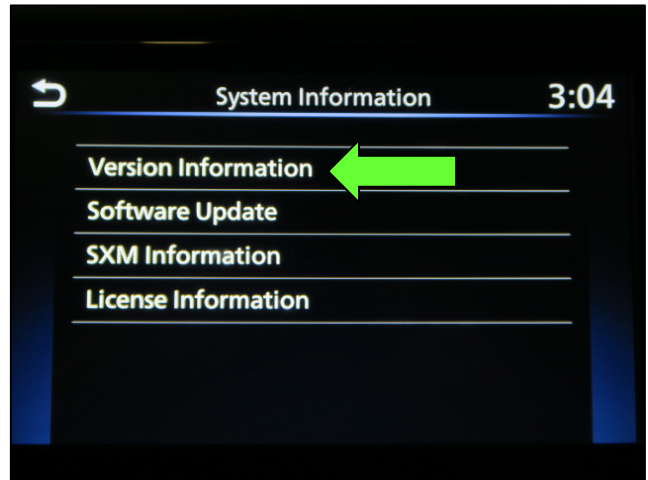
Figure 20

28. Select **Version Information**.

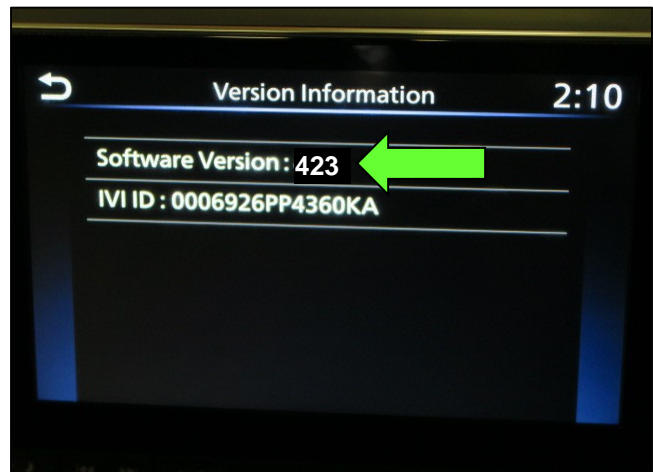
Figure 21

29. Verify the **Software Version** is now **423**.

- If the **Software Version** is NOT **423**, start this procedure over and verify that the correct software shown in step 9 on page 6 is downloaded.
- If the **Software Version** is 423, the reprogramming is complete.
