<b>HYUNDAI</b> <b>Technical Service Bulletin</b>	GROUP <b>CAMPAIGN</b>	NUMBER <b>22-01-043H</b>
	DATE <b>MAY 2022</b>	MODEL(S) ELANTRA (AD) KONA (OS) VELOSTER (JS)
<b>SUBJECT:</b>	ENGINE MONITORING LOGIC (SERVICE CAMPAIGN 974)

**Description:** Hyundai is conducting a service campaign to enhance the knock sensor logic with the Cylinder Noise Diagnostic System (CNDS) software update. CNDS is to detect abnormal cylinder wall scuffing or noise of the engine block before potentially severe engine damage occurs. If abnormal noise is detected, the Malfunction Indicator Lamp (MIL) will blink continuously. In addition, DTC P1327 will be recorded in the ECM.

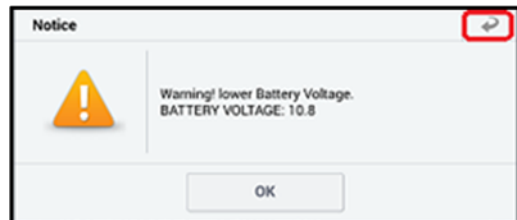
**GDS Vehicle Battery Voltage Warning:**

If voltage is below 12 volts as per the GDS warning, then select **Back** and run the engine at least 15 minutes to reach an adequate battery state of charge to prevent ECU Update failure. Cycle the ignition **OFF/ON** before retrying ECU update again.

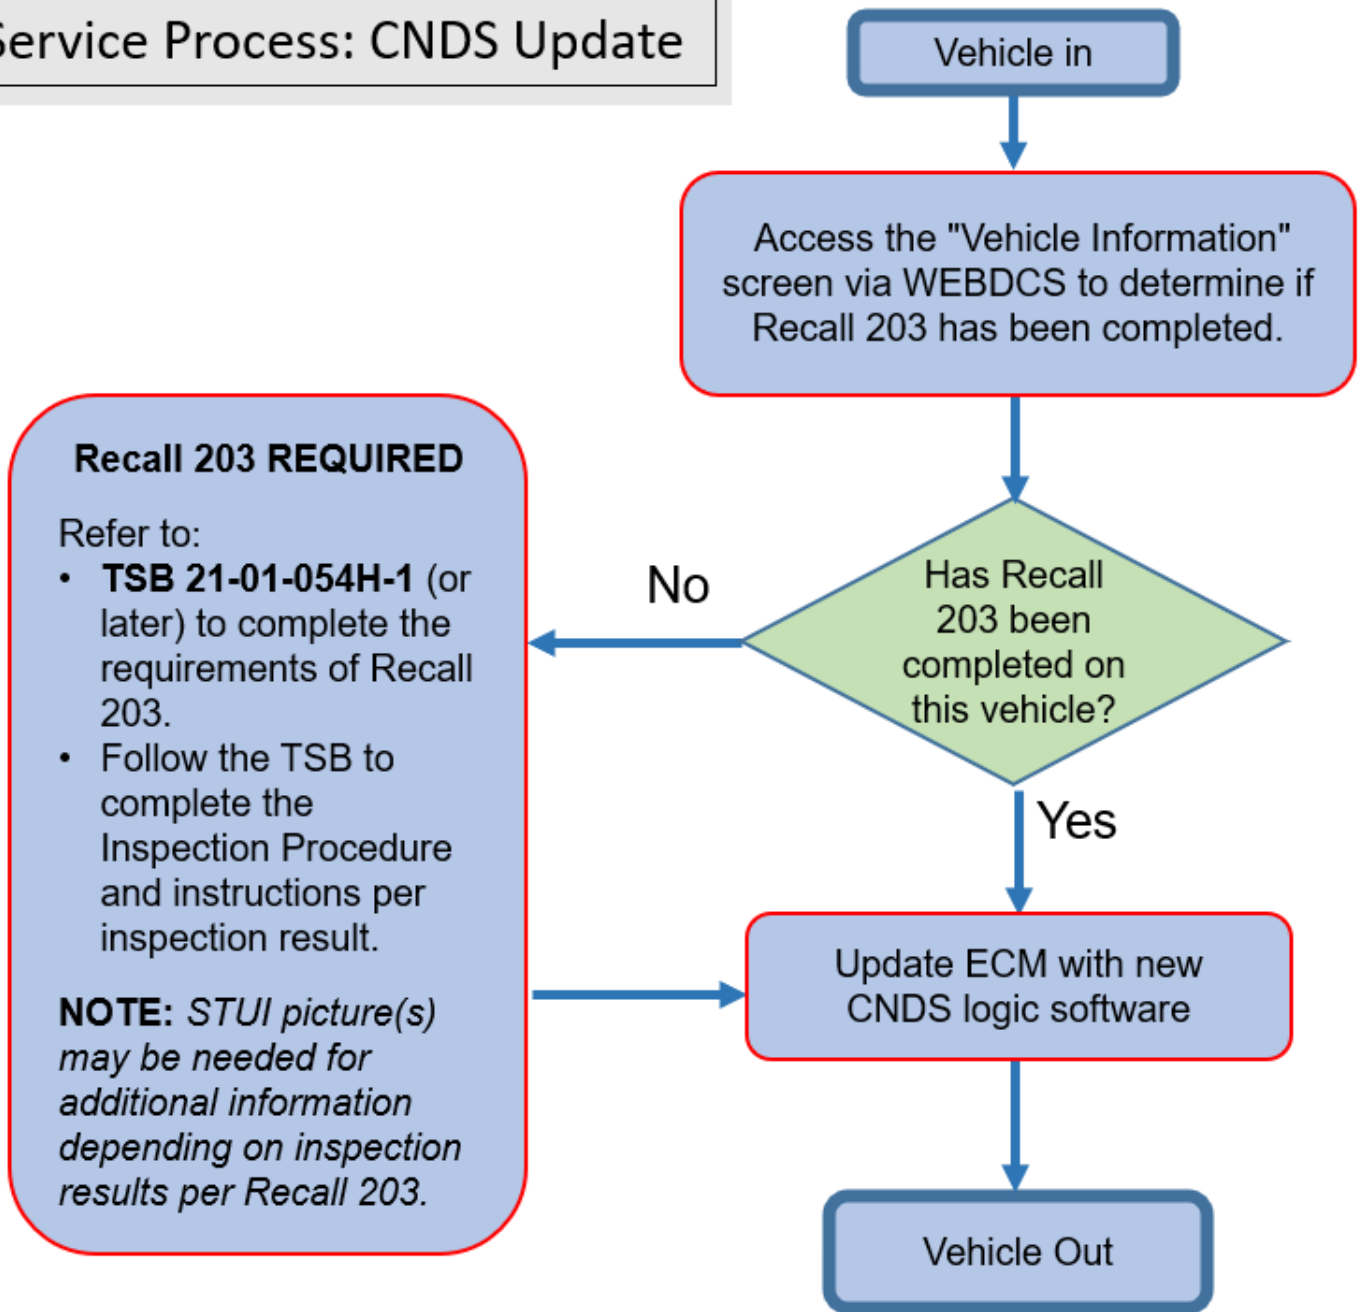
**Service Process: CNDS Update**

**Service Procedure Flowchart:**
