# Service Bulletin

Bulletin No.: 21-NA-177

**Subject:** Service Power Steering Message Illuminated on Driver Information Center (DIC), DTC C0051 58 – Steering Wheel Angle Sensor Error Stored or in History

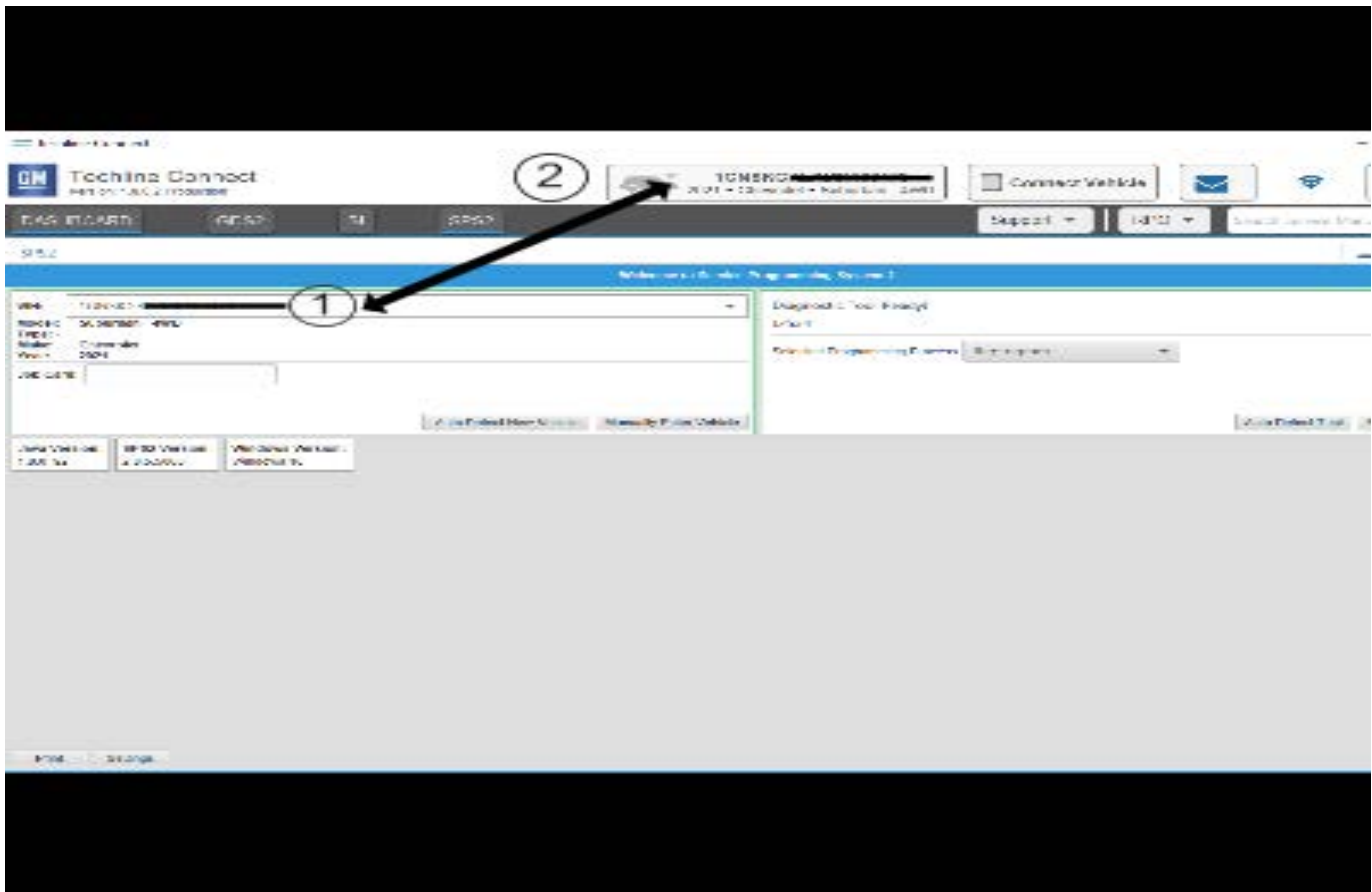
**Caution:** Be sure the VIN selected in the drop down menu (1) is the same as the vehicle connected (2) before beginning programming.
