Service Bulletin

Bulletin No.: 22-NA-002

Subject: Malfunction Indicator Lamp Illuminated with DTCs P0299/P0234 Set During Cold or Freezing Temperatures

Brand:	Model:	Model Year:		VIN:		Engine:	Transmission:
		from	to	from	to		
Chevrolet	Equinox	2018	2022	—	—	Equipped with 1.5L Engine (RPO LYX)	All
GMC	Terrain

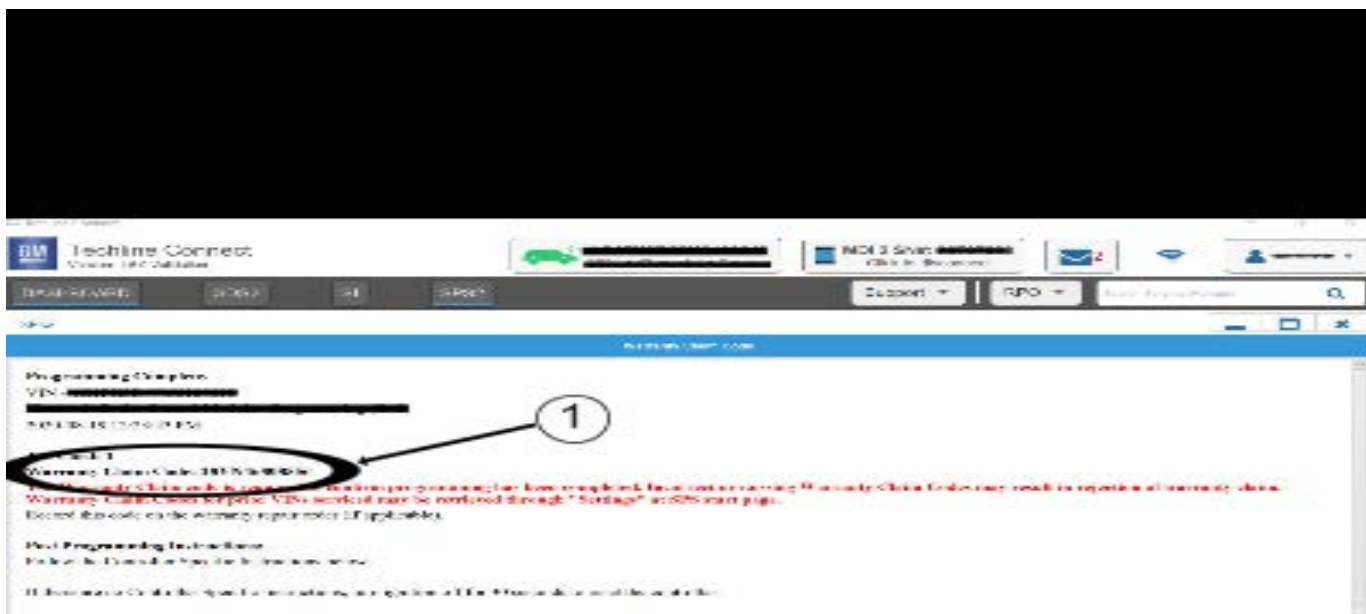
5644478

Note: The screenshots above are an example of module programming and may not be indicative of the specific module that is being programmed. Module selection and VIN information have been blacked out.
