Head Unit Software Update (Panasonic)

Service Category Audio/Visual/Telematics

Section Navigation/Multi Info Display

YEAR(S)	MODEL(S)	ADDITIONAL INFORMATION
2022	LX600, NX250, NX350, NX350H, NX450H+

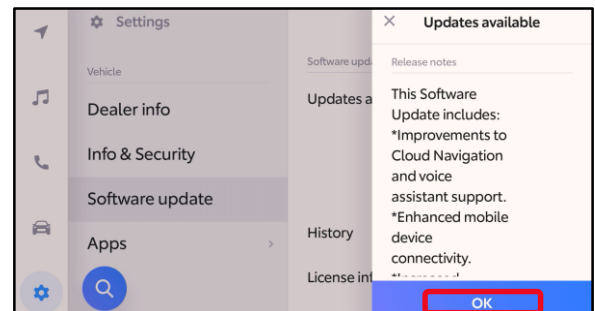
Figure 2.

Vehicle operators can perform this update directly by accepting the on-screen notification (see Figure 1) advising Software update available or by locating Software update from the Settings menu and initiating the available update (see Figure 2). The release notes text below will be displayed to the customer (see Figure 2):

“This Software Update includes: *Improvements to Cloud Navigation and voice assistant support. *Enhanced mobile device connectivity. *Increased performance resulting in a better experience.”

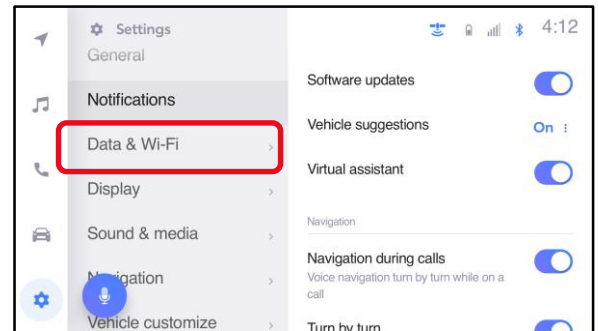
Figure 4.

3. Select Data & Wi-Fi.

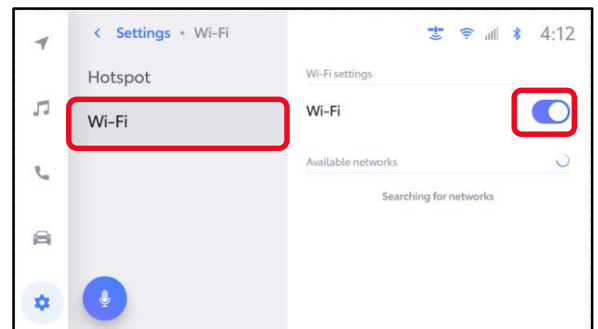
Figure 5.

4. Select Wi-Fi and turn the Wi-Fi toggle to ON.

- This step is used to connect the vehicle to an EXTERNAL Wi-Fi source.
- Wi-Fi connection is NOT required for updates that are delivered through DCM data.

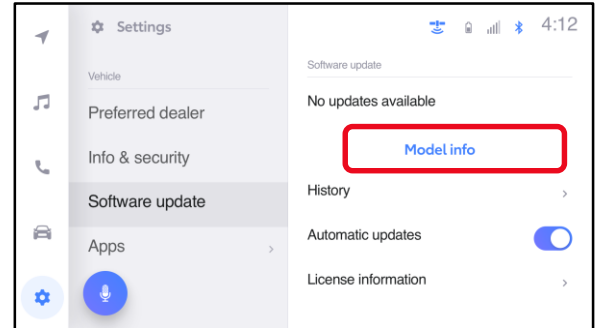
Figure 9.

2. Are software updates available?
 - **YES** — Continue to step 3 to update the vehicle.
 - **NO** — This bulletin does NOT apply, continue diagnosis using the applicable Repair Manual.

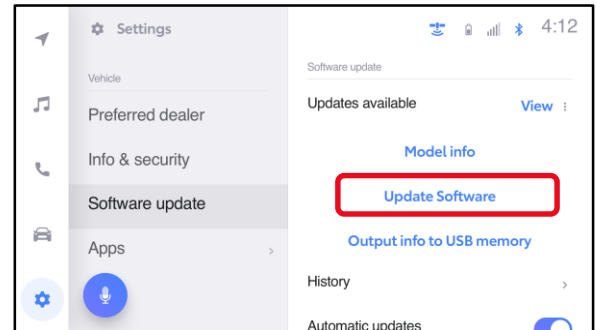
Figure 11.

6. Select Update Software.

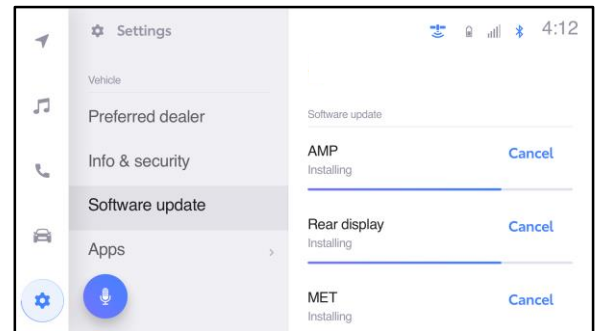
Figure 15.

10. Wait for the update to download. Once the head unit begins installation, the update will take about 10 minutes.

- Do NOT turn OFF the engine or ACC BEFORE the software is ready for updating.
- Selecting Cancel will cancel the installation of the specific component, but it can be installed manually later.

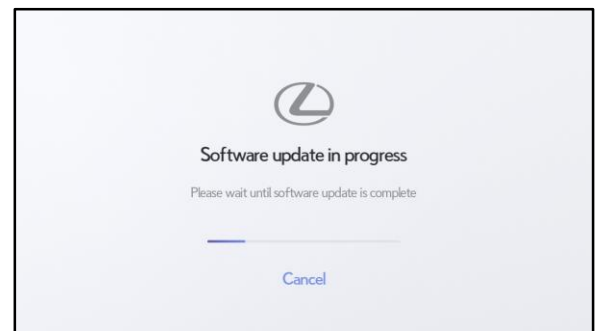
Figure 16.

11. If a major update is being installed the message "{Software update in progress}" will be displayed.

- Do NOT turn OFF the engine or ACC BEFORE the software is ready for updating.
- Selecting Cancel will cancel the installation of the specific component, but it can be installed manually later.

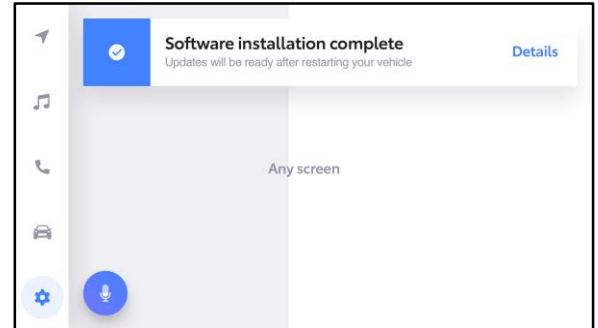
Figure 17.

12. The software installation is complete when either a “Software installation complete” banner (Figure 17) or the “Software update complete” screen (Figure 18) is displayed.

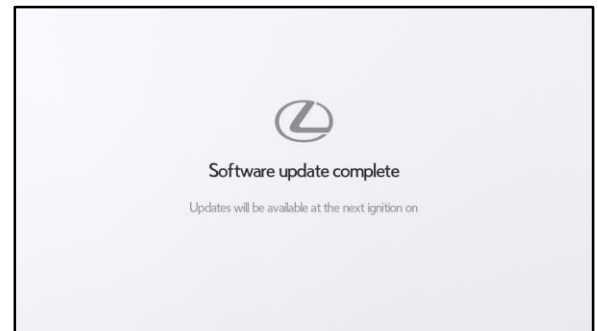
Figure 18.

If the vehicle has installed a major update, and the “Software update complete” screen is displayed, then an IG-OFF/ON will need to be performed prior to attempting to operate any of the infotainment functions.

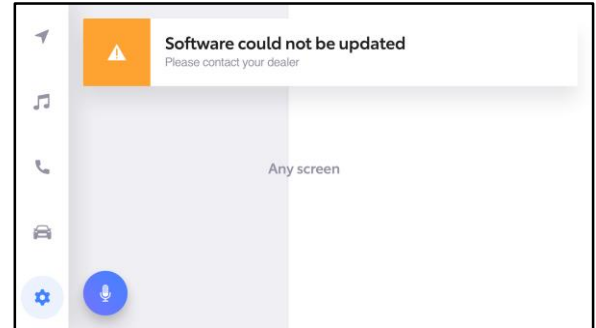
Figure 20.

14. If after IG-OFF/ON a “Software could not be updated” banner appears, continue to the [USB Update Procedure](#) subsection.

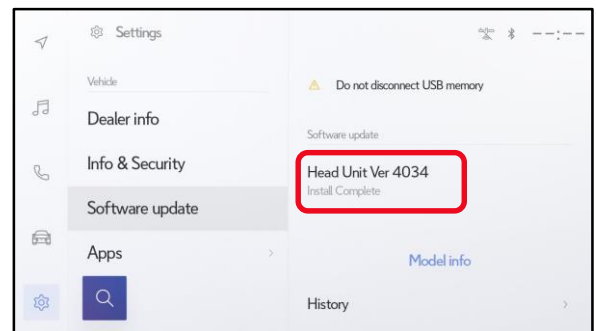
- A. When the update is complete, “Install Complete” will show on the head unit, as shown in Figure 26.
- B. The “Software update” pop-up message may also appear, as shown in Figure 27.
