Head Unit Software Update (Panasonic)

Service Category Audio/Visual/Telematics

Section Navigation/Multi Info Display

YEAR(S)	MODEL(S)	ADDITIONAL INFORMATION
2022	Tundra

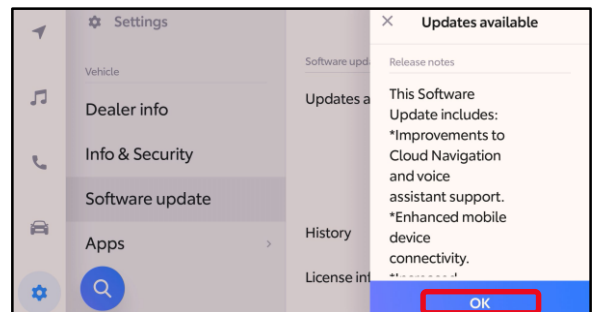
Figure 2.

Vehicle operators can perform this update directly by accepting the on-screen notification (see Figure 1) advising Software update available or by locating Software update from the Settings menu and initiating the available update (see Figure 2). The release notes text below will be displayed to the customer (see Figure 2):

“This Software Update includes: *Improvements to Cloud Navigation and voice assistant support. *Enhanced mobile device connectivity. *Increased performance resulting in a better experience.”

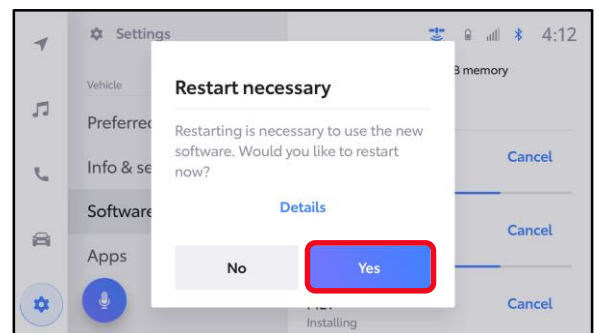
Figure 19.

- If a restart is necessary, select Yes to restart the head unit.

If No is selected or the vehicle is switched to IG-OFF, the installation will occur at the next IG-ON.
