Service

Category Audio/Visual/Telematics

Section Cellular Communication Market USA

A DCM reset and firmware update is now available to address these conditions. Follow the DCM Reset and Firmware Update Procedure in this bulletin to update the firmware.

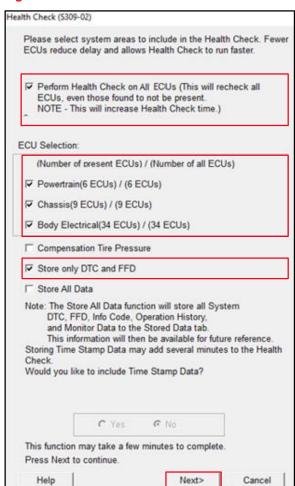
Figure 1.

- Ensure the customer has an active account BEFORE beginning this process.
- If the customer has waived telematics services, an account may need to be temporarily created to perform this update.
- 2. Using Techstream, perform a Health Check and clear ALL DTCs.
 - A. Check the "Perform Health Check on all ECUs" box.
 - B. Check the "Store only DTC and FFD" box.
 - C. Click on Next.

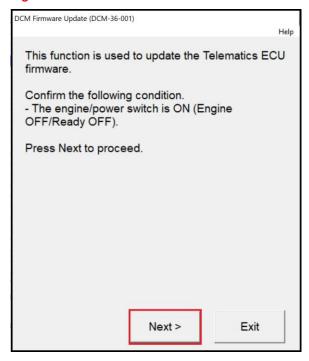
Figure 3.

9. Click on Next when the DCM firmware update screen appears.

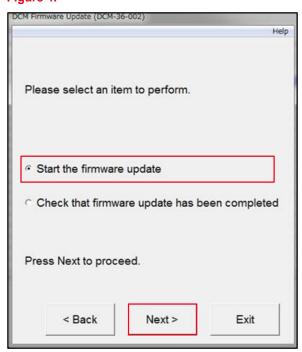
Figure 4.

10. Select "Start the firmware update" and click on Next when the item selection screen appears.

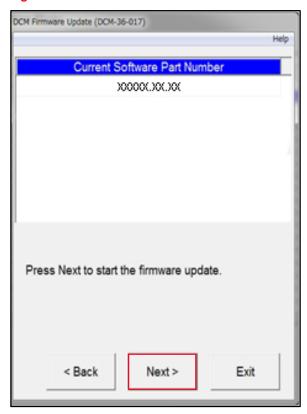
Figure 5.

- Do NOT press Exit until the update process has completed.
- During the update process, the green and red LEDs will both be ON and will reset several times resulting in the LEDs being temporarily OFF during the process. The download process will take about 5 – 10 minutes.

If the screen in Figure 5 does NOT appear and an error message displays, begin the Firmware Update Procedure again from step 4. The battery reset MUST be performed again.
