TECHNICAL INSTRUCTIONS

22TC01

DATA COMMUNICATION MODULE (DCM) REPROGRAMMING

2021 MODEL YEAR C-HR, RAV4 PRIME, TUNDRA

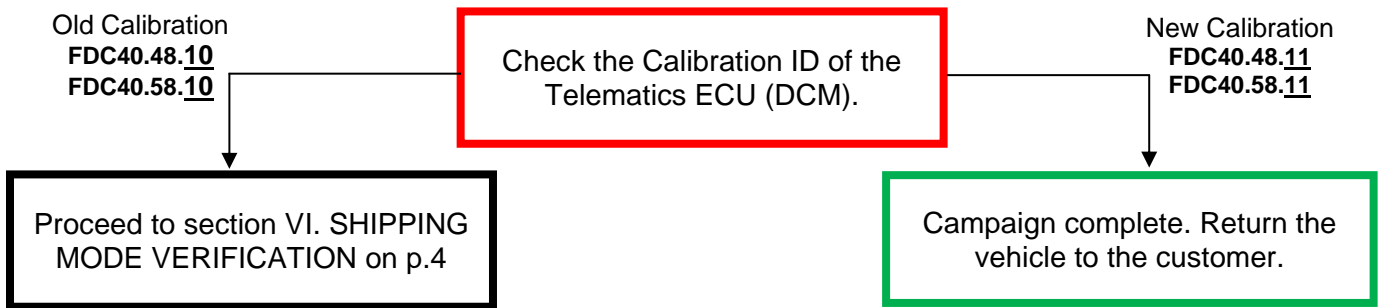
2. CHECK CURRENT CALIBRATION

- Locate the Calibration column for the Telematics in the Stored Data tab for this vehicle.
- Check the Calibration ID of the Telematics ECU (DCM).

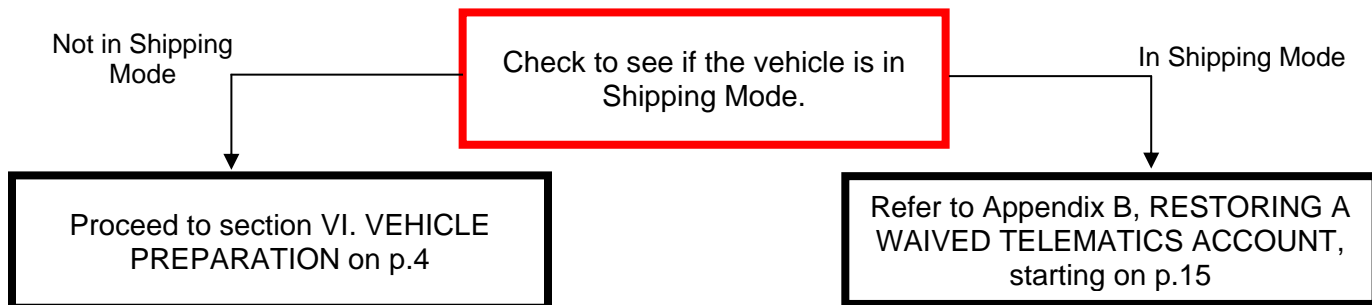
1. CHECK TELEMATICS DATA LIST

- a) Select the “System Select” tab at the top left of the screen, select “Telematics” and click the right-arrow.
- b) Select “Data List.”
- c) Check to see if the Telematics Activation Status value is “Shipping.”

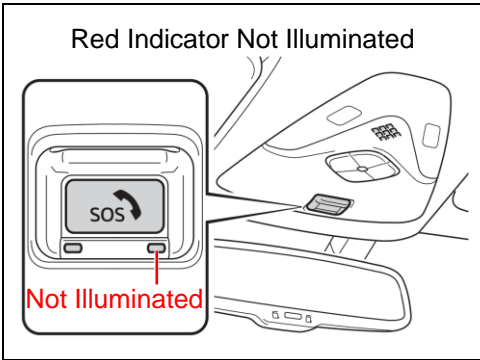
1. REPROGRAM CALIBRATION ID

- a) Confirm that the red indicator next to the SOS button is not illuminated. If the red indicator remains illuminated for longer than 2 seconds after IG-ON, there is a problem with the system that must be resolved before continuing.

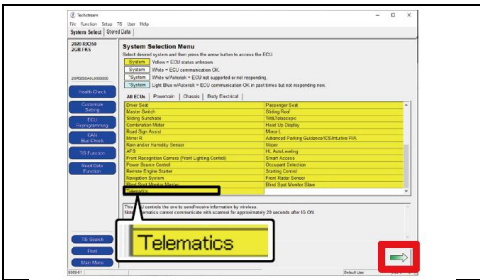
- b) Select the "System Select" tab at the top left of the screen, select "Telematics" and click the right-arrow.

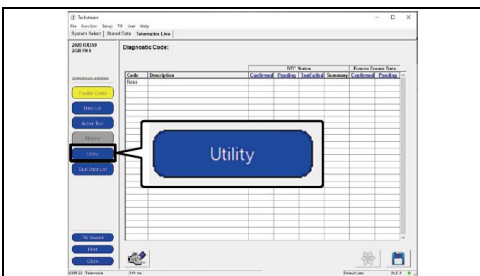
- c) Click "Utility".

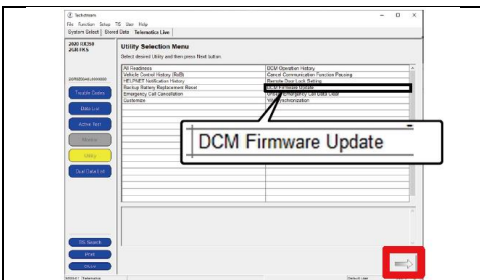
- d) Select "DCM Firmware Update" and click the right-arrow.

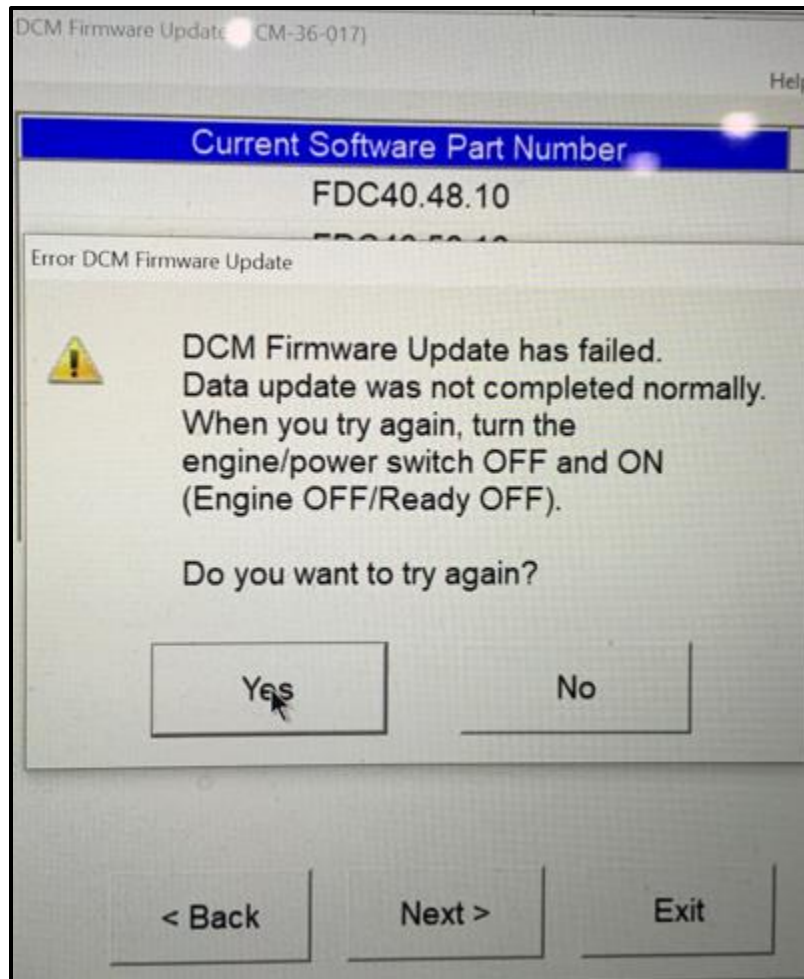
If the error message below is displayed after attempting to start the firmware update, refer to the Appendix B, RESTORING A WAIVED TELEMATICS ACCOUNT, starting on page 15. Otherwise proceed to the next step.

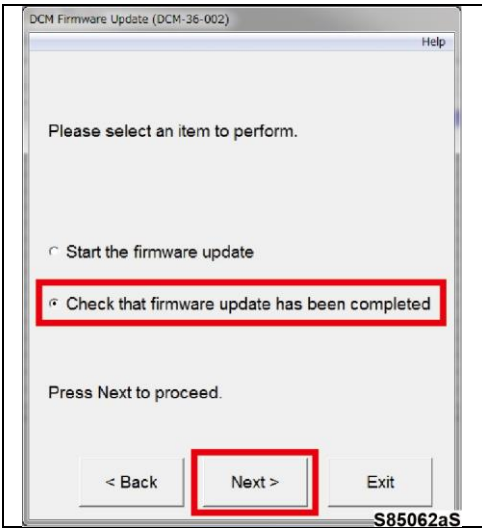
- d) Click “Next”.

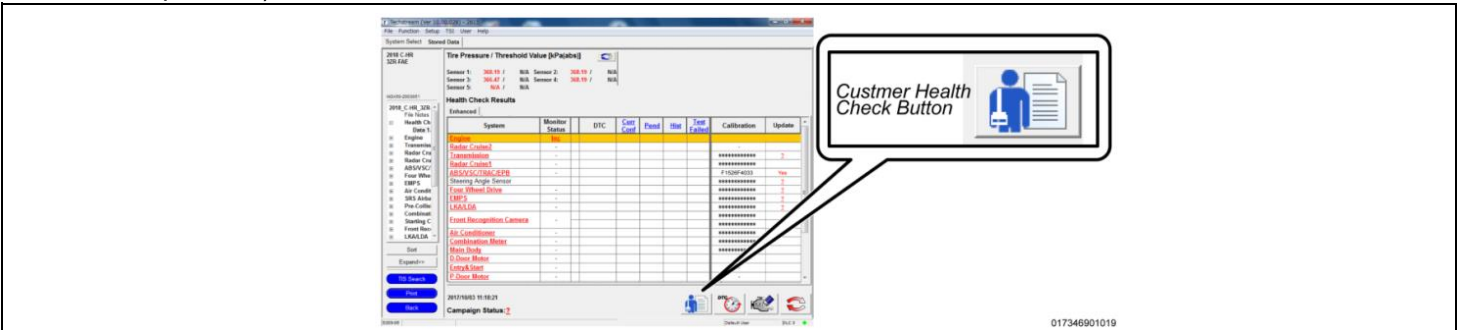
- a) From the Stored Data tab, select the Customer Health Check Report button (TIS will launch when button is pressed).

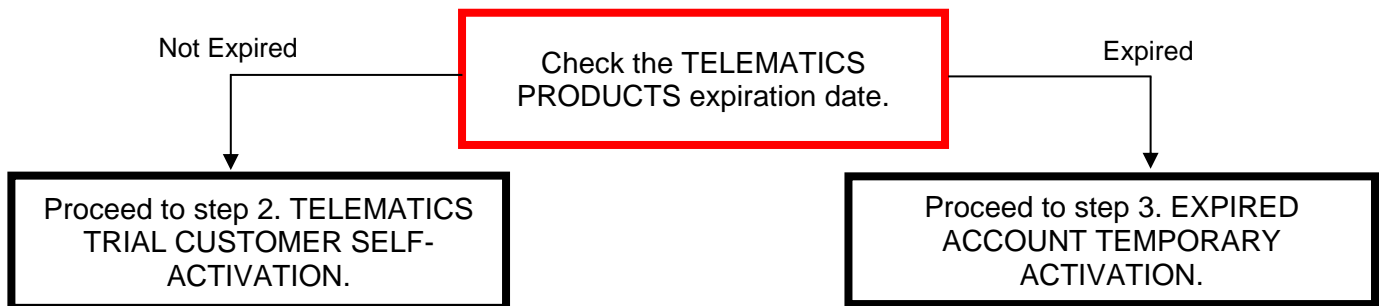
1. CHECK TELEMATICS EXPIRATION DATE

- a) Navigate to <https://one.tis.toyota.com/serviceLane/>.
- b) Enter the VIN in Vehicle One-View and click Search.
- c) Scroll down to the Telematics tab and check the expiration date of TELEMATICS PRODUCTS.

Subscription Details						
VEHICLE CAPABILITY						
App Suite Capable	Yes	Navigation	No	Dynamic Commute	No	
Safety Capable	Yes	Destination Assist	No	Dynamic Map/Route	No	
Wifi Capable	Yes	Dynamic POI Search	No	Scout GPS Link Capable	No	
TELEMATICS PRODUCTS						
Telematics System	Contract ID	Subscriber	Role	Effective Date	Expiration Date	Status
Safety Connect		** *****	PRIMARY SUBSCRIBER	09/22/2021	09/22/2022	WAIVED
