This Technical Bulletin details the general process for carrying out a Software Version Management (SVM) software update for any Technical Bulletin (TSB) / Update.

Technical Background

01-18-12 - Software Version Management

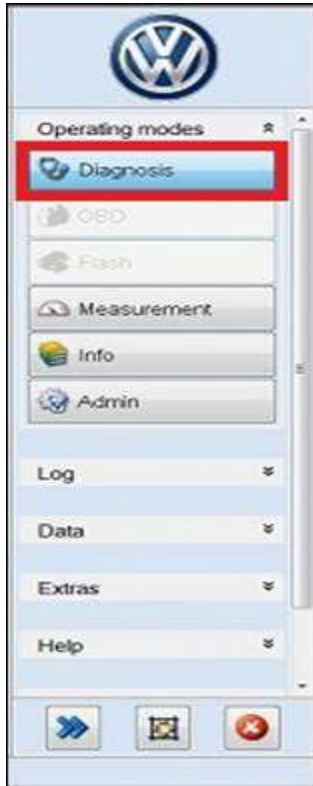
Figure 1

6. On ODIS Service application start up, make sure to select "Diagnosis" under Operating modes and not "Flash" (Figure 1).

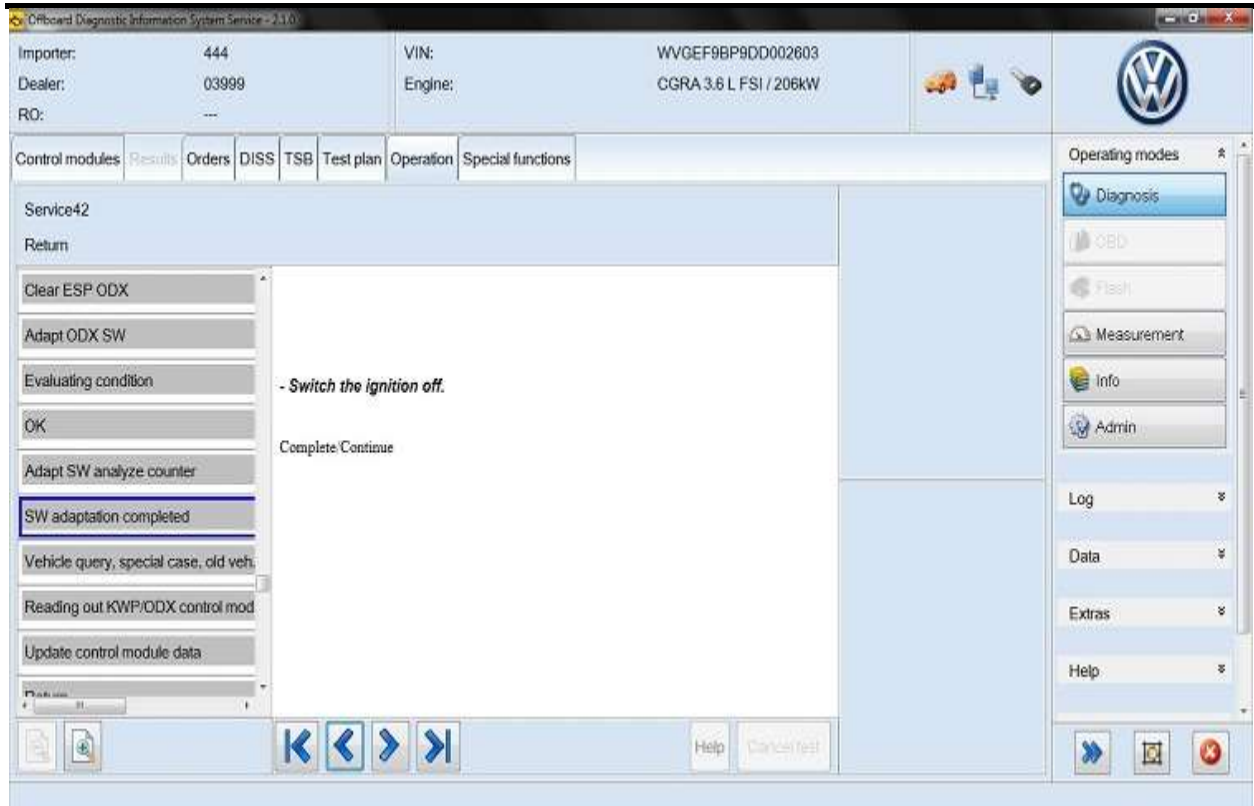
Figure 8

14. When the adaptation completes, switch the ignition OFF (Figure 8).

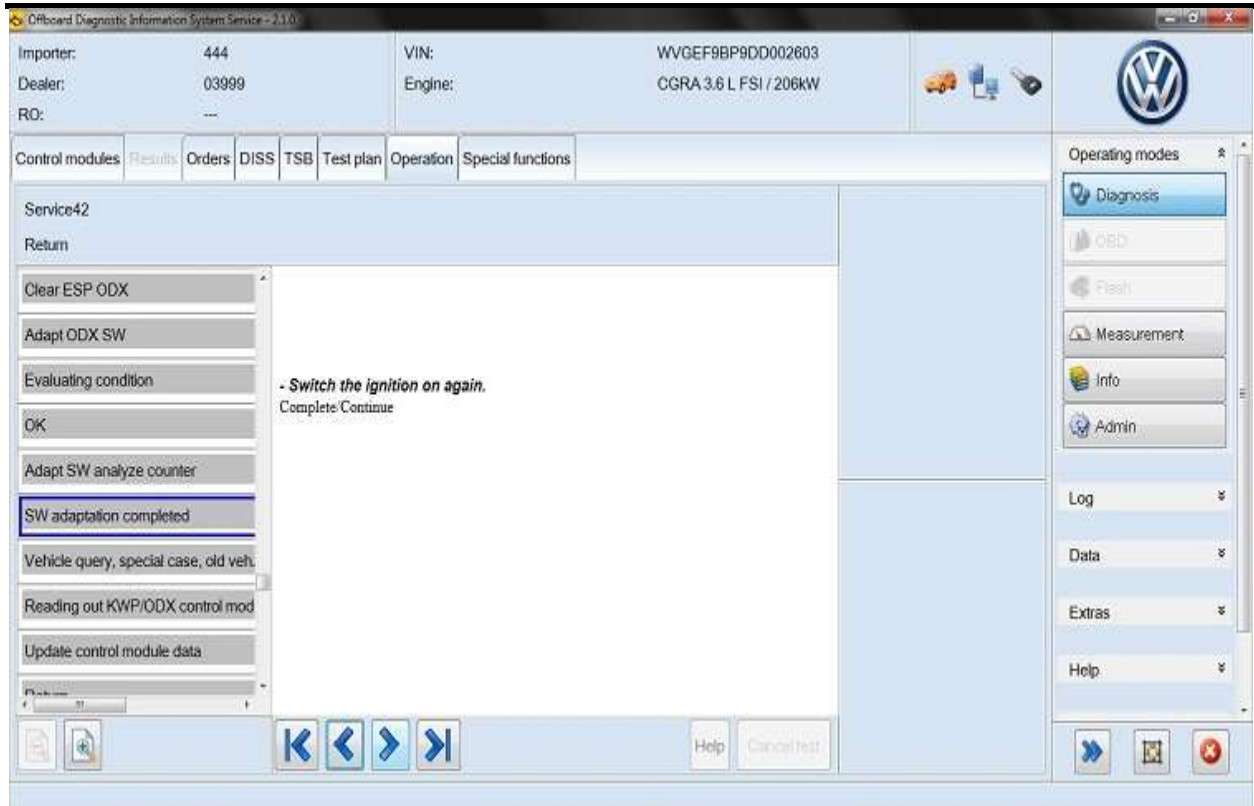
Figure 9

15. When prompted, switch the ignition ON (Figure 9).

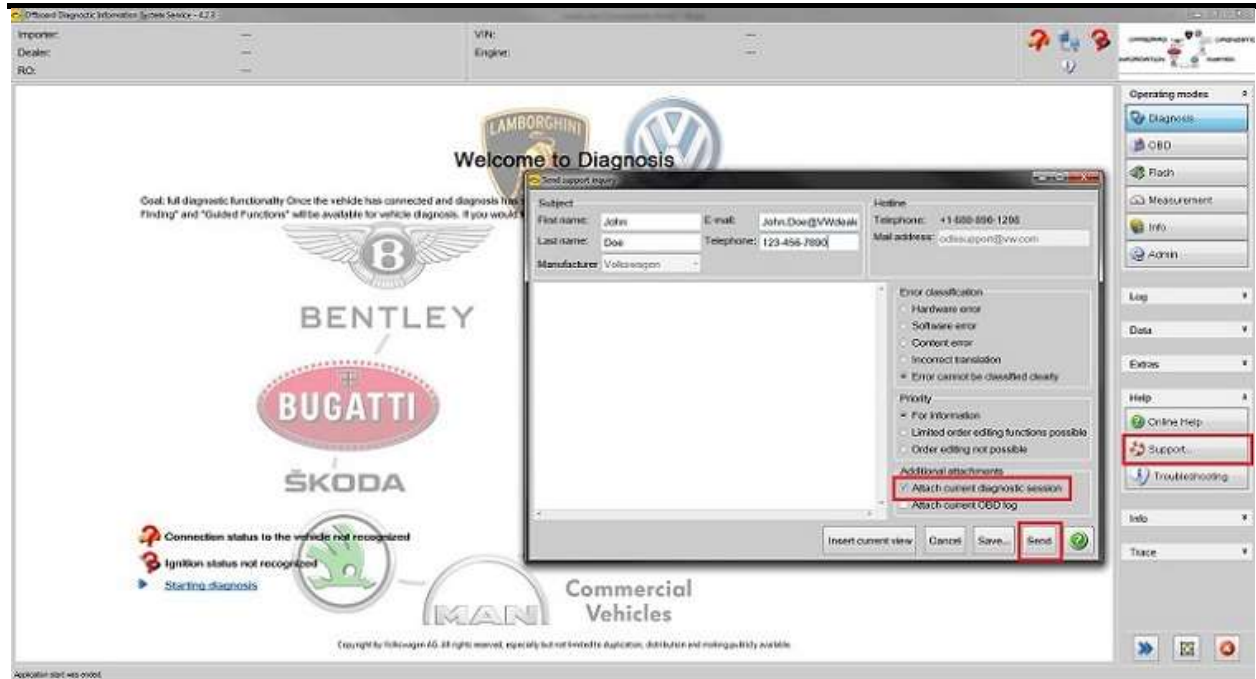
Figure 11
Warranty

Any other ERP Codes encountered during the SVM process that cause a stop in work need an ODIS Service application feedback sent to Support (see figure 11).

When sending an ODIS Service application feedback please ensure the option "Attach current diagnostic session" is selected.
