June 2022  
SF657A

## Subject: Freightliner and Western Star CTP Software Update

**Models Affected: Specific model years 2019-2022 Freightliner and Western Star 47X and 49X vehicles manufactured July 11, 2019, through March 9, 2022.**

The CTP software will be updated to correct communication error.

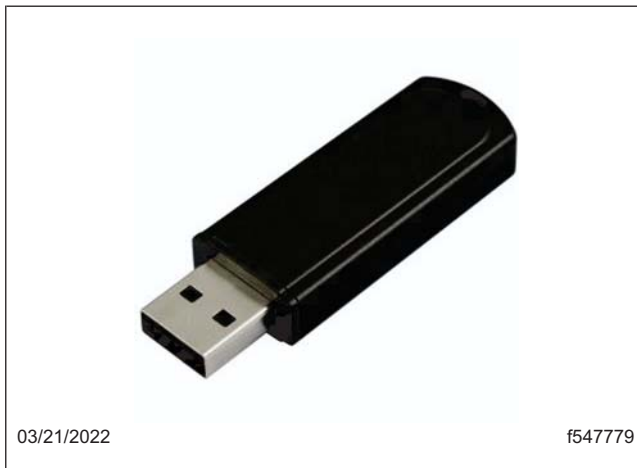
Fig. 1, USB Flash Drive

- The configuration file only has to be downloaded once; this file can be used to update multiple vehicles using the same USB drive.
- A dealer provided USB drive with a storage capacity of 1 to 32 GB is required to complete the CTP software update. See [Fig. 1](#).
- A dealer provided mini USB adapter is also required to complete the CTP software update. See [Fig. 2](#).

**IMPORTANT:** The USB drive must have 1 to 32 GB of storage space. It is recommended to format the USB drive before using it for this software update; this will result in the contents (if any) of the USB drive to be permanently erased.

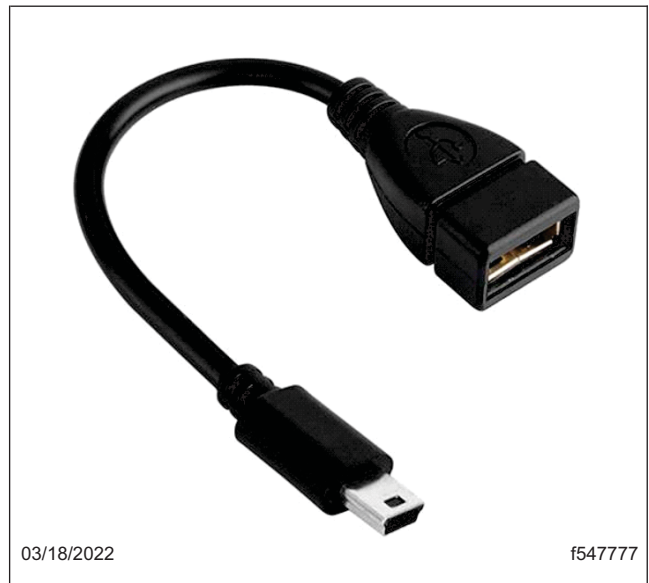
Fig. 2, USB A Female to Mini USB B 5-Pin Male Adapter Cable

The USB Adapter must be On-the-Go (OTG) protocol compliant. Non-OTG compliant adapters may result in failure of the CTP software update.

**NOTE:** The USB Adapter must be On-the-Go (OTG) protocol compliant. Non-OTG compliant adapters may result in failure of the CTP software update.

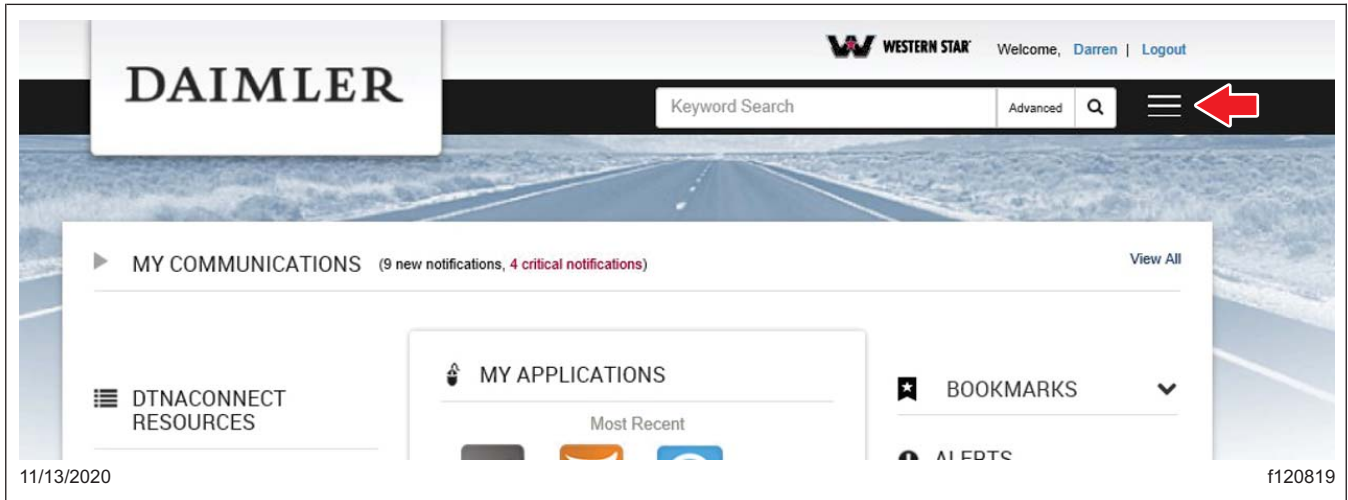
**Fig. 3, DTNA Connect Home Screen**

- On the laptop, go to DTNA Connect, then select the three menu bars at the upper right-hand corner of the web page. See [Fig. 3](#).

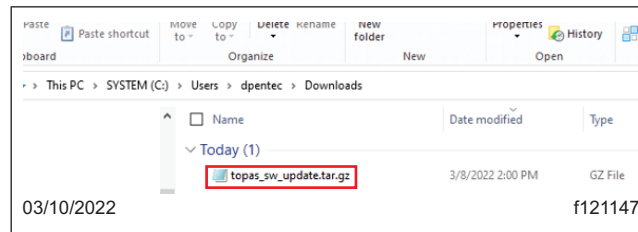
**Fig. 6, Downloaded Software**

6. A download box will appear in the upper right corner of the browser window. Once the download is complete, open the 'Downloads' folder and verify the downloaded file name is 'topas\_sw\_update.tar.gz.' See [Fig. 6](#).

**IMPORTANT:** Multiple software downloads on the same laptop may result in the file name being changed due to duplicate copies. Make sure only the file with the original name 'topas\_sw\_update.tar.gz' is used for this procedure.

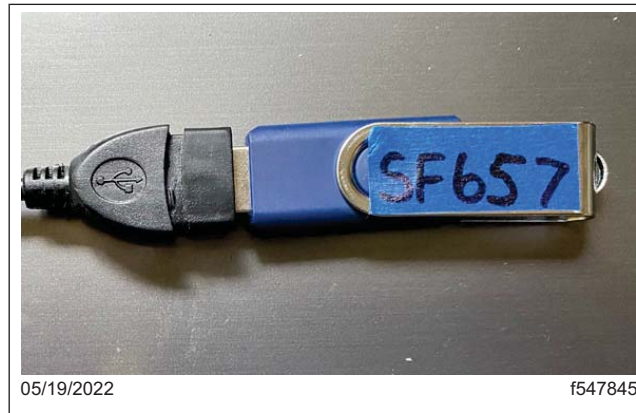
**Fig. 7, USB Flash Drive Labeled SF657**

- Write the campaign number, SF657, on a blank label, and attach it to the USB drive, as shown in [Fig. 7](#). This USB drive can be used to update multiple vehicles as noted at the beginning of the work instructions.

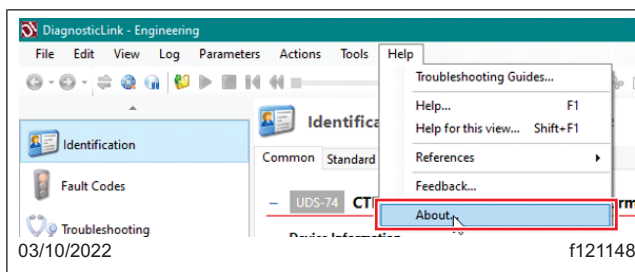
**Fig. 8, Opening the About DiagnosticLink Professional Window**

**IMPORTANT:** Make sure that DiagnosticLink is updated to the latest version (8.15 SP1 at the time of publication, or newer) before programming the vehicle. To verify, go to 'Help,' then select 'About.' See [Fig. 8](#) and [Fig. 9](#).

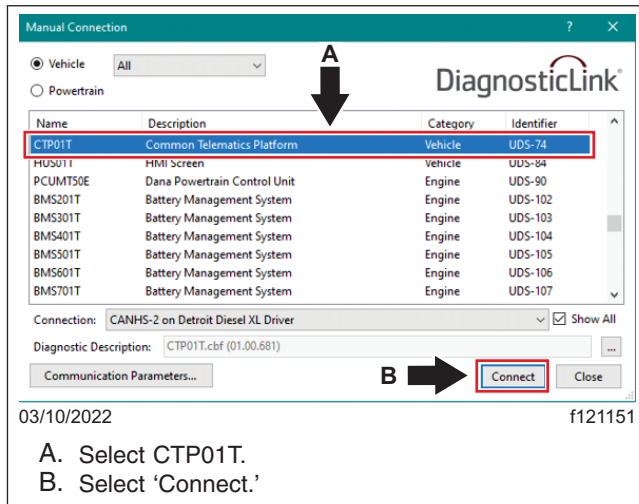
Fig. 11, Manual Connection Window

- In the 'Manual Connection' window that appears, select 'CTP01T,' then select the 'Connect' button. See [Fig. 11](#). Wait until the CTP01T connection turns green, as shown in [Fig. 12](#).

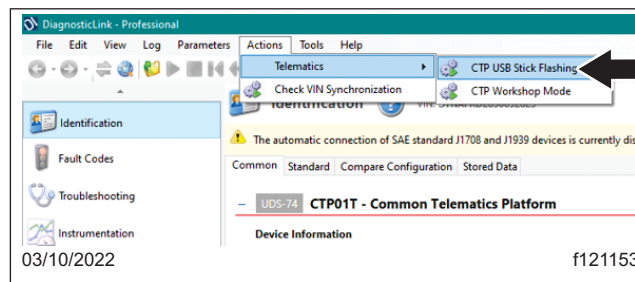
Fig. 13, Opening CTP USB Stick Flashing Window

- Go to 'Action,' 'Telematics,' then select 'CTP USB Stick Flashing.' See [Fig. 13](#).

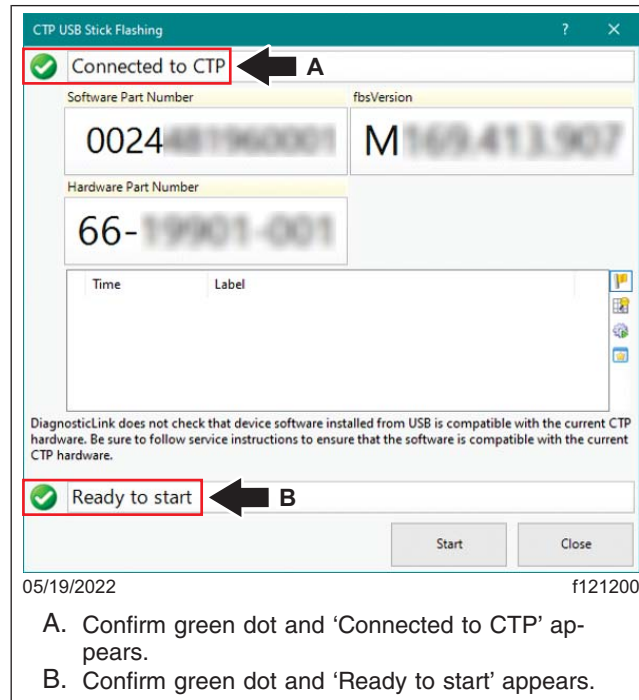
**Fig. 14, CTP USB Stick Flashing Window**

10. In the 'CTP USB Stick Flashing' window that appears, verify that a green dot appears beside 'Connected to CTP' on the top, a green dot appears beside 'Ready to start' at the bottom. See [Fig. 14](#).

- If the green dot beside 'Connected to CTP' on the top, and the green dot beside 'Ready to start' at the bottom do not appear, disconnect the CTP01T, close and restart DiagnosticLink program. Repeat steps 5 through 10. If the issue still persists after a second attempt, call Detroit Connect support at 855-253-0420, or email [detroitconnect@daimlertruck.com](mailto:detroitconnect@daimlertruck.com).

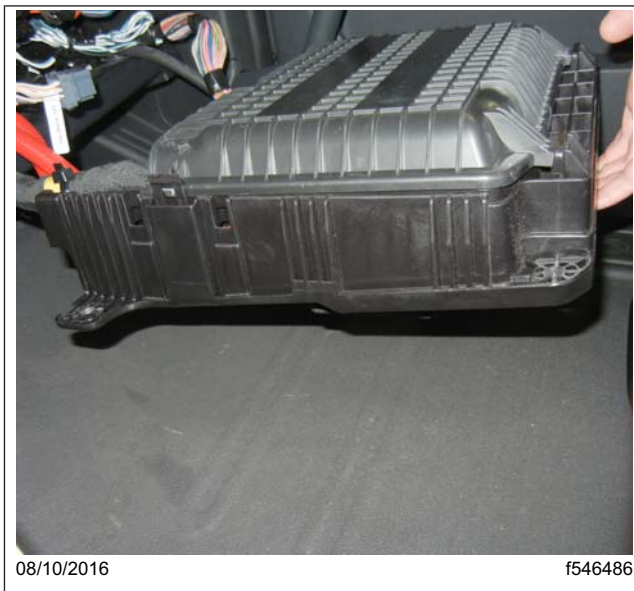
**Fig. 15, Lowering the VPDM to the Cab Floor**

**IMPORTANT:** The VPDM is positioned on the mounting tabs to assist with retaining the VPDM in position while mounting fasteners are removed. Care should be taken so the VPDM does not fall to the floor after all four mounting fasteners have been removed.

12. Remove the four VPDM mounting fasteners, then gently lower the VPDM on to the cab floor. See **Fig. 15**.
13. Locate the CTP on the upper shelf in the electronics bay. Using a USB mini to USB A adapter, connect the USB drive containing the SF657 software to the CTP at the large blue USB mini connector. See **Fig. 16**. Some vehicles may already have a harness connected at the large blue CTP connector, which must be disconnected for this procedure. Make sure the USB adapter and the USB stick are completely inserted.

**Make sure that the cab floor is clear of debris and tools. If the VPDM is lowered on to debris, especially metal objects, it could permanently damage the VPDM.**

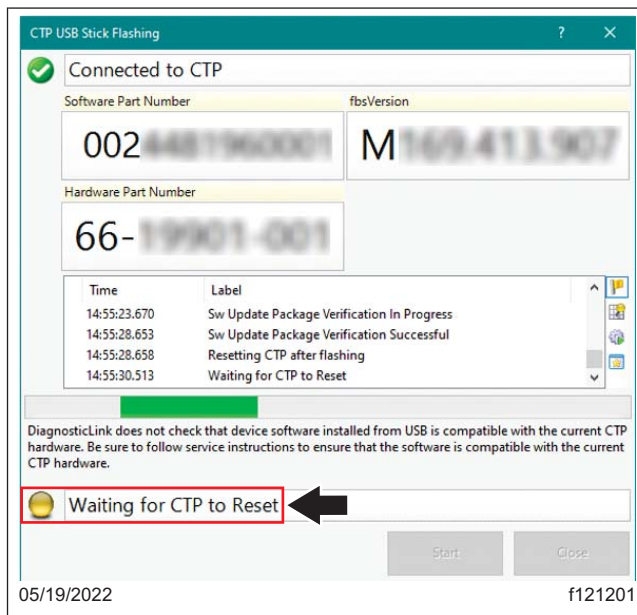
Fig. 17, Waiting for CTP to Reset Status Message

NOTE: The flashing process is automated and requires no interaction with the panel throughout the process. The CTP will shut down and go offline before installing the update. The message 'Waiting for CTP to Reset' will now appear and remain at the bottom of the 'CTP USB Stick Flashing' window while the CTP is offline for approximately 30 minutes until the new software is installed and activated. The message 'Flashing Complete' may also appear at the bottom of the 'CTP USB Stick Flashing' window. See [Fig. 17](#) and [Fig. 18](#).

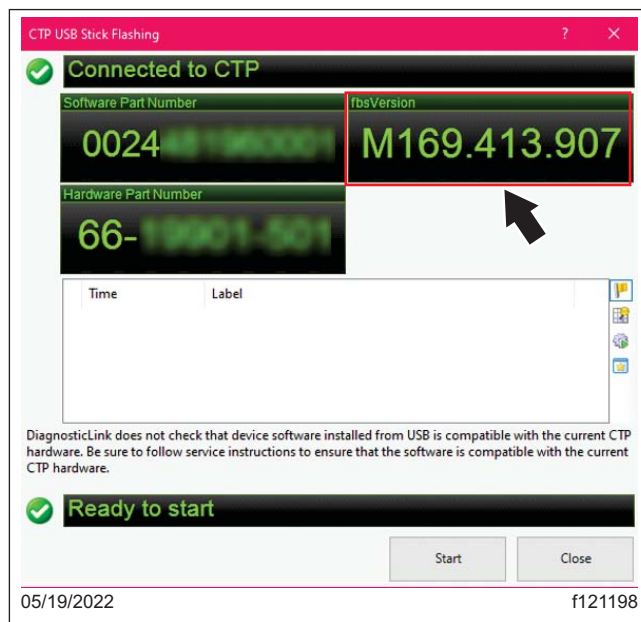
**Fig. 19, Verifying fbsVersion**

- Once the CTP01T connection turns green in the 'Connections' window, go to 'Actions,' 'Telematics', then select 'CTP USB Stick Flashing.' Verify the 'fbsVersion' is '169.413.907.' See **Fig. 19**. If the 'fbsVersion' does not match the above version, disconnect the CTP01T and connect again. Then verify the version again.
