Service Alert

MAZDA CONNECT SYMPTOM TROUBLESHOOTING (7TH
GENERATION VEHICLES)

Service Alert No.: SA-004/22

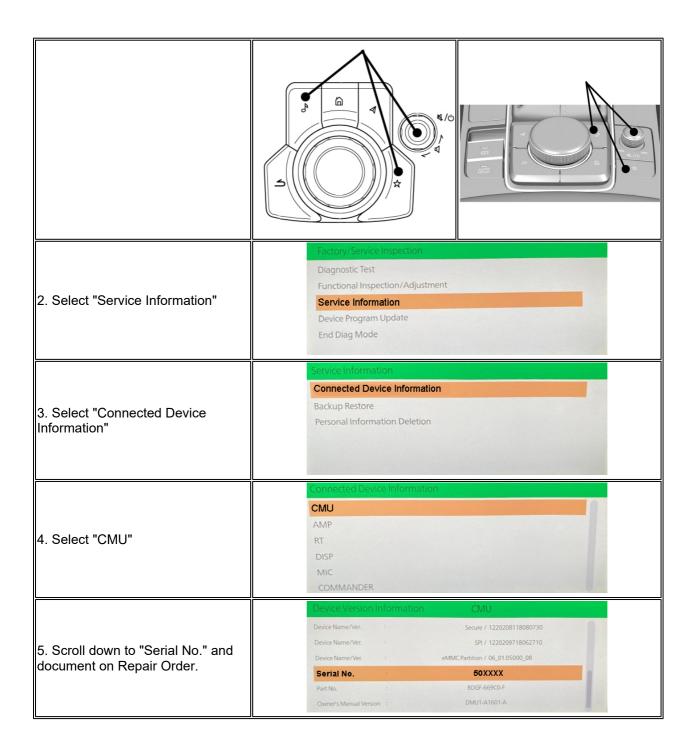
CMII Serial Number Retrieval

CIVIO Seriai Nulliber Retrieval							
1. Press and hold the Volume knob, then press and hold the Entertainment and Favorites buttons at the same time for 3-5 seconds and the Factory /Service Inspection screen will appear.	CX-5 and CX-9	Mazda3, CX-30, MX-30

6. Return to Factory/Service Inspection main screen and select End Diag Mode
