WNC3 - Re-Programming 7.2 kW High-Voltage Charger (OBC) (Workshop Campaign)

Concerns: **High-voltage charger (OBC) 7.2 kW**

Action required: Re-program the 7.2 kW (OBC) high-voltage charger with updated software.

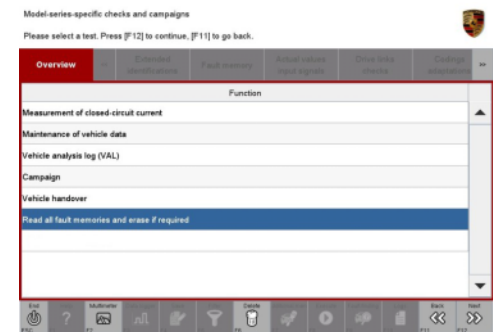
Erase fault memory

1.4 Press **•F8** to delete fault memory entries.

1.5 Press **•F12** ('Yes') to confirm whether you really want to delete all fault memory entries.

The faults stored in the fault memories of the various control units are deleted.

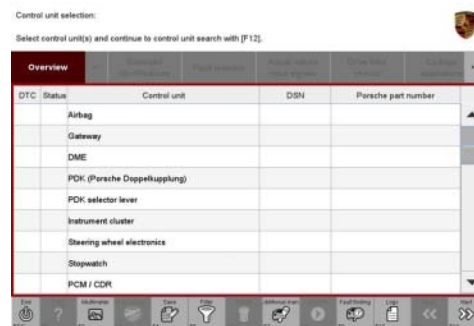
Control unit selection

- 1.6 Once you have erased the fault memories, select the **'Overview'** menu to return to the control unit selection screen. ⇒ *Control unit selection*
- 2 Switch off ignition.
- 3 Disconnect the PIWIS Tester from the vehicle.
- 4 Switch off and disconnect the battery charger.
- 5 Enter the campaign in the Guarantee and Maintenance booklet.
