June 24, 2022

Version 1

ACC Warning Light Is On With DTC B2A60-96

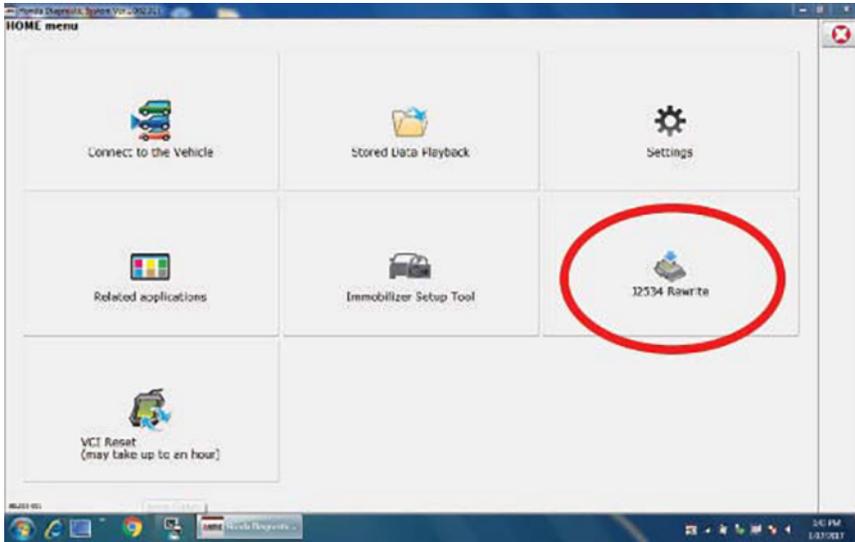
2. From the HOME menu, select the **J2534 Rewrite**.

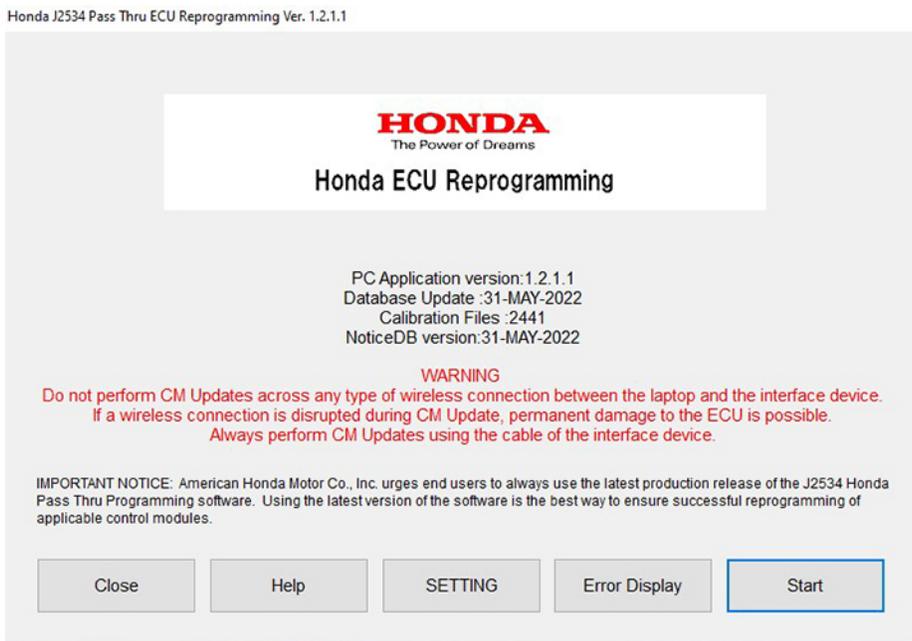
4. Connect the i-HDS to the vehicle and select **Start** to begin reprogramming.

Honda J2534 Pass Thru ECU Reprogramming Ver. 1.2.1.1

CM Update Mode

Use a battery booster while reprogramming the vehicle.
Press ENTER.

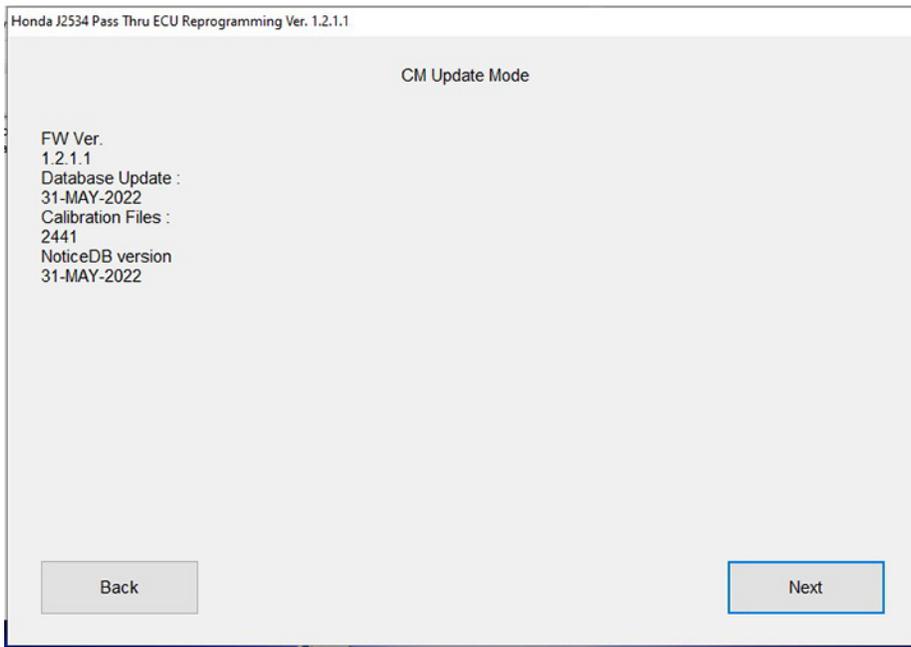
5. Follow the screen prompts, then select **Next**.

1. Connect the PC to the Pass-thru device.
2. At the vehicle, turn the ignition switch ON(II), then connect the pass-thru device to the vehicle's SAE J1962 connector (DLC).
3. Click Next to continue.

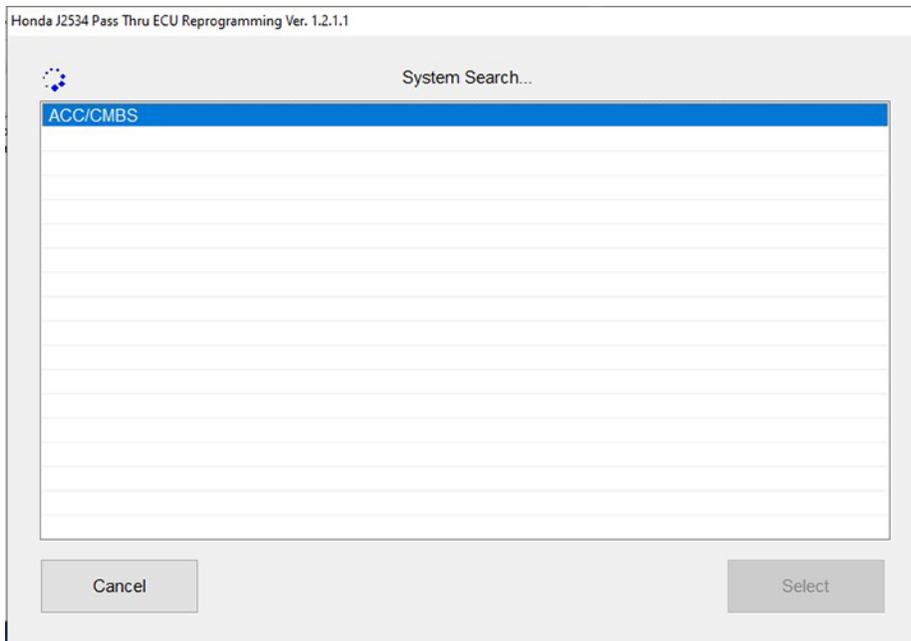
Honda J2534 Pass Thru ECU Reprogramming Ver. 1.2.1.1

VIN & Repair Order

VIN:

Repair Order#:

Odometer(mile):

7. Select the **ACC/CMBS**, and then **Select**.

NOTE: Wait until vehicle communication has completed.

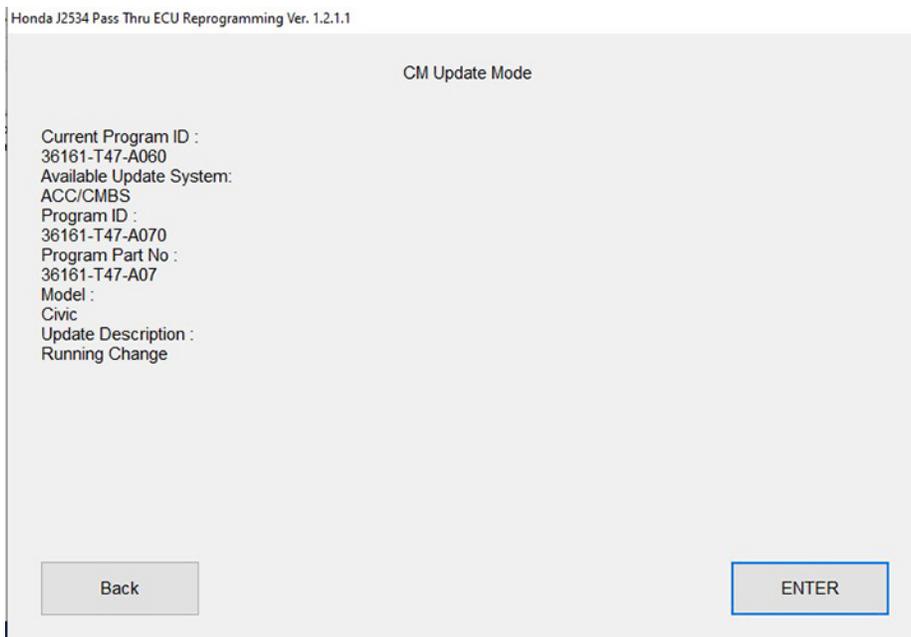
8. Confirm the update information, then select **ENTER** to proceed.

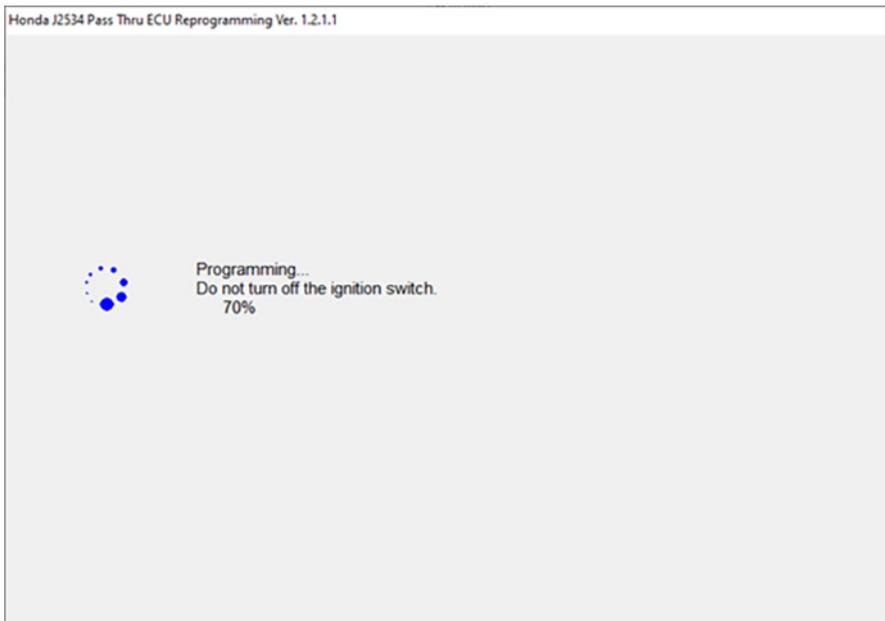
9. Select **ENTER** to begin reprogramming, and follow the screen prompts.

CM Update Mode

ACC/CMBS
Completed.
Turn the ignition switch OFF.

Turn the ignition switch ON within 60 seconds.

58 secs to go

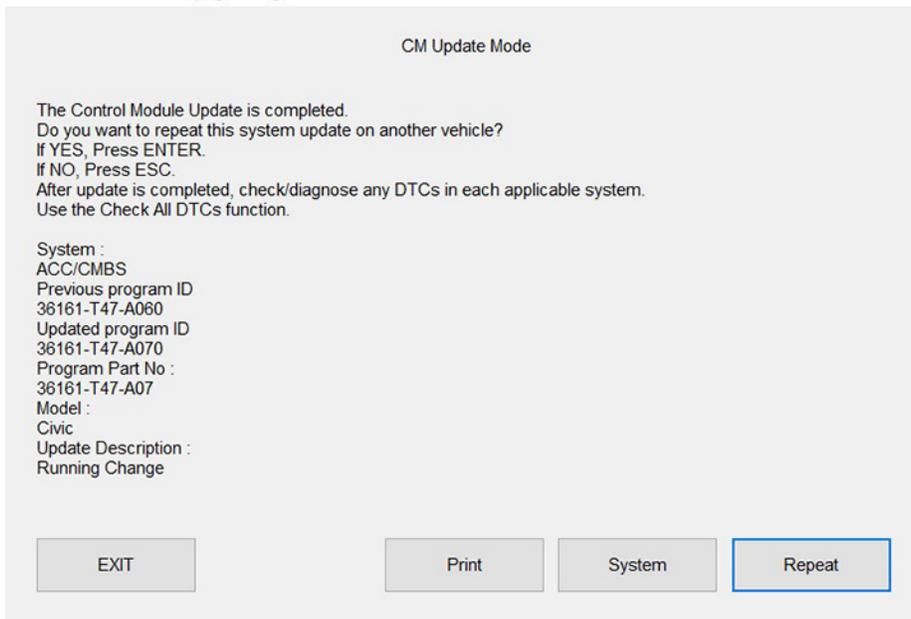
10. Once the module is updated, the following screen appears, then select **EXIT**.

Honda J2534 Pass Thru ECU Reprogramming Ver. 1.2.1.1
