2020 TLX Rear Toe Actuator Warning Lights with C1600-94

AFFECTED VEHICLES

Year	Model	Trim Level
2020	TLX	ALL with FWD

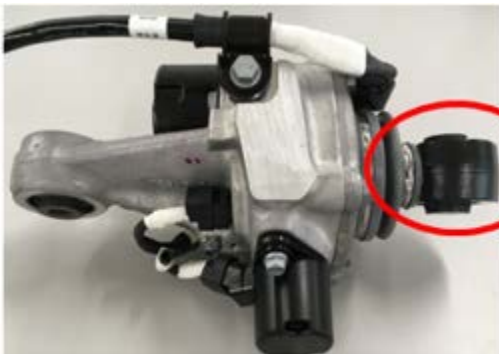
Below part view

With the vehicle on a lift, take a picture from below the rear toe actuator and from above.

- 1: Provide photos of LH/RH Rear Toe Actuators Assy (See samples below.) and do an alignment (Provide before/after data)
- 2: Ask if the customer noticed the following:
 - Limp mode (Yes/No):
 - Road conditions (dry/wet/snow/gravel/grass):
 - Throttle input (accel/decel/cruising):
 - Driving conditions (straight ahead or obstacle avoidance maneuver e.g., pothole/ball/animal):
 - If turning, steering wheel input (e.g., 9 O'clock, 1 O'clock):
