SUBJECT: **Customer Satisfaction Program 21M05 - Supplement # 1**
Certain 2017-2022 Model Year Super Duty Vehicles Equipped with a Power Release Tailgate - Unintended Tailgate Opening

REF : **Customer Satisfaction Program 21M05**
Dated May 20, 2022

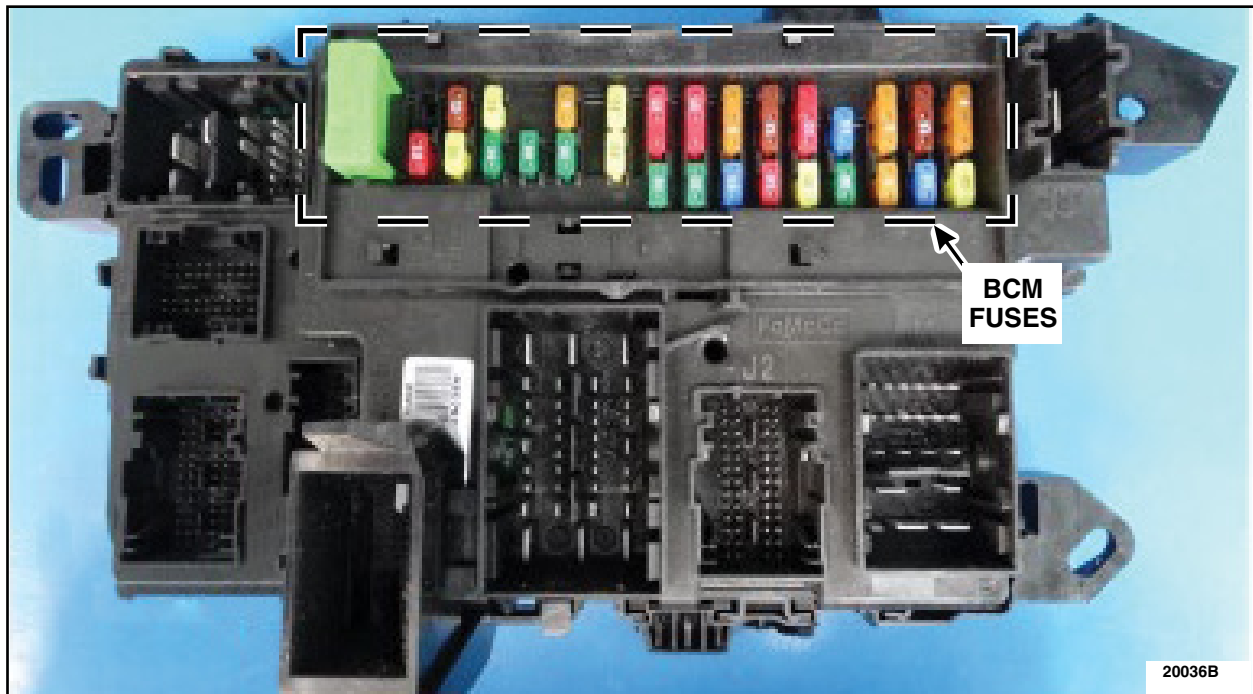
FIGURE 2

7. Remove each BCM fuse, one at a time, and inspect for any sign(s) of moisture and/or corrosion.
See Figure 2.

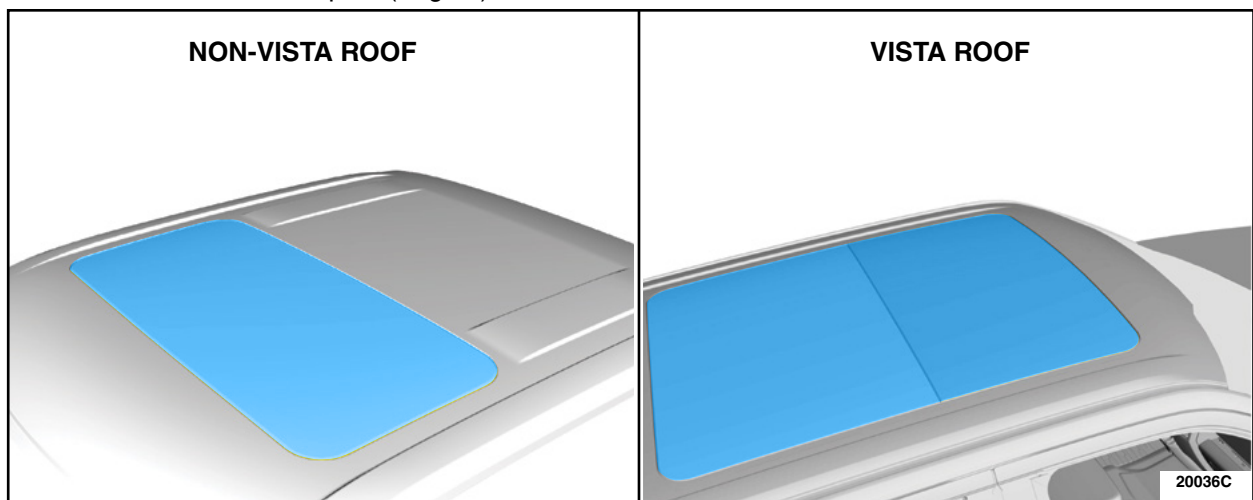
FIGURE 3

8. Is the vehicle equipped with a roof opening panel? See Figure 3.

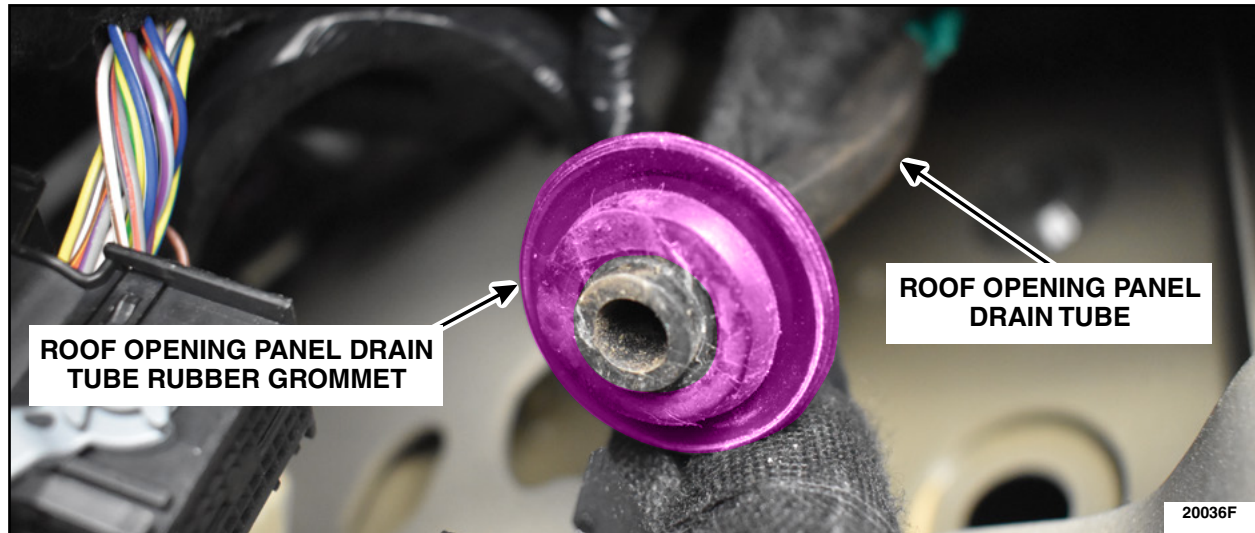
FIGURE 6

11. Is the grommet attached to the roof opening panel drain tube as seen in Figure 6?

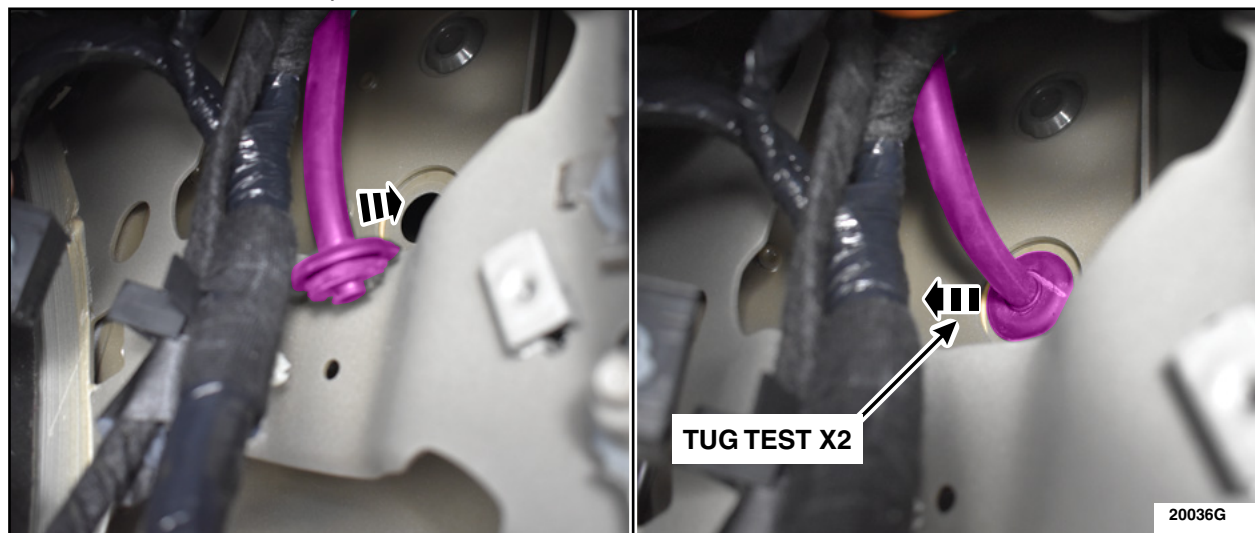
FIGURE 7

12. Install the roof opening panel drain tube into the body panel making sure that the grommet is fully seated. Perform a 2 tug test on the roof opening panel drain tube.

- Did the drain tube and grommet remain in place? See Figure 7.

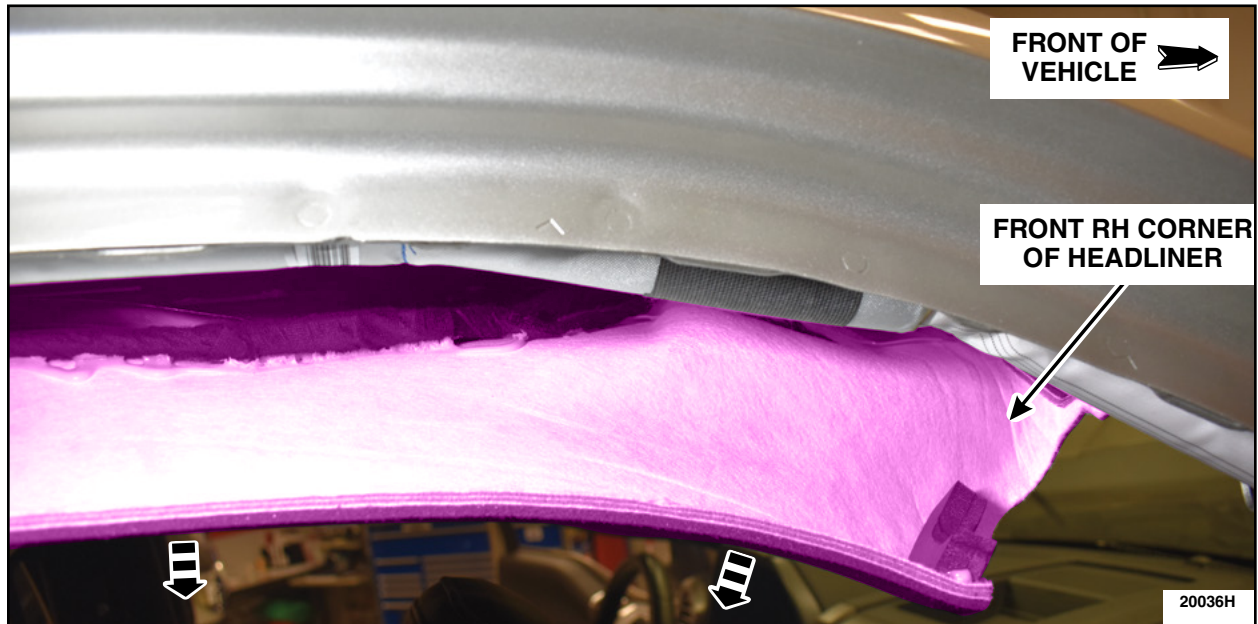
FIGURE 8

14. Lower the front RH corner of the headliner. See Figure 8.

⚠ CAUTION: Do not bend or crease the headliner.

29. Lower the front RH corner of the headliner. See Step 14, Figure 8. Pour a glass of water into the roof opening panel drain tube channel and immediately inspect the drain tube, at the roof opening panel for water leakage. See Figure 17.

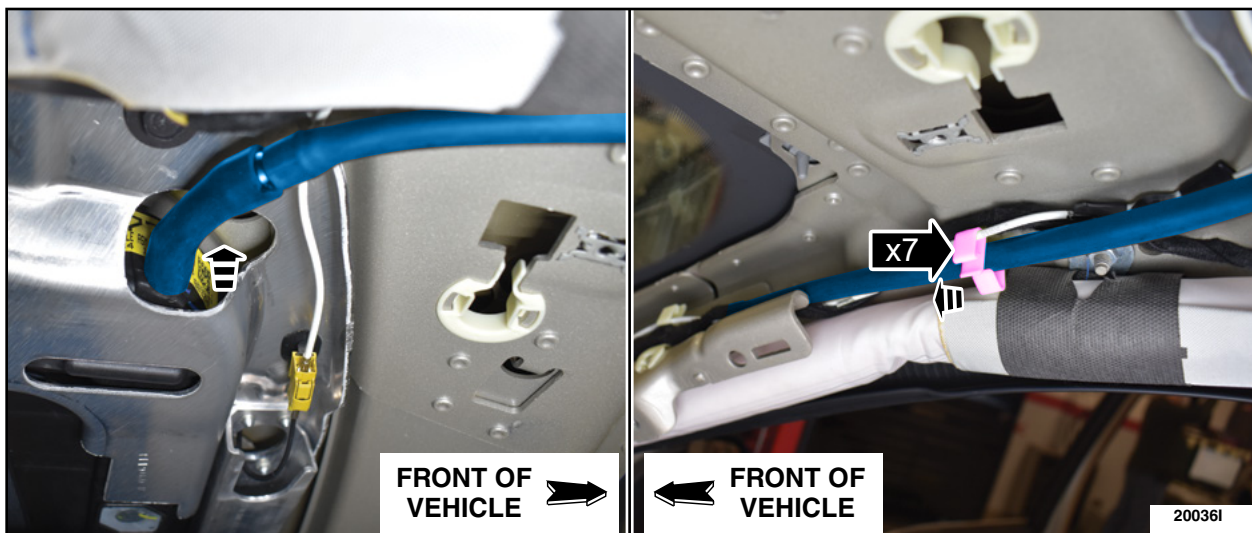
FIGURE 9

15. Remove the roof opening panel drain tube. See Figure 9.

1. Remove the drain tube grommet located behind the BCM.
2. Disconnect the drain tube at the roof opening panel.
3. Release the drain tube retainers located along the RH A-pillar down through the Instrument Panel (IP).
4. Remove the drain tube out the top of the IP.

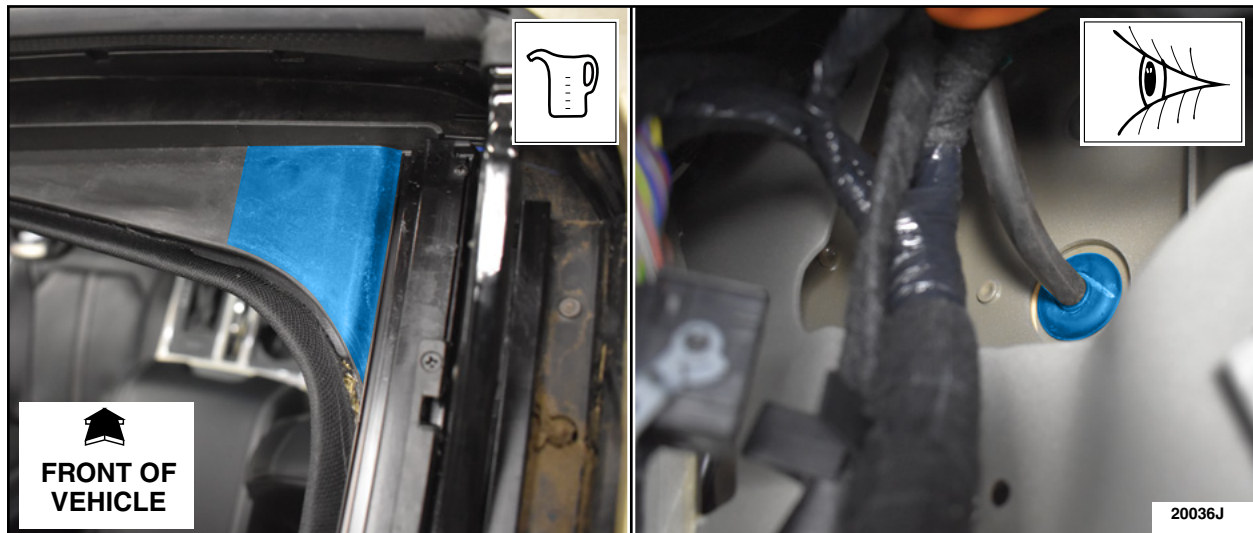
FIGURE 10

16. Install a *new* roof opening panel drain tube by reversing Step 15.
17. Pour a glass of water into the roof opening panel drain tube channel and immediately inspect the roof opening panel drain tube grommet for water leakage. See Figure 10.
- Is there water leakage inside the vehicle at the grommet?
- Yes - Proceed to Step 18.
No - Proceed to Step 19.

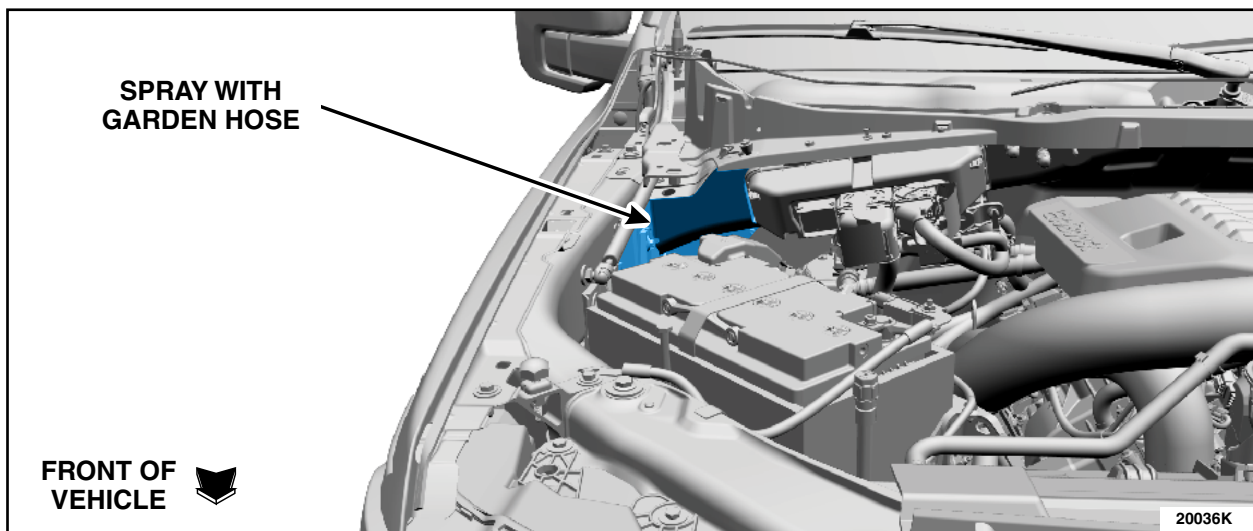
FIGURE 11

19. Using a garden hose, spray the upper RH side of the engine compartment fire wall. See Figure 11.

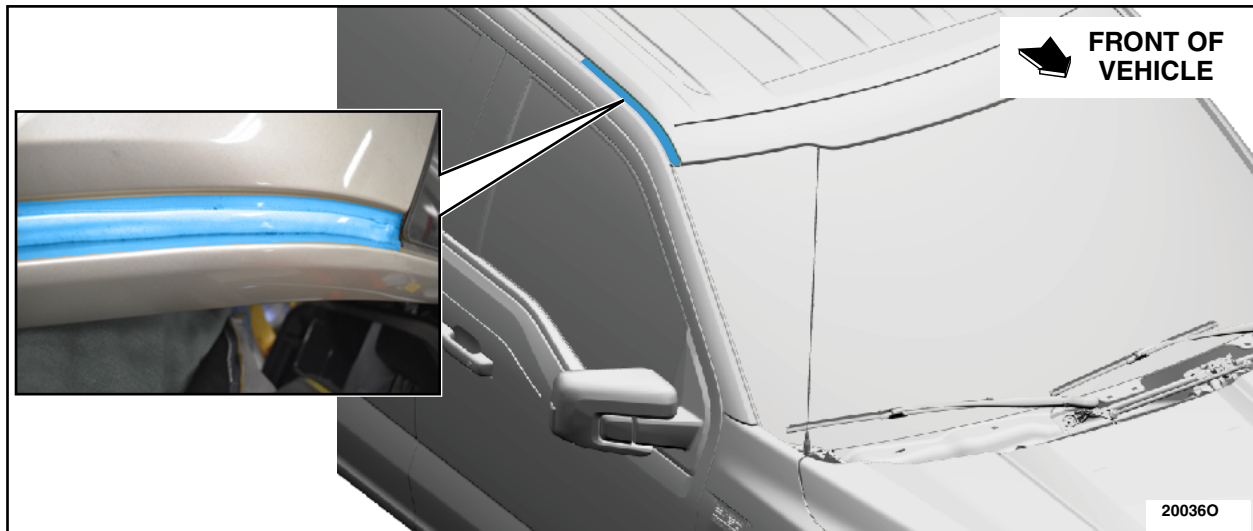
FIGURE 15

27. Using a garden hose, run water over the front RH roof ditch, immediately inspect the A-pillar inside the vehicle for signs of moisture and/or leakage. See Figure 15.

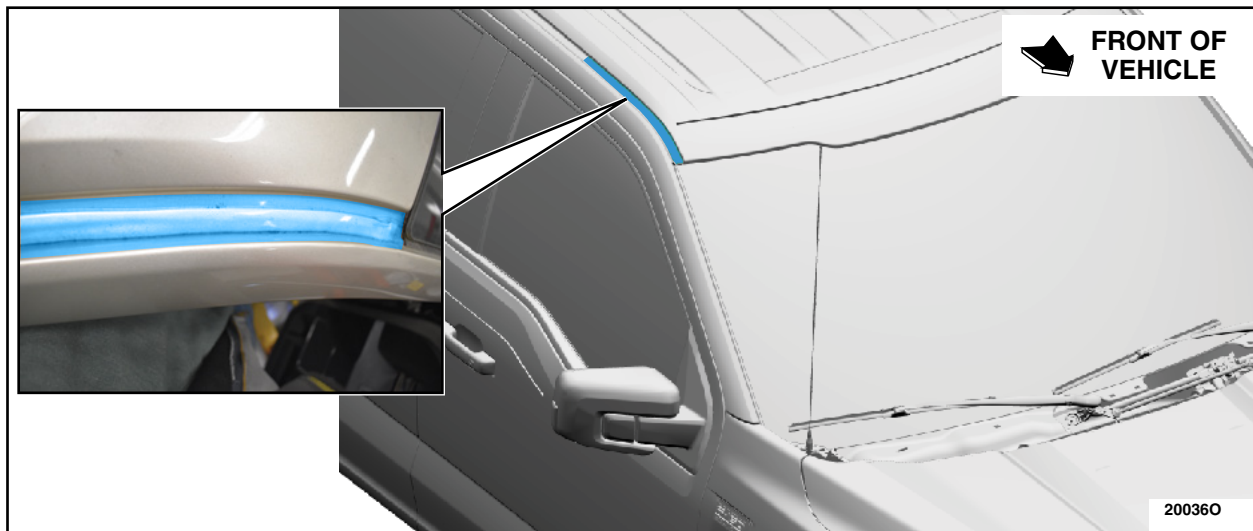
FIGURE 16

28. Apply some Motorcraft® TA-32 Clear Silicone Rubber to the front RH roof ditch. See Figure 16. Allow the sealer to cure, then proceed to Step 27.

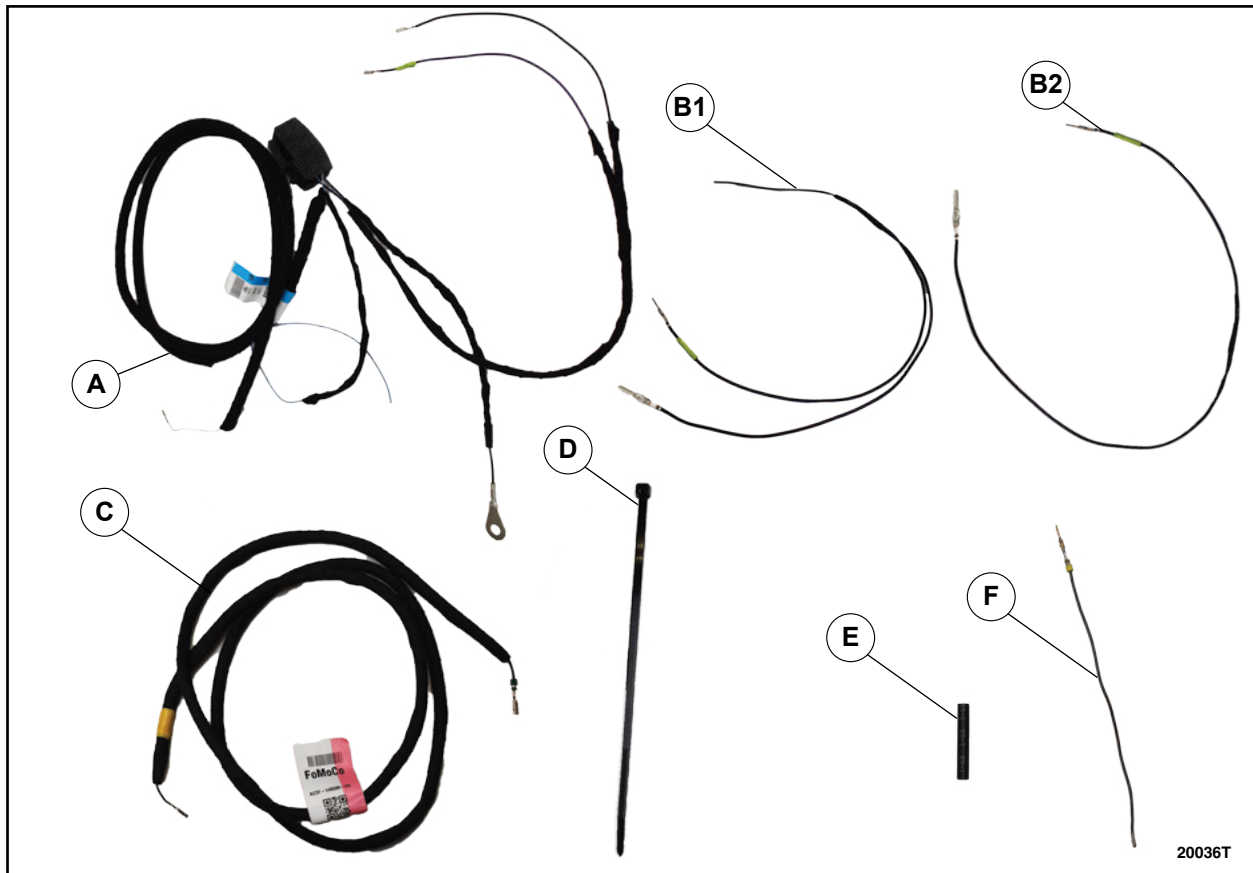
FIGURE 21

Complete Tailgate Actuator Ground Wiring Part Kit

ITEM	DESCRIPTION	QUANTITY
A	Relay Harness	1
B1	Floor Board Jumper (3 end version)	*1
B2	Floor Board Jumper (2 end version)	*1
C	Tailgate Jumper Harness	1
D	Tie Strap	-
E	Heat Shrink Tubing	4
F	Under Body Harness Jumper	1

NOTE: The parts being installed in this procedure are not labeled. Refer to Figure 21 for component identification.

NOTE: Use the parts chart on Figure 21 Page 13 to verify if you have B1 or B2 version Floor Board Jumper.

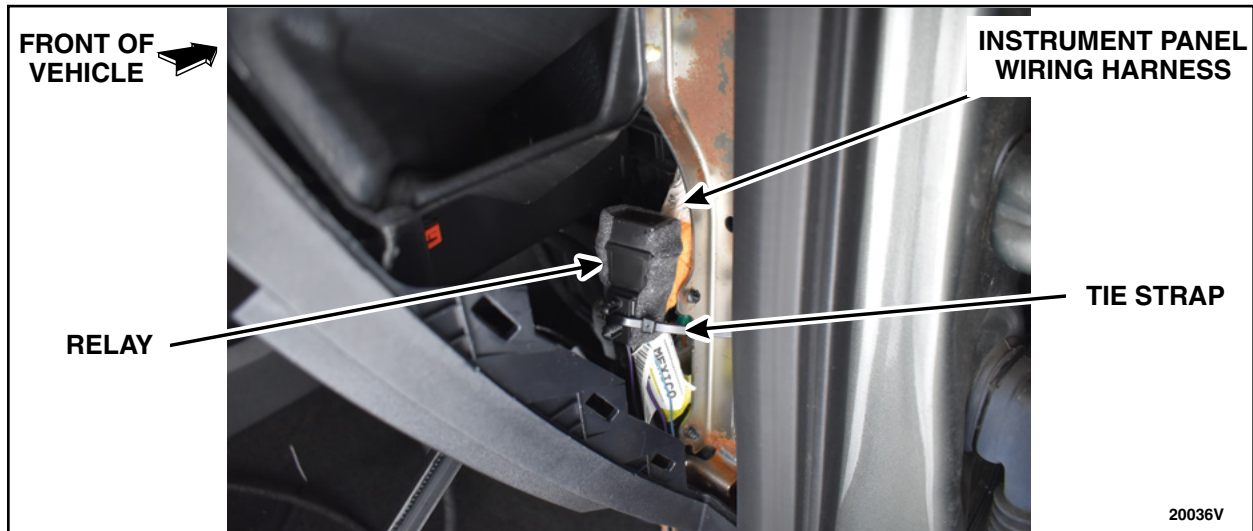
FIGURE 23

41. Place the relay, included in the kit, onto the instrument panel wiring harness and secure using a tie strap. See figure 23.

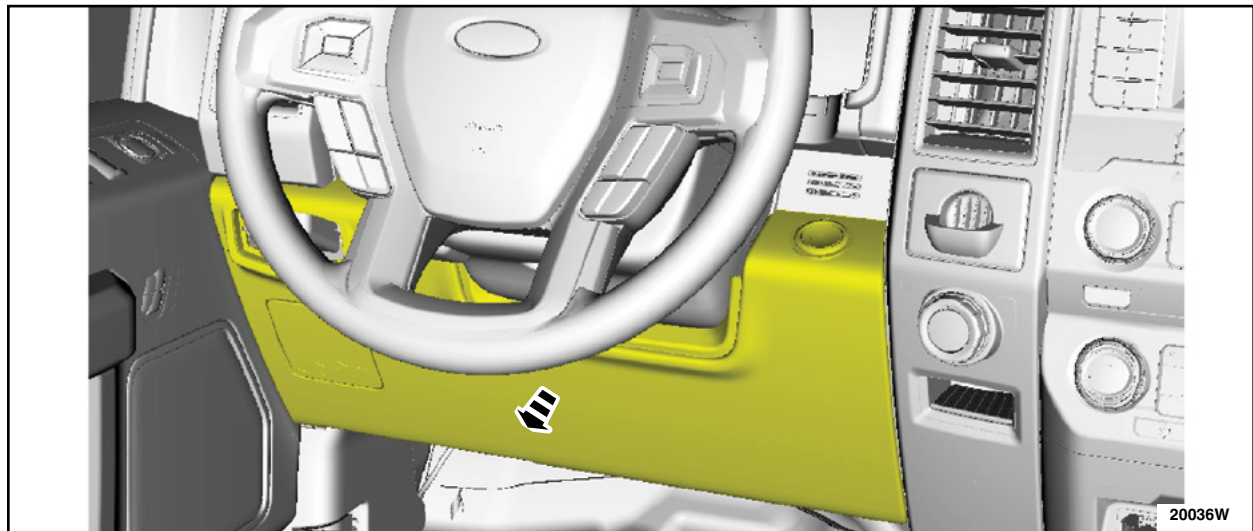
FIGURE 24

42. Lower the steering column opening trim panel. See Figure 24.

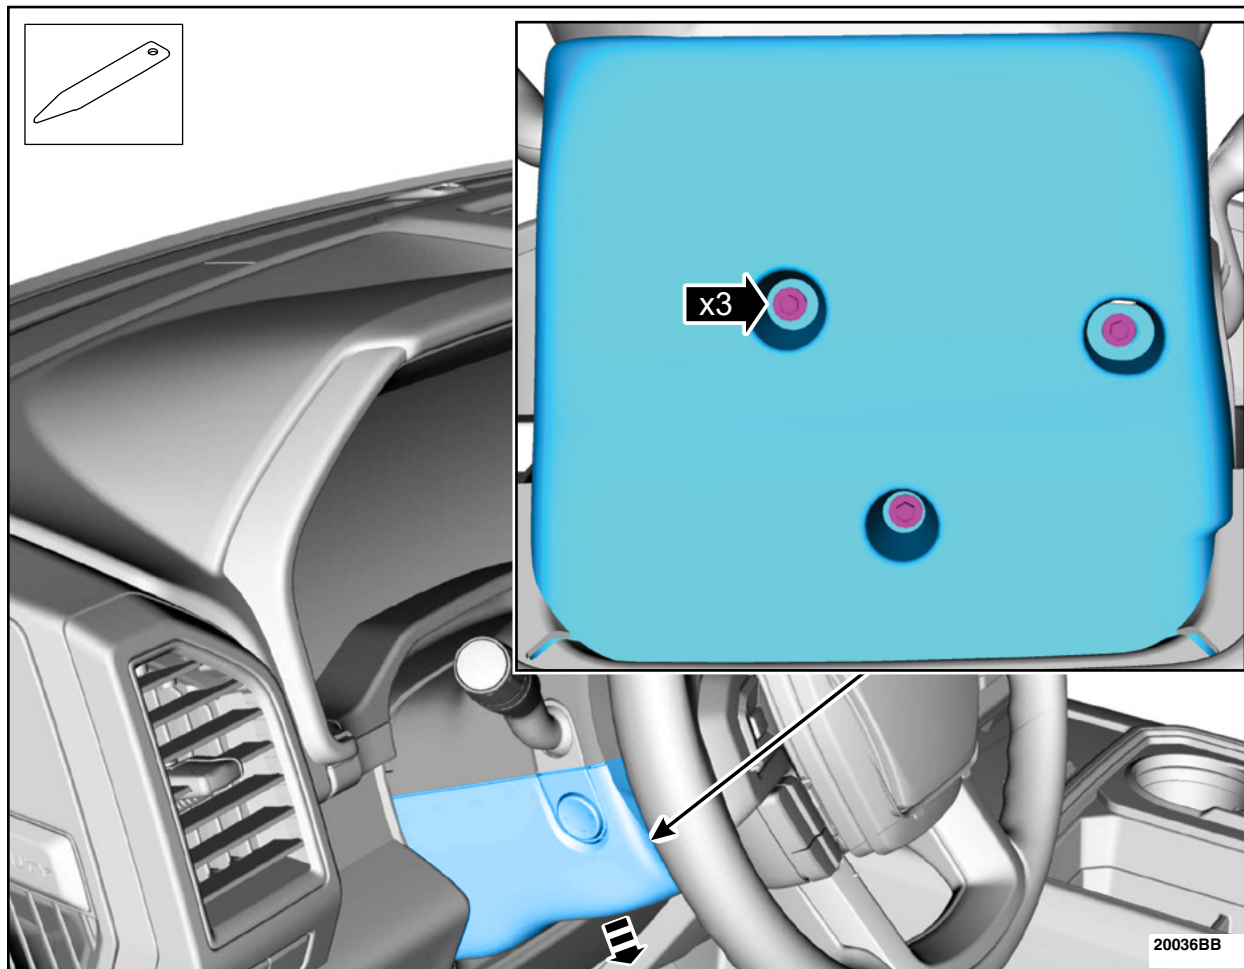
FIGURE 25

43. Remove the bolts and the lower steering column shroud. See Figure 25.

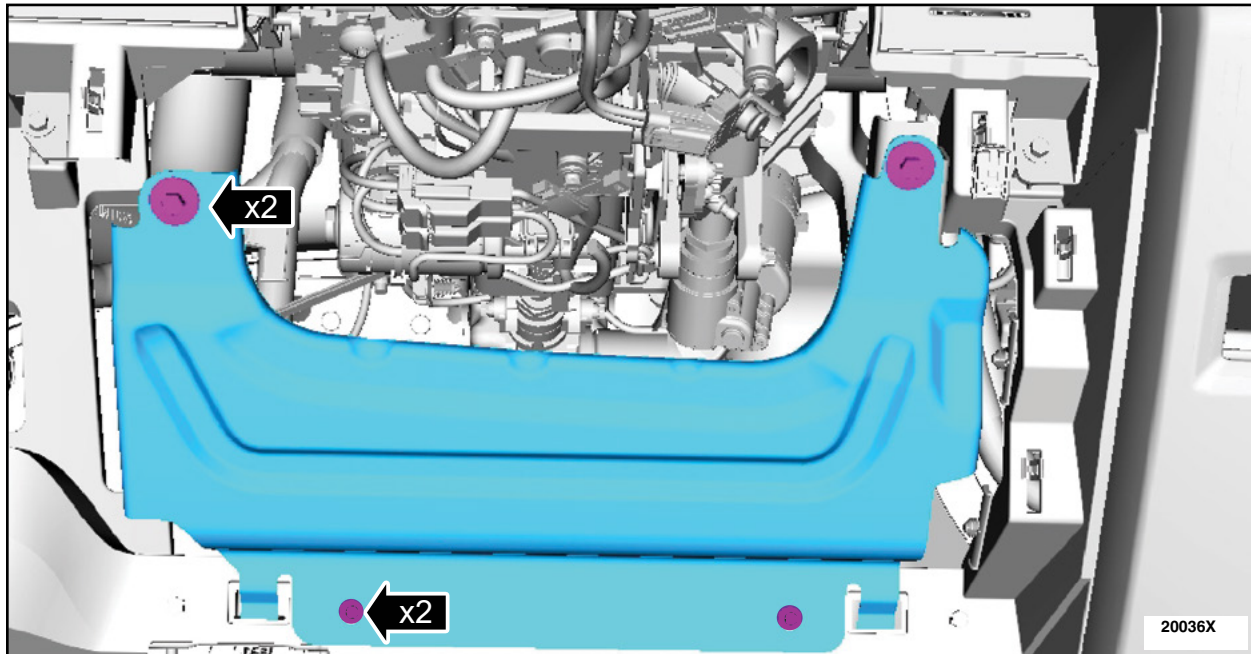
FIGURE 26

44. Remove the bolts and the steering column reinforcement panel. See Figure 26.

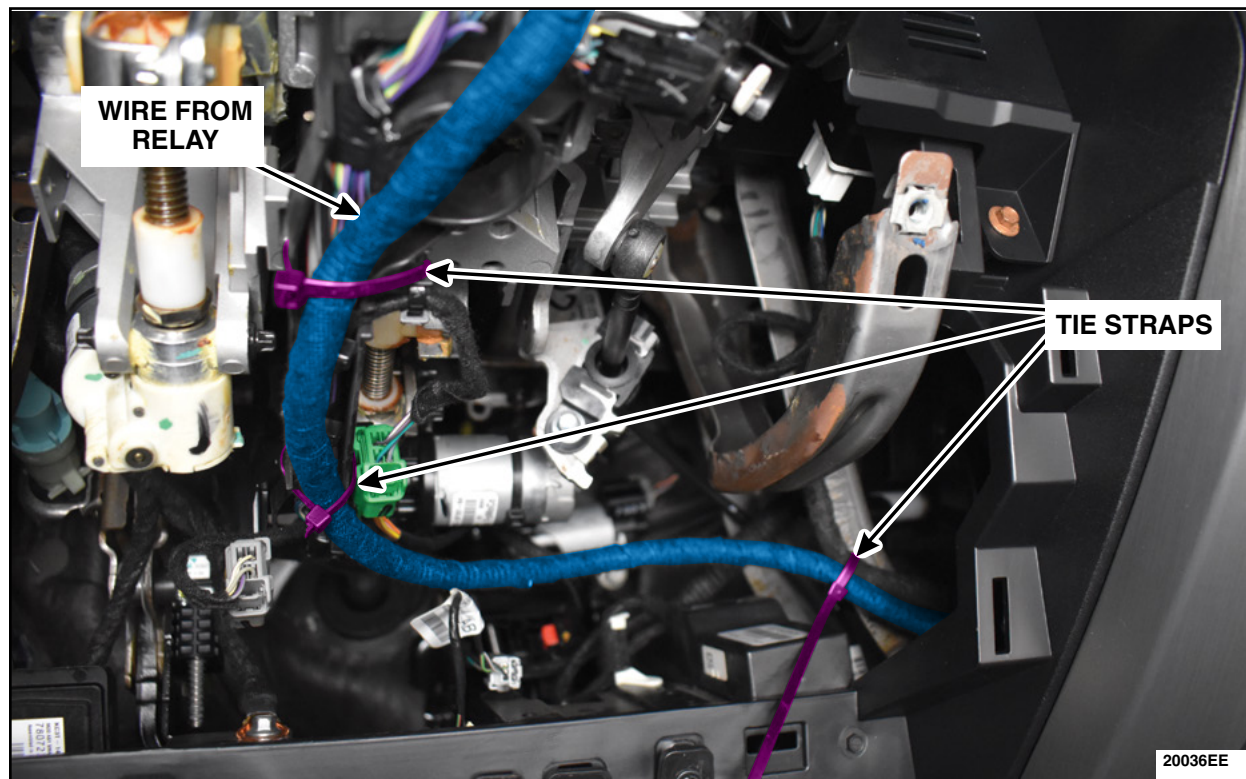
FIGURE 32

50. Secure the wire from the relay using tie straps. See Figure 32.

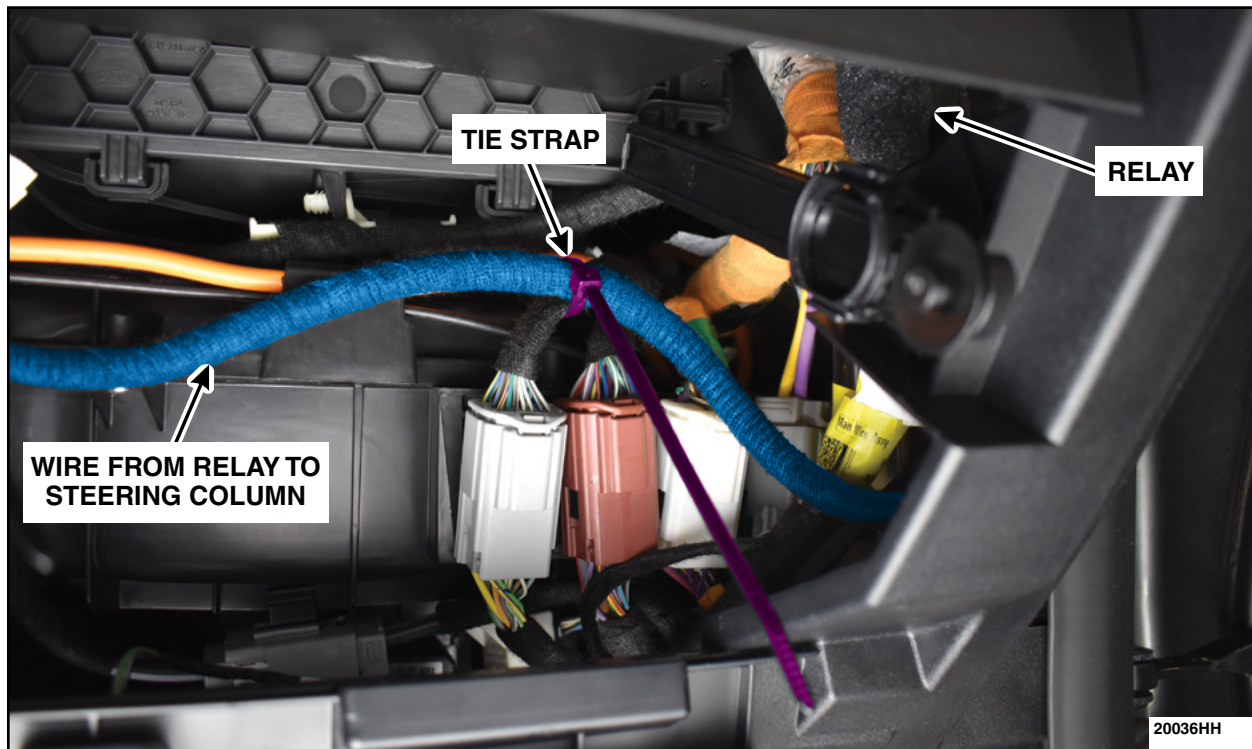
FIGURE 35

53. Secure the wire from the relay to the wiring harness on the climate control housing using a tie strap.
See Figure 35.

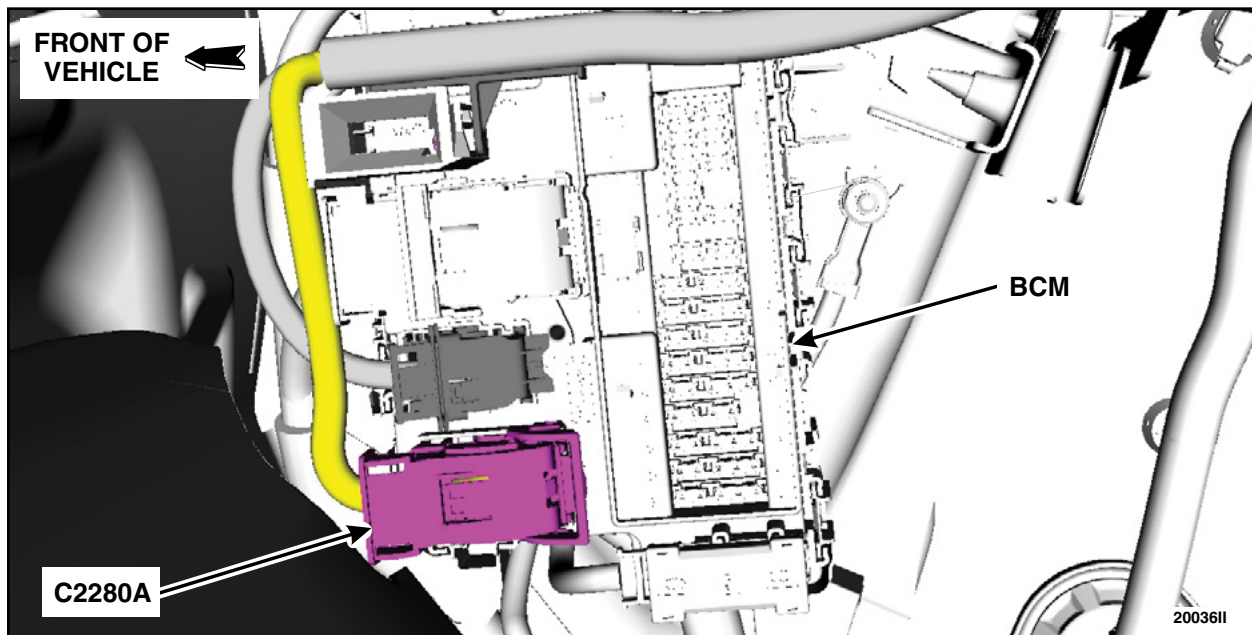
FIGURE 36

54. Disconnect C2280A from the BCM. See Figure 36.

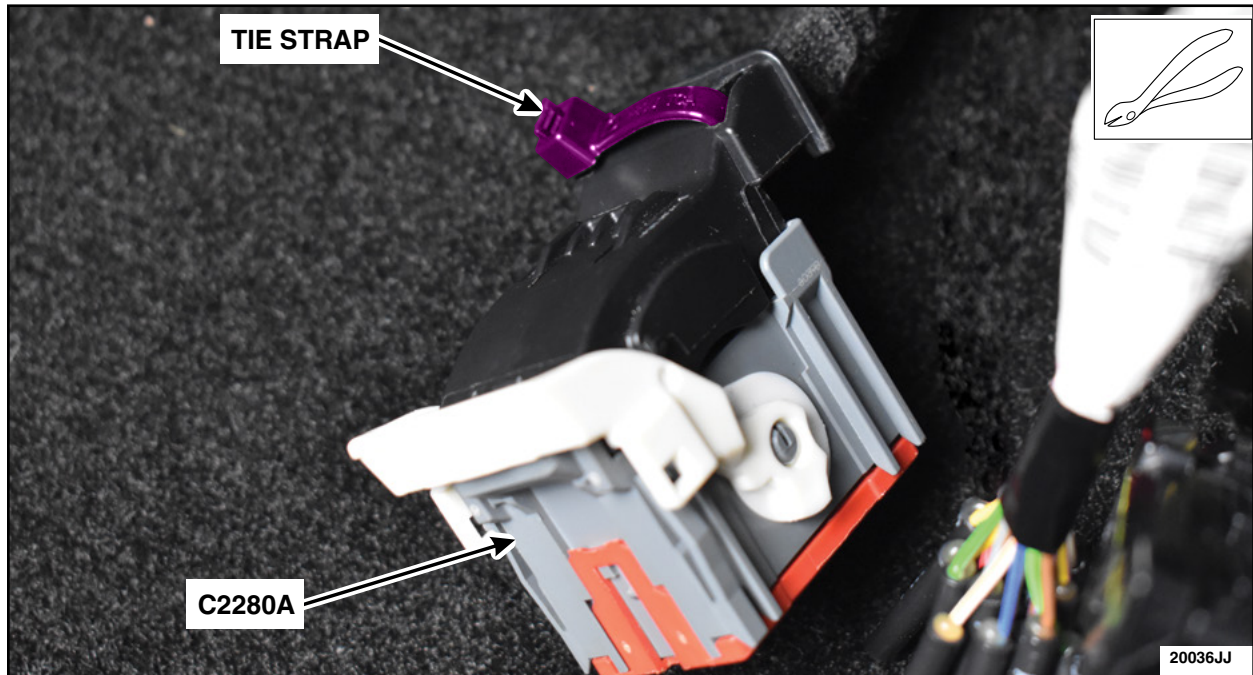
FIGURE 37

55. Remove the tie strap from C2280A. See Figure 37.

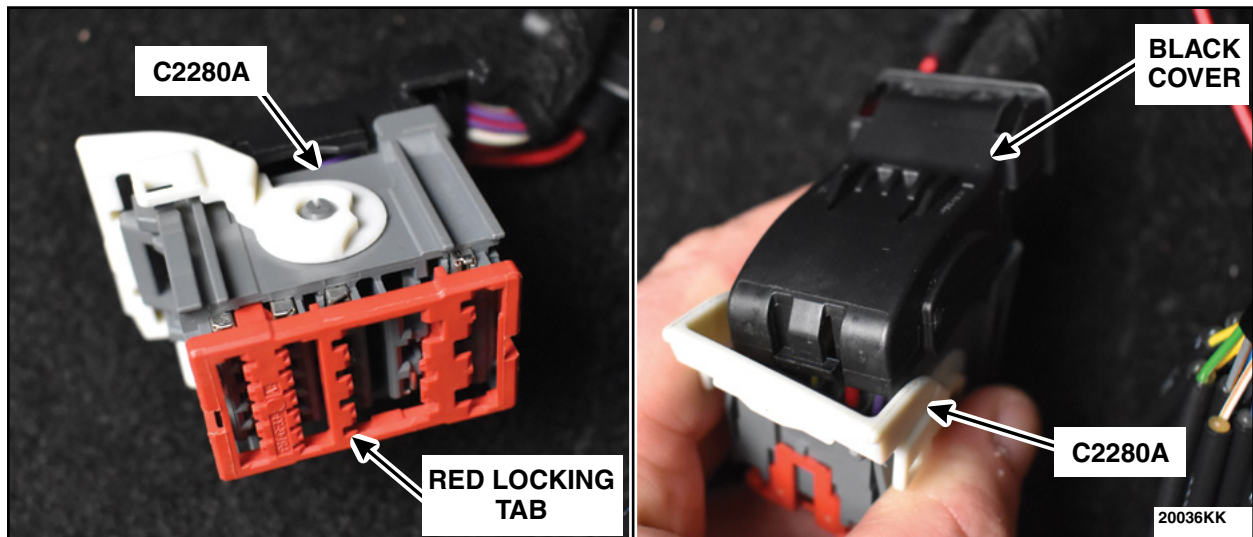
FIGURE 38

56. Remove the red locking tab and the black cover. See Figure 38.

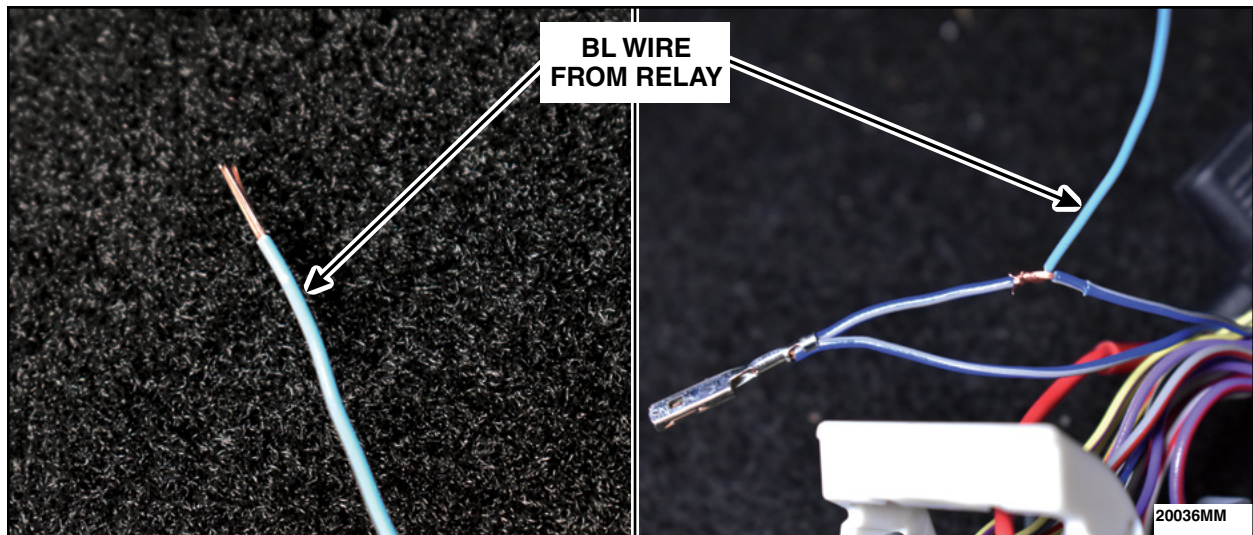
FIGURE 40

58. Strip the tip of the Blue (BL) wire from the relay and twist it into the Blue-White (BL-WT) wire from C2280A pin 6 to create an inline splice. See Figure 40.

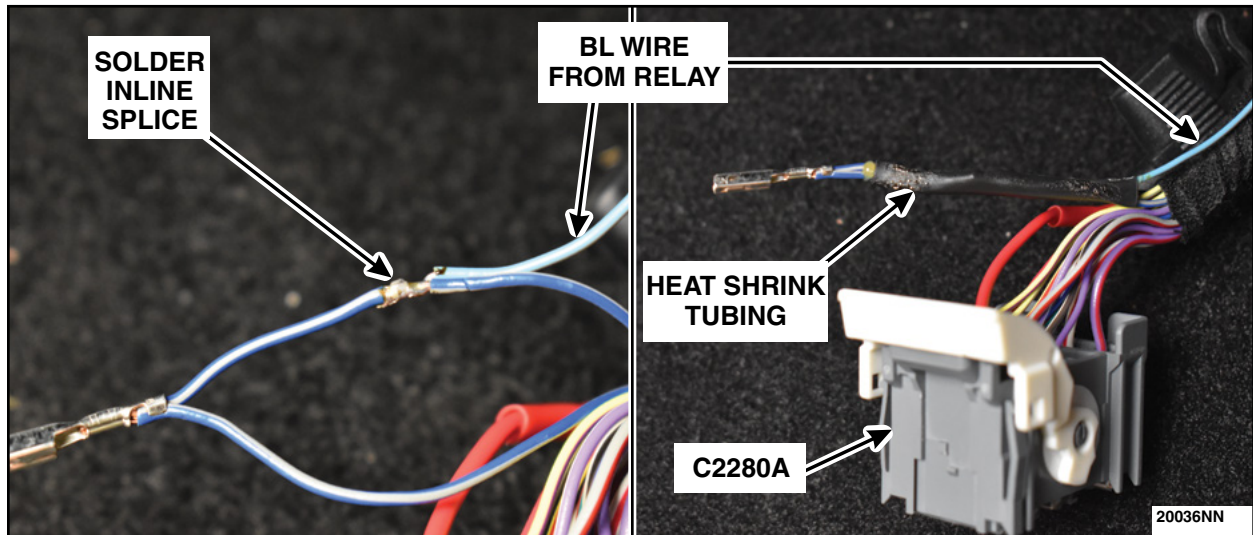
FIGURE 41

59. Solder the BL wire from the relay to the inline splice, apply heat shrink and heat to seal the inline splice. Reinstall the terminal into pin 6. See Figure 41.

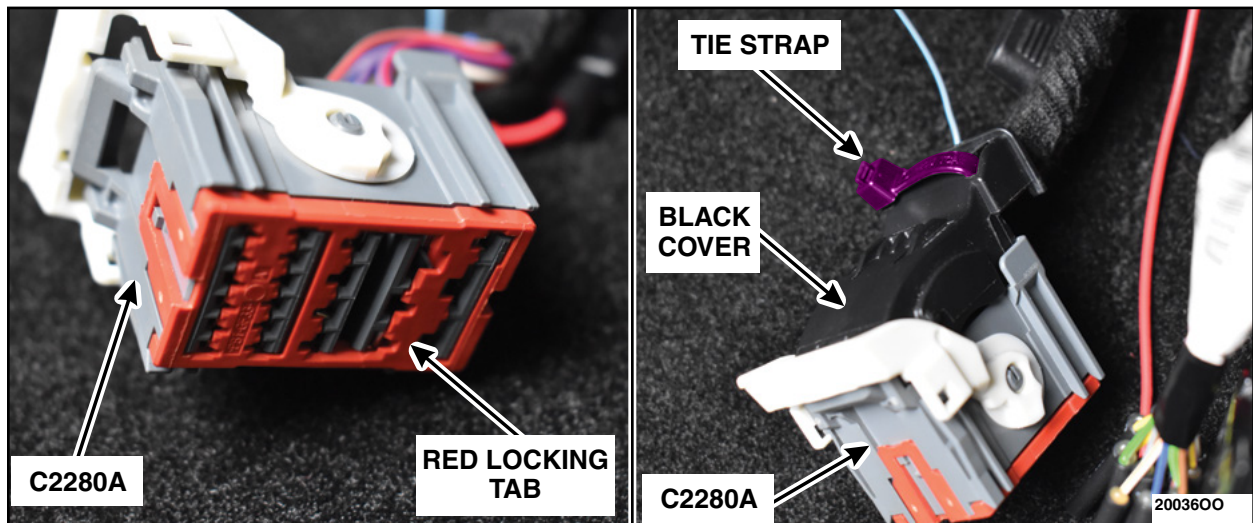
FIGURE 42

60. Install the red locking tab and the black cover. Secure using a tie strap and trim any excess. See Figure 42. Reconnect C2280A to the BCM.

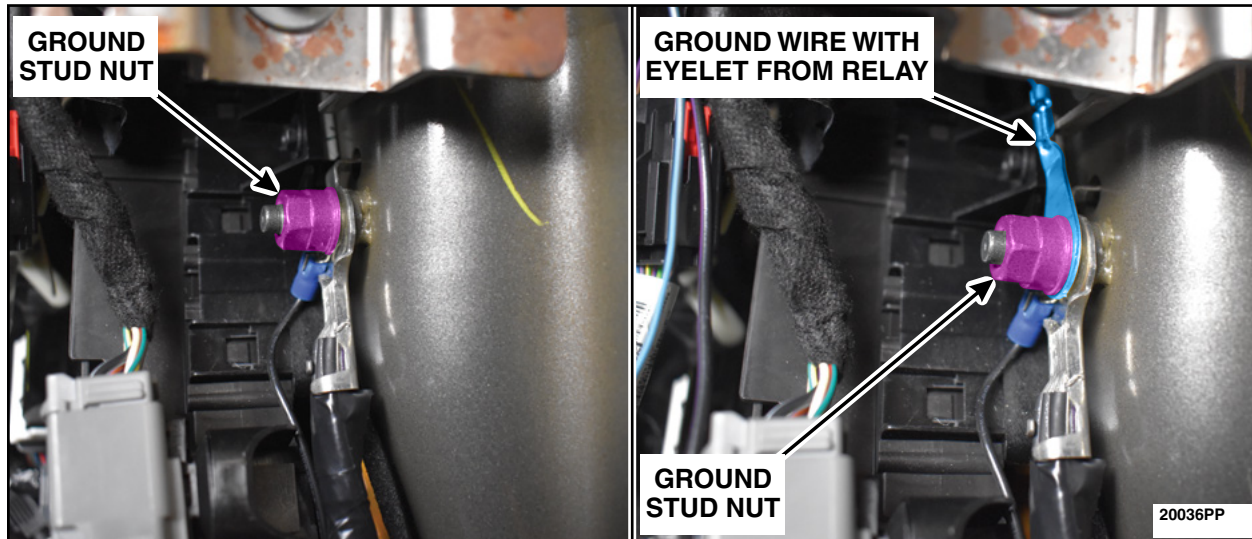
FIGURE 43

61. Remove the ground nut, install the ground wire with the eyelet from the relay on to the ground stud. Reinstall the ground stud nut. See Figure 43.

- Torque: 70 in lb (8 Nm)

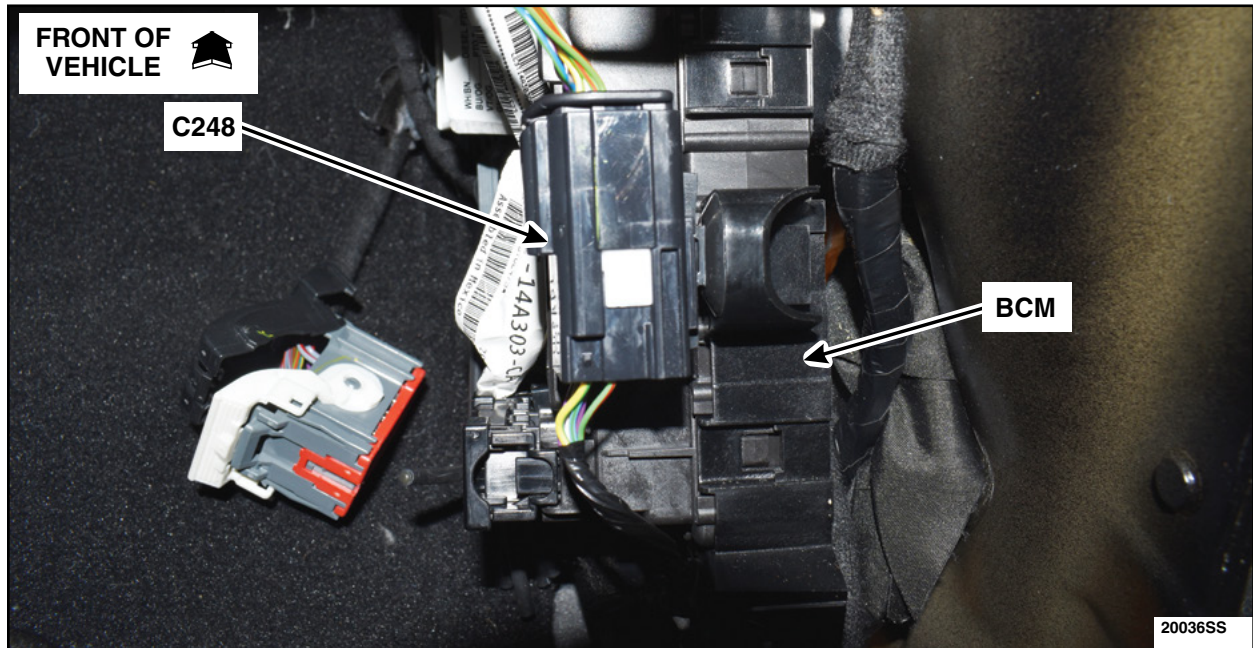
FIGURE 44

62. Locate and disconnect connector C248 on the BCM. See Figure 44.

NOTE: Black C248 shown, gray C248 similar.

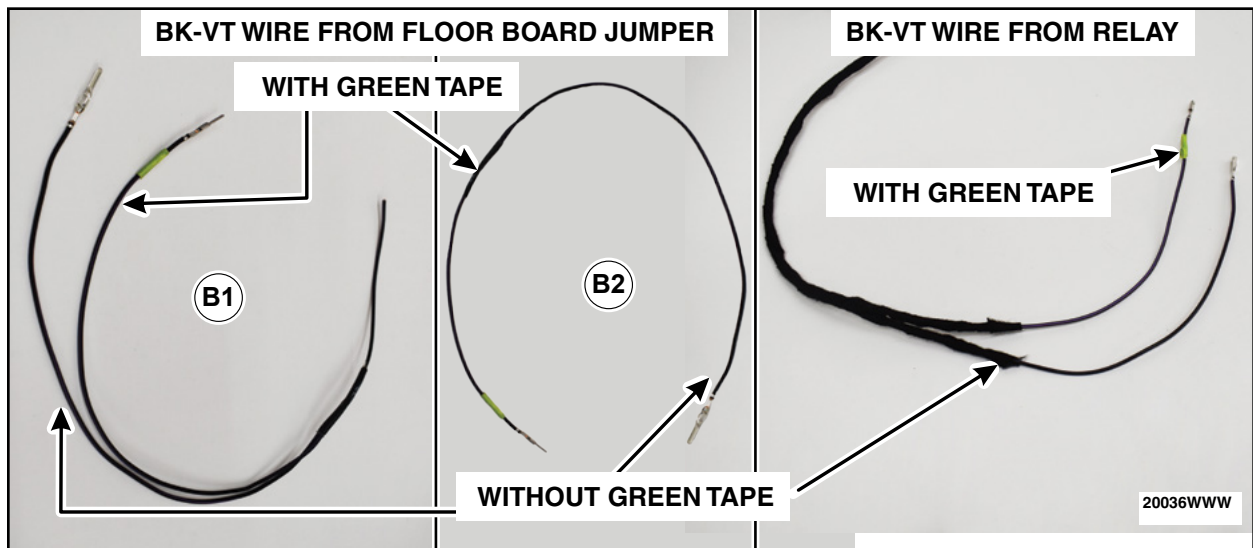
FIGURE 45

Black Connector - **For B1 version Floor Board Jumper:** Cut off and seal with heat shrink tubing the Black-Violet (BK-VT) wire **WITH** the green spot tape on both the relay and the floor board jumper wire. The BK-VT wire **WITHOUT** the green spot tape will be used for this connector. See Figure 45.

For B2 version Floor Board Jumper: Cut off the terminal on the end **WITH** the green spot tape on the floor board jumper wire, on the relay cut off and seal with heat shrink tubing. The BK-VT wire **WITH** the green spot tape the, BK-VT wire **WITHOUT** the green spot tape will be used for this connector. See Figure 45.

Grey Connector - **For B1 version Floor Board Jumper:** Cut off and seal with heat shrink tubing the Black-Violet (BK-VT) wire **WITHOUT** the green spot tape on both the relay and the floor board jumper wire. The BK-VT wire **WITH** the green spot tape will be used for this connector. See Figure 45.

For B2 version Floor Board Jumper: Cut off the terminal on the end **WITHOUT** the green spot tape on the floor board jumper wire, on the relay cut off and seal with heat shrink tubing the BK-VT wire **WITHOUT** the green spot tape. The BK-VT wire **WITH** the green spot tape will be used for this connector. See Figure 45.

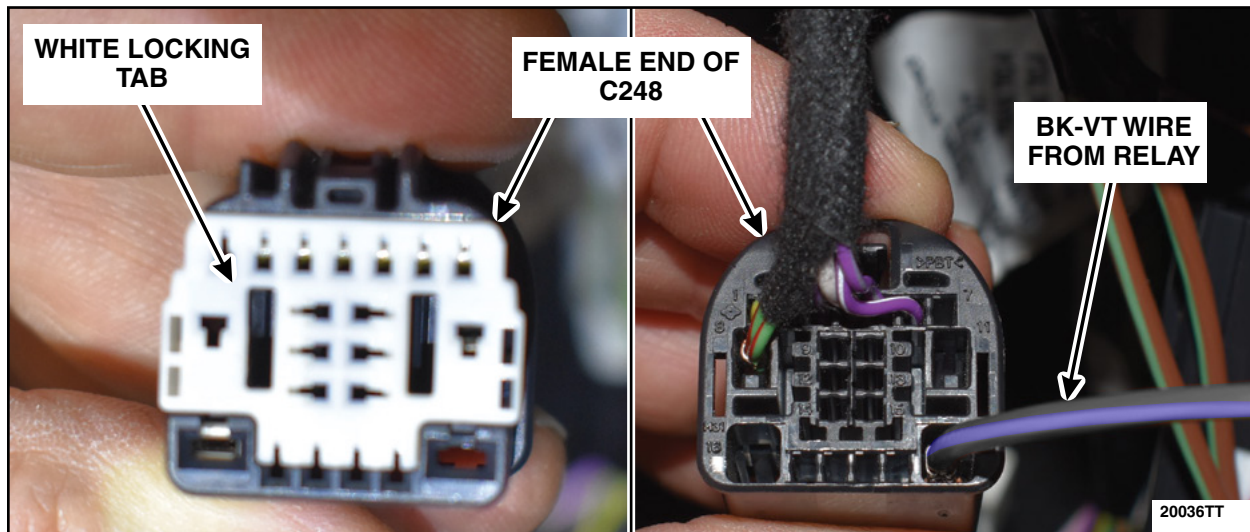
FIGURE 46

63. Remove the white locking tab from the female end of C248. Install the BK-VT wire from the relay into pin 21 for a black connector and pin 2 for a grey connector. Reinstall the white locking tab. See Figure 46.

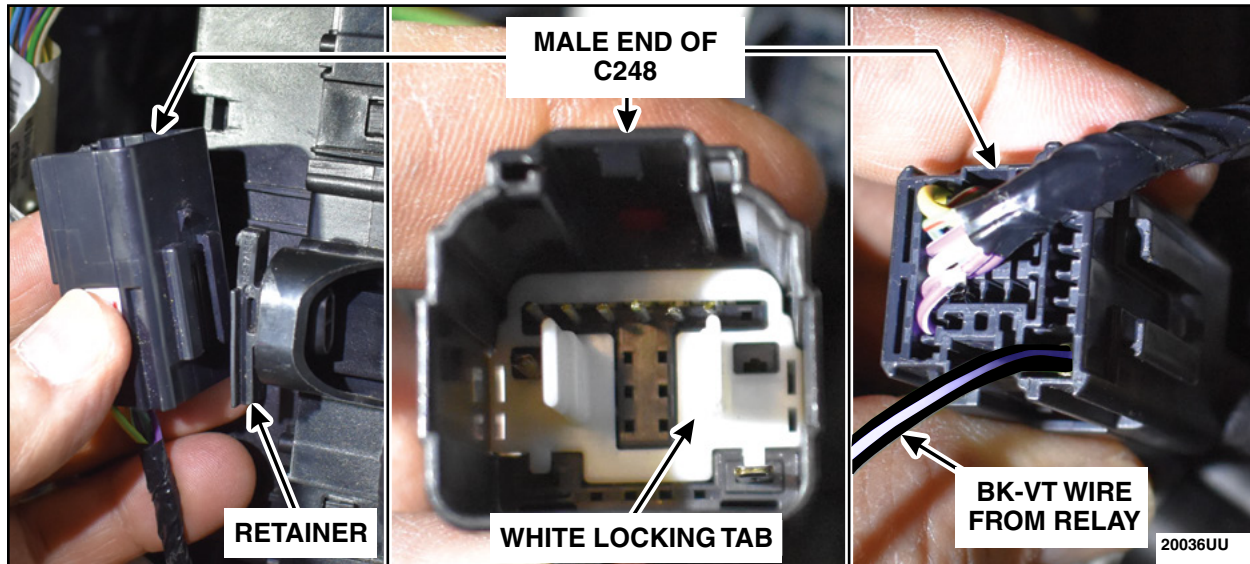
FIGURE 47

64. Detach the male end of C248 from the BCM retainer. Remove the white locking tab and install the BK-VT wire from the relay into Pin 21 for a black connector or pin 2 for a grey connector. Reinstall the white locking tab, attach C248 to the BCM retainer and reconnect C248. See Figure 47.
