SUBJECT: **Customer Satisfaction Program 21M05 - Supplement # 1**
Certain 2017-2022 Model Year Super Duty Vehicles Equipped with a Power Release Tailgate - Unintended Tailgate Opening

REF : **Customer Satisfaction Program 21M05**
Dated May 20, 2022

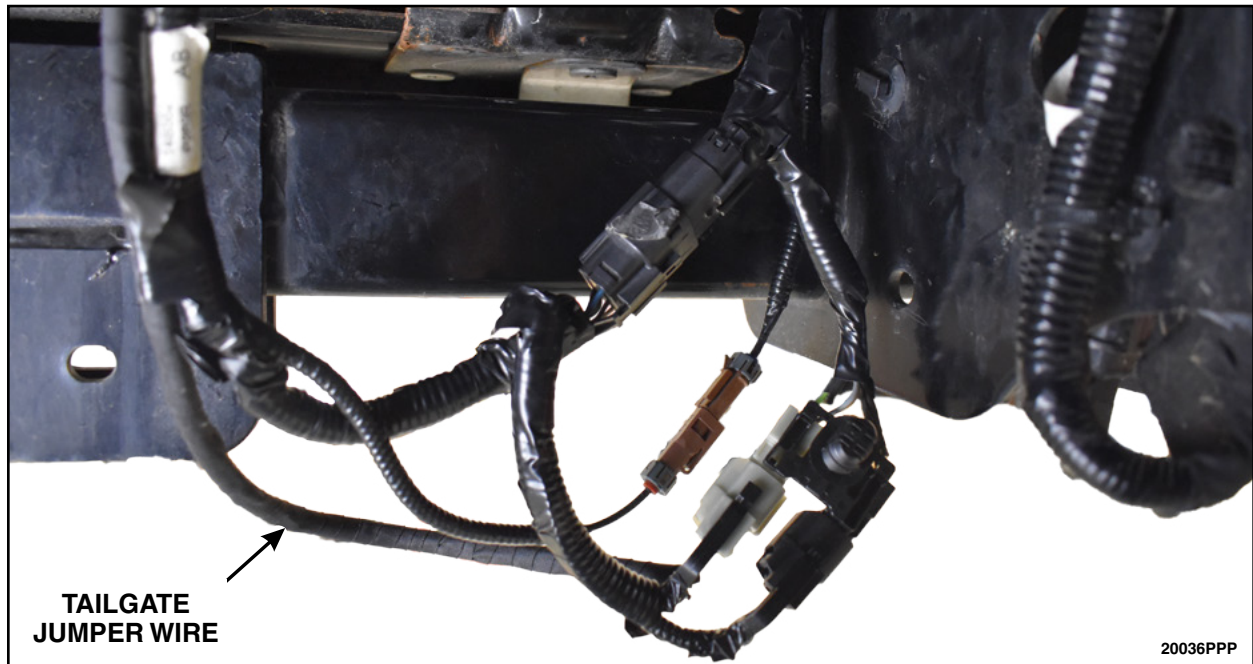
FIGURE 73

97. Position back the convolute and wrap any exposed wires on the harness with black electrical tape.
See Figure 73.

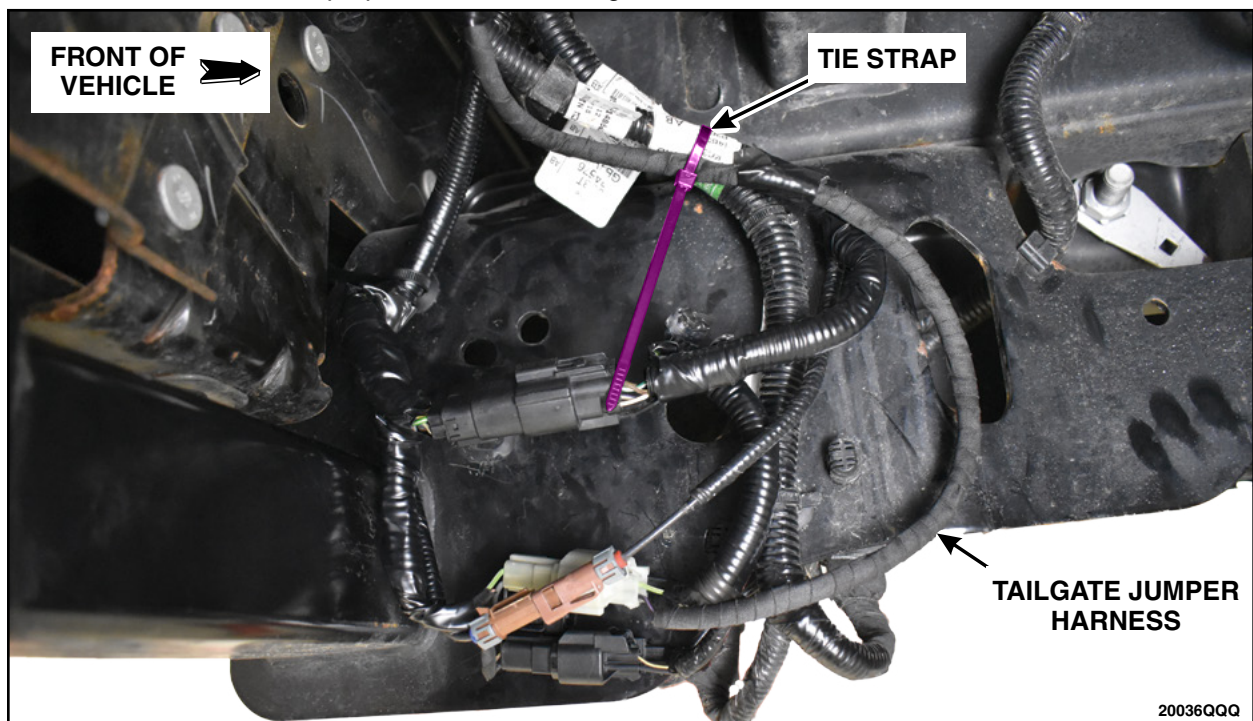
FIGURE 74

98. Secure the tailgate jumper harness using a tie strap then cut the excess length of the tie strap. Return the connectors into the proper locations. See Figures 74 and 75.
