MODEL
2020-2021MY
Soul (SK3)
2021MY
Seltos (SP2)

NUMBER
227 (Rev 2, 07/14/2022)

TECHNICAL SERVICE BULLETIN

**SERVICE ACTION: MIL ON DTC P0605 AND/OR P2181
ECM LOGIC IMPROVEMENT (SA463)**

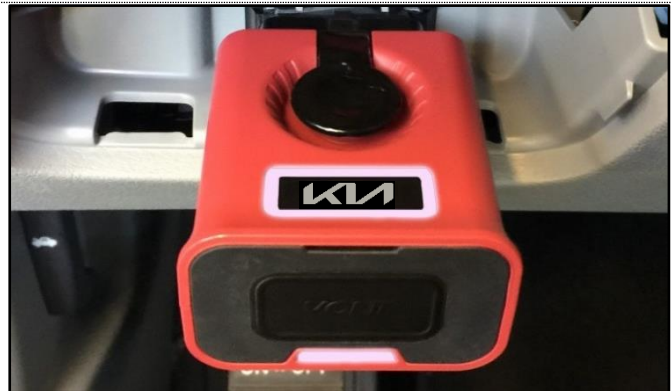
1. Connect the VCI-II to the OBD-II connector, located under the driver's side of the instrument panel.

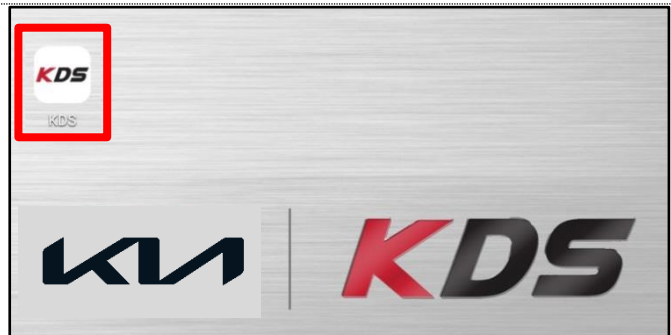
2. With the ignition ON, turn ON the KDS tablet. Select **KDS** from the home screen.

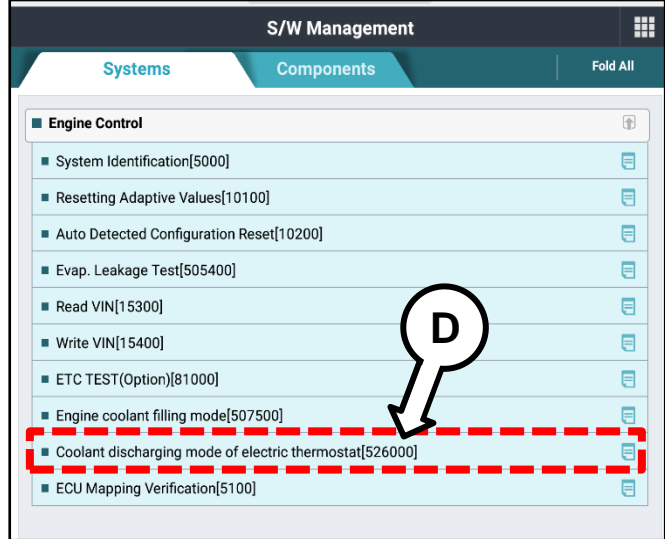
2. From the Systems / Engine Control menu, select 'Coolant Discharging Mode of Electric Thermostat' (D).

*** NOTICE**
The KDS screenshot(s) shown are from a 2021MY Seltos (SP2). Your screens may be displayed slightly different.

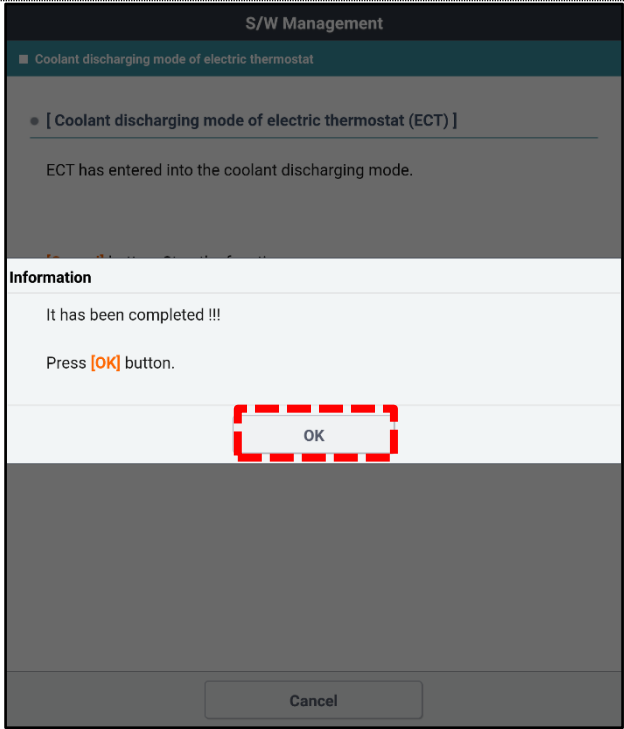
6. When the procedure is completed select **'OK'**.

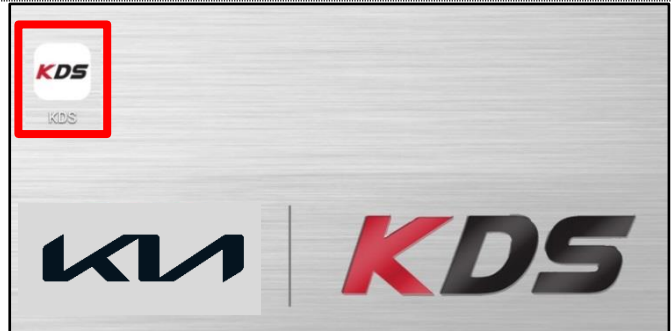
2. With the ignition ON, turn ON the KDS tablet. Select **KDS** from the home screen.

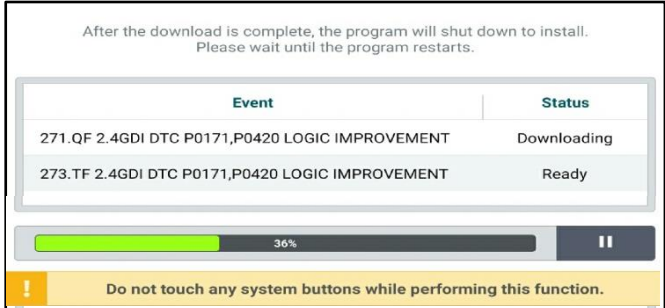
5. The KDS will check the server for recently uploaded Events and then automatically download **Upgrade Event**:

KDS screenshot shown above is for demonstration purposes only. Events shown in screenshot are not applicable to this bulletin.
