**SERVICE BULLETIN**

**APPLICABILITY:** 2022MY BRZ Models **NUMBER:** 15-297-22  
**SUBJECT:** Reprogramming File Availability for Optimization of Gen 4 Denso CP1 Infotainment Systems **DATE:** 07/01/22

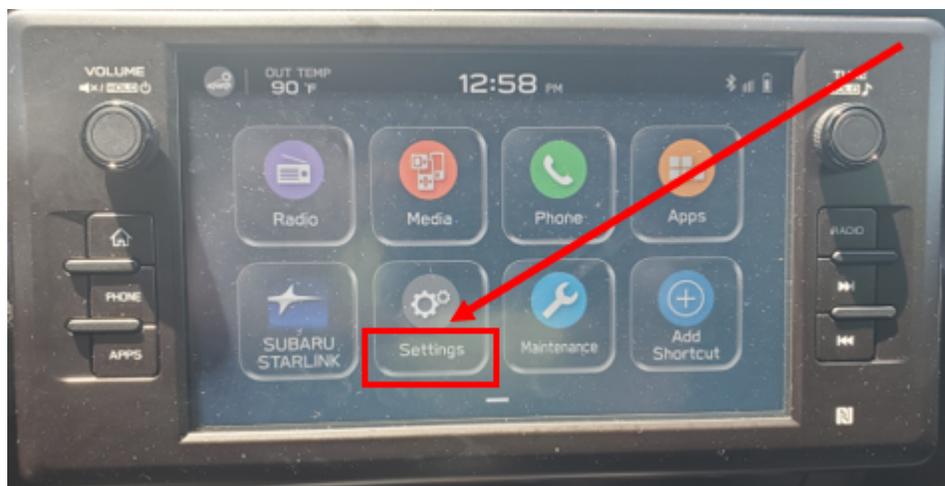
- 1a)** After starting the engine and system boot-up completes, from the HOME screen, touch the **Settings** button.

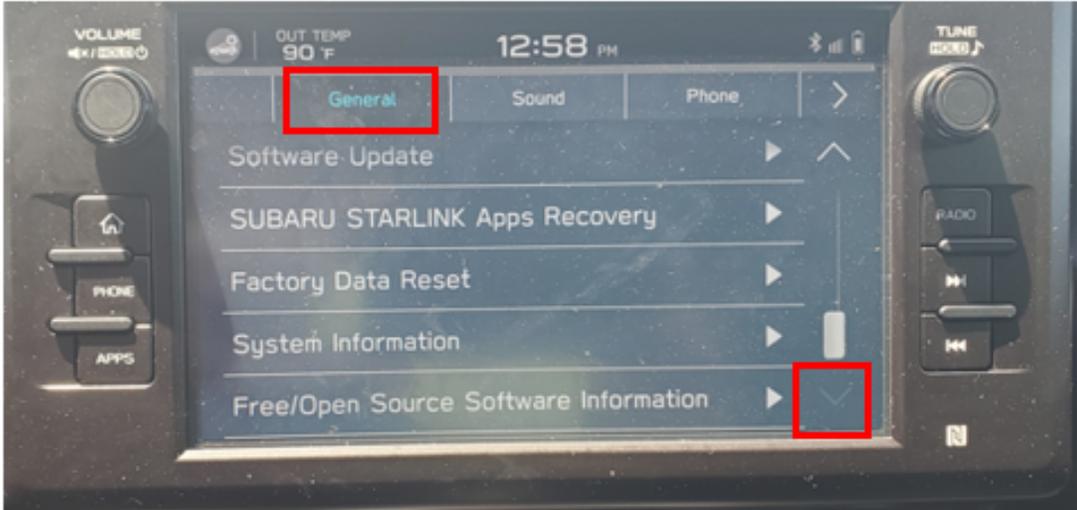
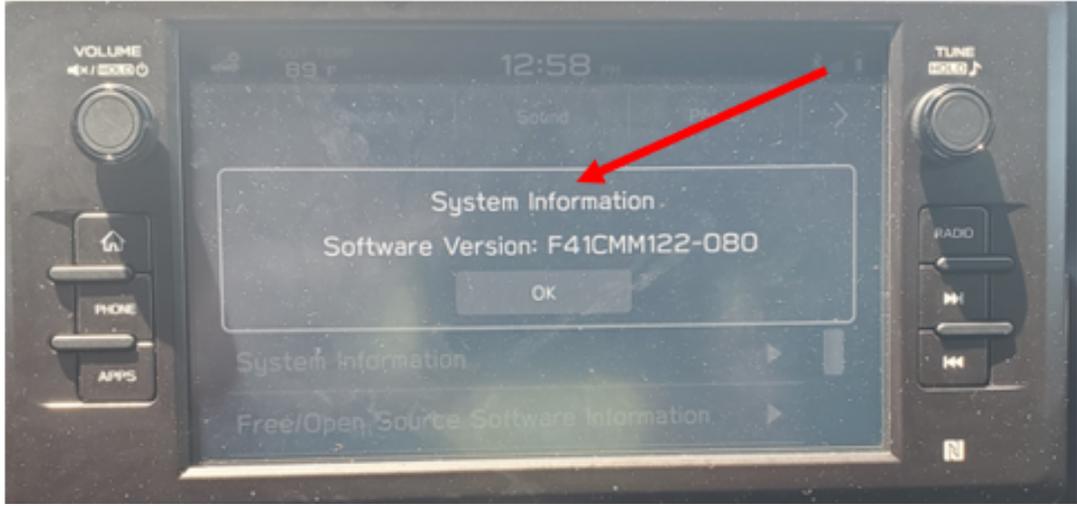
1b) Press the **General** button. Use the down arrow to scroll to **System Information** then press to display the System Information / Version information.

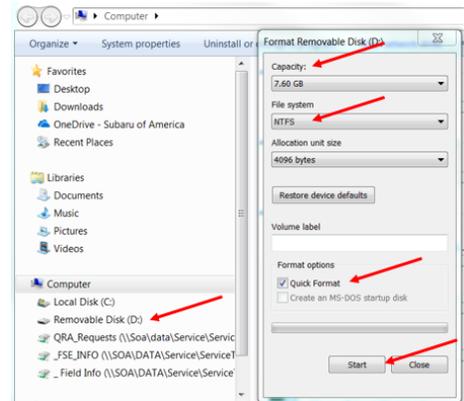
- Make sure the USB flash drive contains no other files.
- Right click on the corresponding “Removable Disk”.
- Select “Format”.
- From the File System drop-down menu, select “NTFS”
- Check the “Quick Format” box (if not already done).
- Click on “Start” to format the USB flash drive.

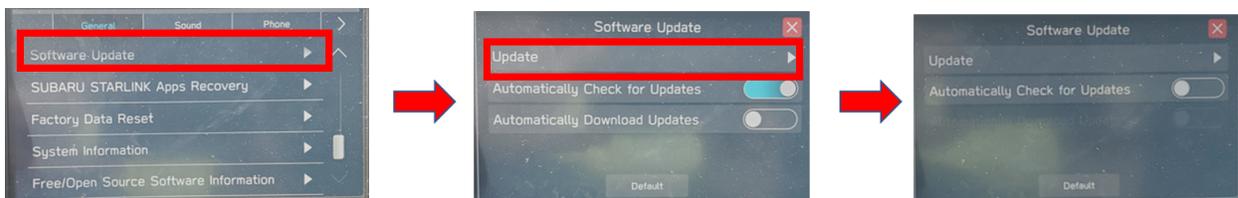
Best practice is to prevent USB software update conflicts with FOTA software update. Please confirm “Automatically Check for Update” setting is turned off following the steps below, prior to starting the software update via USB.

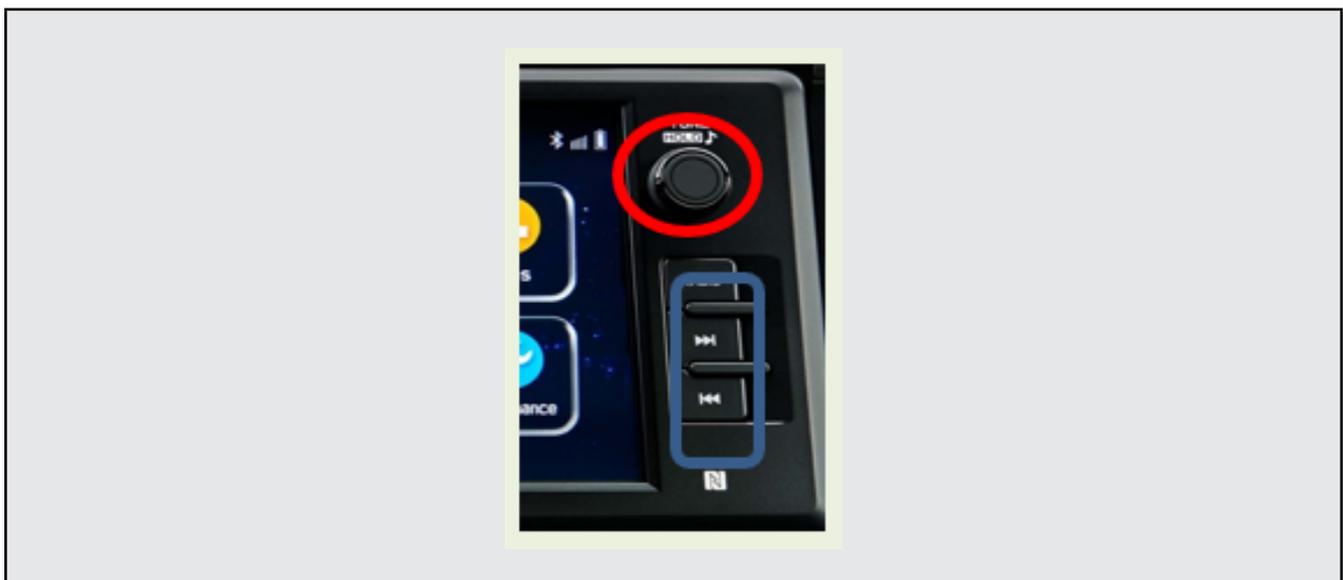
- 4b) How to check the software version. Push the TUNE knob six times while simultaneously pressing down on both sides of the SEEK switch to display the Dealership Mode Menu.

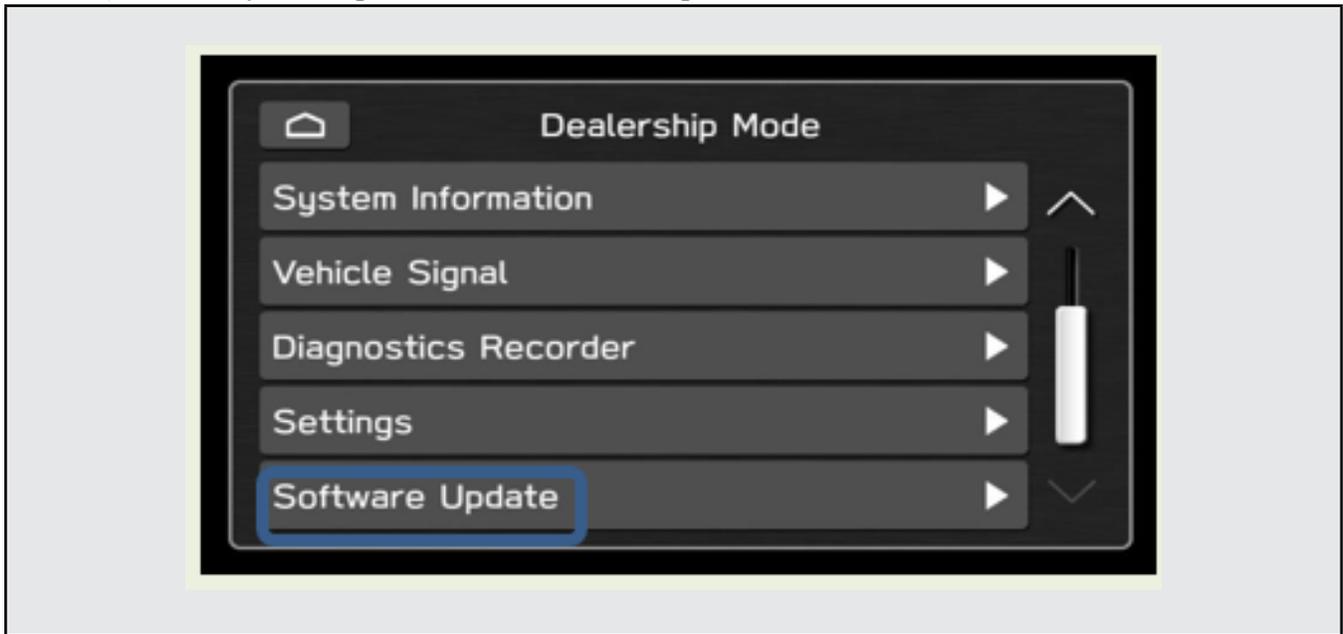
4c) Select System Update from the Dealership Mode Menu

1. Turn the ignition switch or the engine OFF, open the driver side door and close the door then wait for 3 minutes.
2. Open the driver side door then turn the ignition switch or the engine ON.
3. Go to Dealership Mode diagnostics then select Software Update as in STEP 4c.

**1-8. Go to Dealership Mode diagnostics then select Software Update as in STEP 4c.**

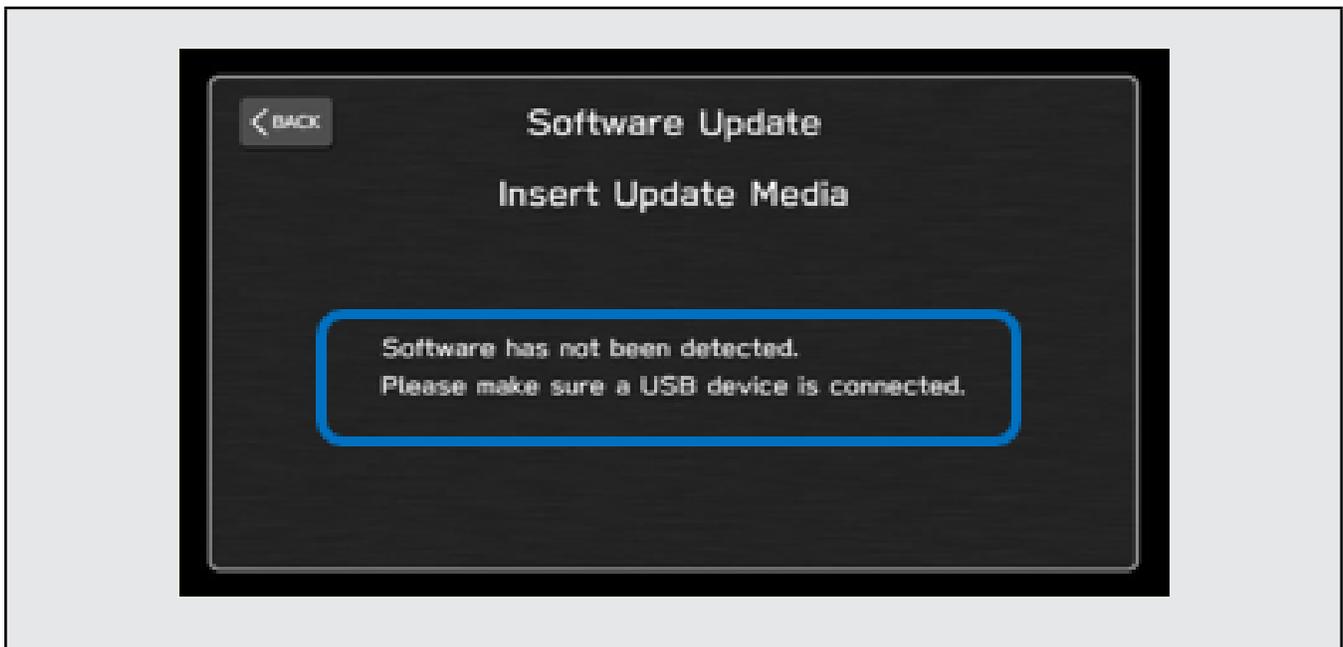
4d) The screen below will be displayed.

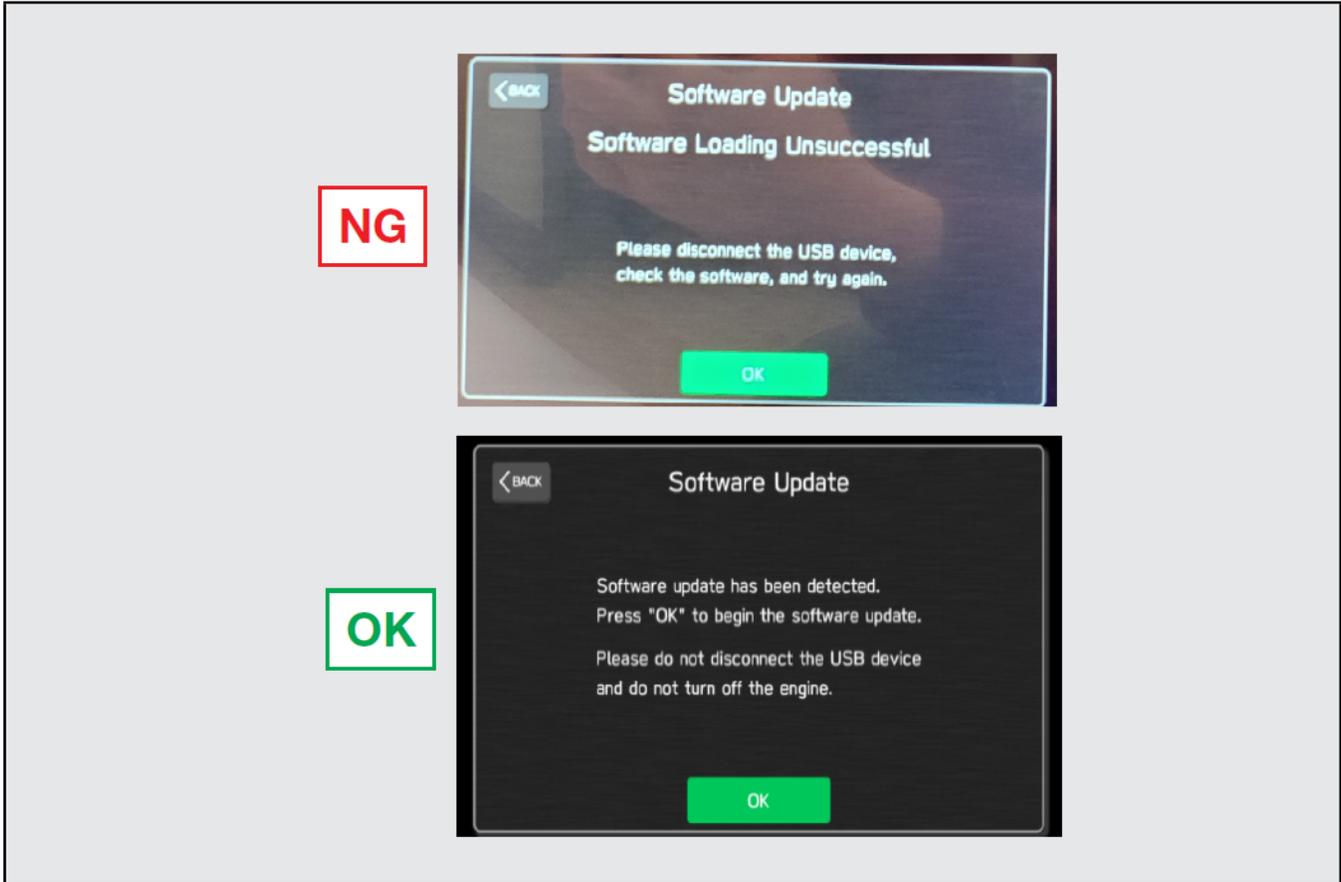
4e) Insert reprogramming USB into the USB port and press **OK**.

**NOTE:** If after plugging in the USB, the screen displays a **Software Loading Unsuccessful** message, confirm the USB device has been properly formatted and the the software on the device matches the system being reprogrammed and retry.

If you get the message Software Update Incomplete as shown below, please don't replace the hardware but retry updating the software according to the instructions in "Appendix B" on pg. 16.

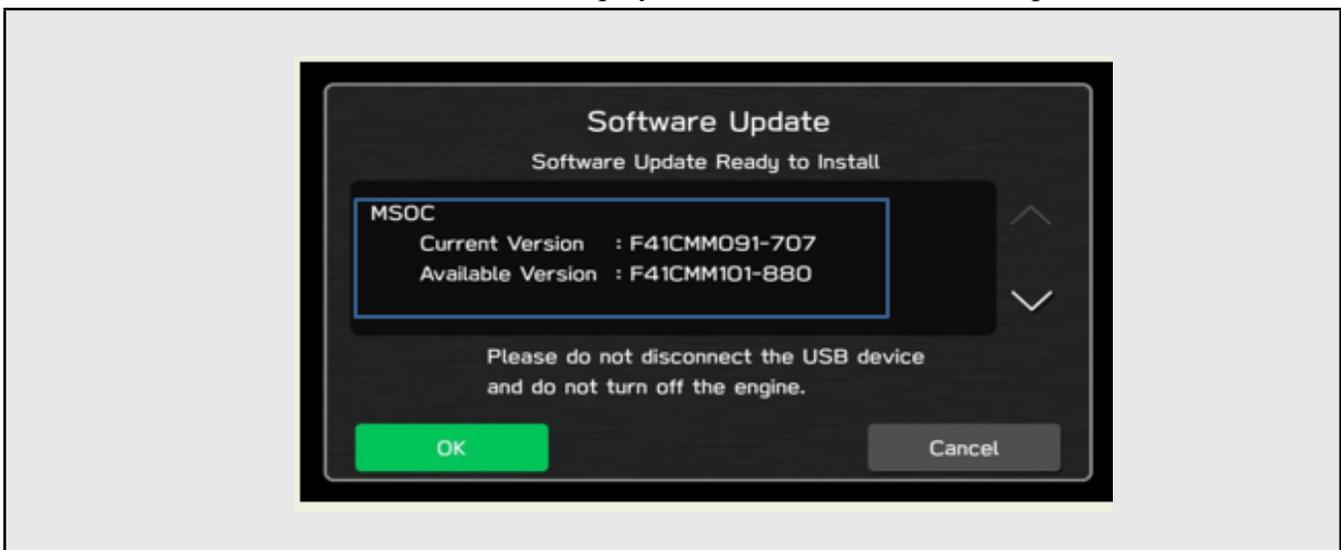
4f) The screen below will be displayed. Press **OK** to start the software update.

**NOTE:** The actual software version displayed will be different from the picture shown below.

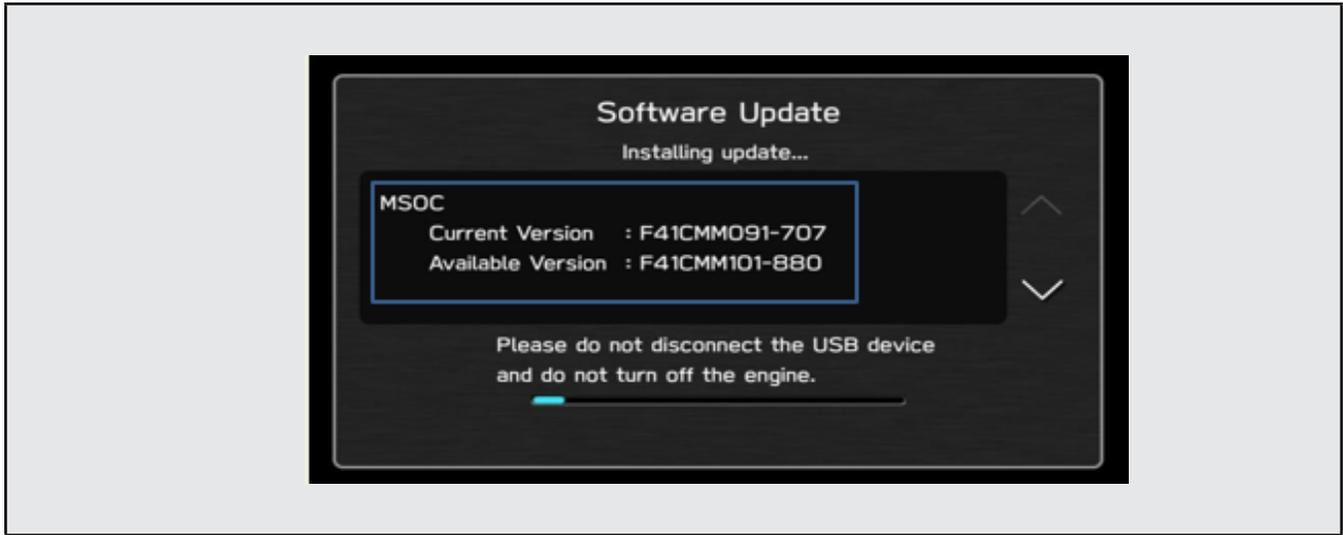
4g) Once the update begins, the screen below will be displayed with a progress bar. It takes about 15 to 20 minutes for the update to complete.

**VERY IMPORTANT:** NEVER turn off the ignition while the software update is in process.

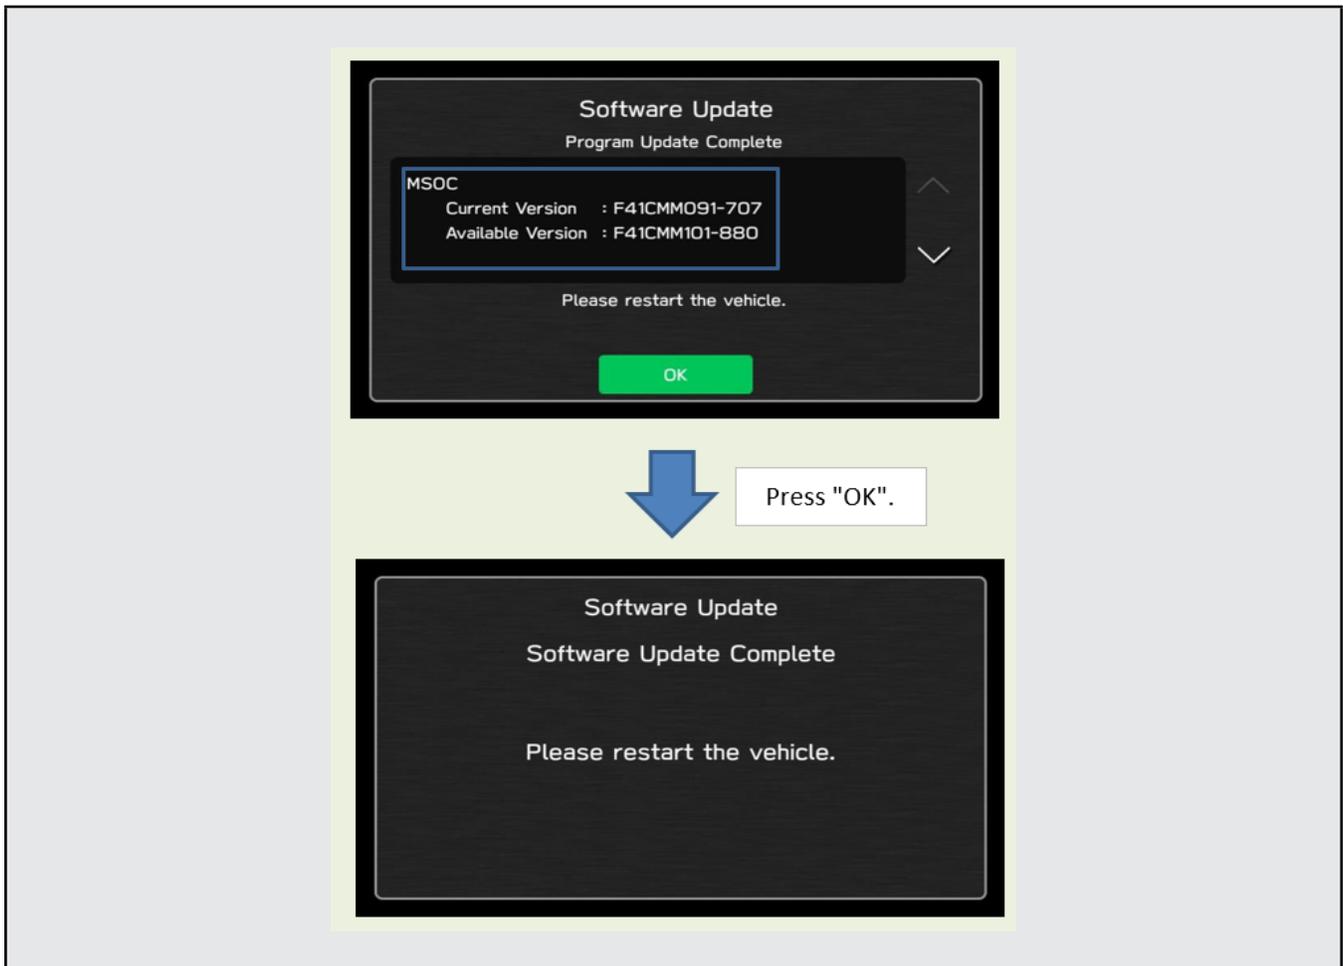
4h) When the software update is complete, the following screen will be displayed (the actual software version will be different).

On a rare occasions a “Software Update Incomplete” message may appear in this step which occurs due to a bug in the software update procedure. Proceed to Step 4i below to confirm the software version has been updated to the latest version.

- 4i) Select **OK** in the screen above then remove the H/U reprogramming USB from the USB port.
- 4j) Turn the Ignition OFF, open the driver’s door then close the driver’s door.
- 4k) Wait for **3 minutes**, then turn the ignition ON.
- 4l) Access Dealership Mode following steps provided item **4b** and using the tables below, confirm the software update completed successfully.

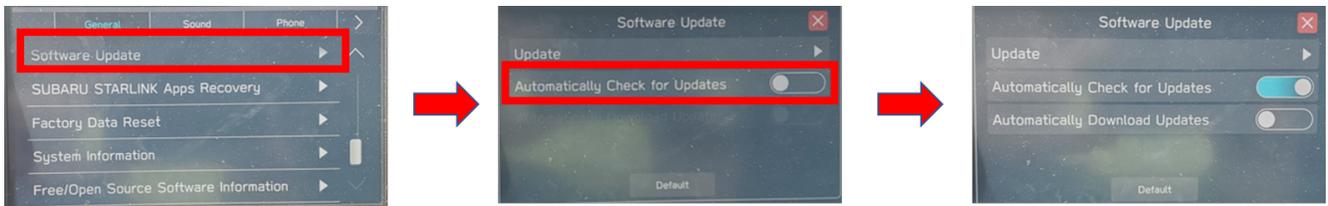
4m) Enable the setting “Automatically Check for Updates” as shown in the steps below.

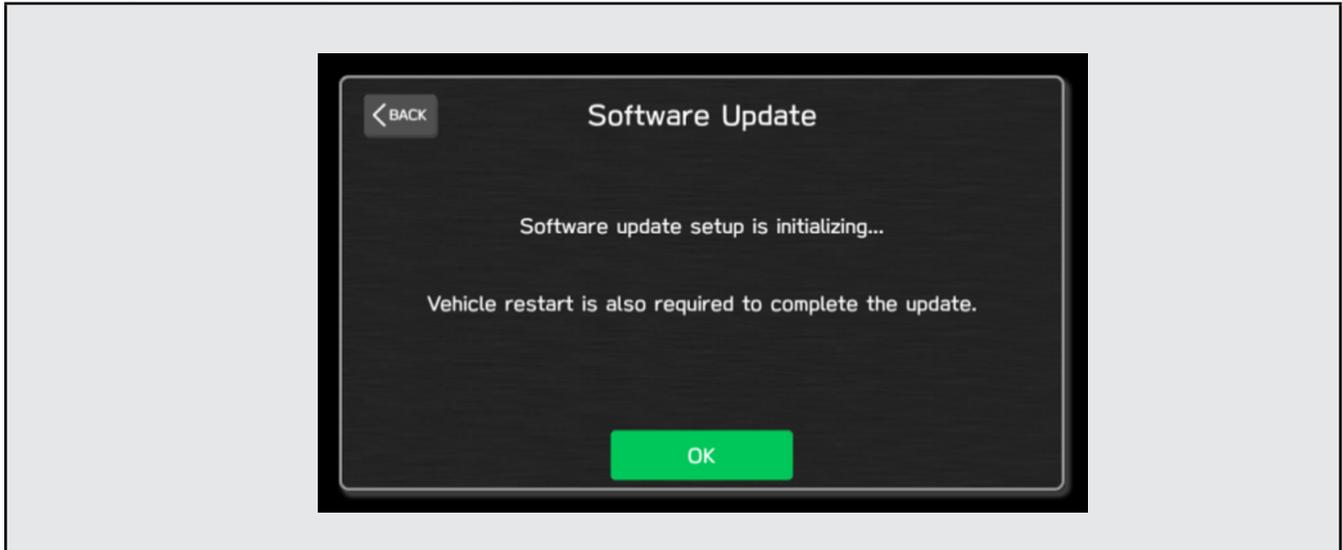
- If the screen shown below appears, **WAIT** for approximately 30 minutes or as long as necessary (waiting for longer than 60 minutes might indicate system malfunction). In that case please perform recovery according to the instructions in “Appendix B ” to allow the Software update setup initialization process to complete.

**IMPORTANT NOTE:** On a RARE occasion, the message “Software update setup is initializing...” may be displayed. Should this occur, proceed to “**Appendix A**” starting on pg. 15 of this bulletin for further instruction.

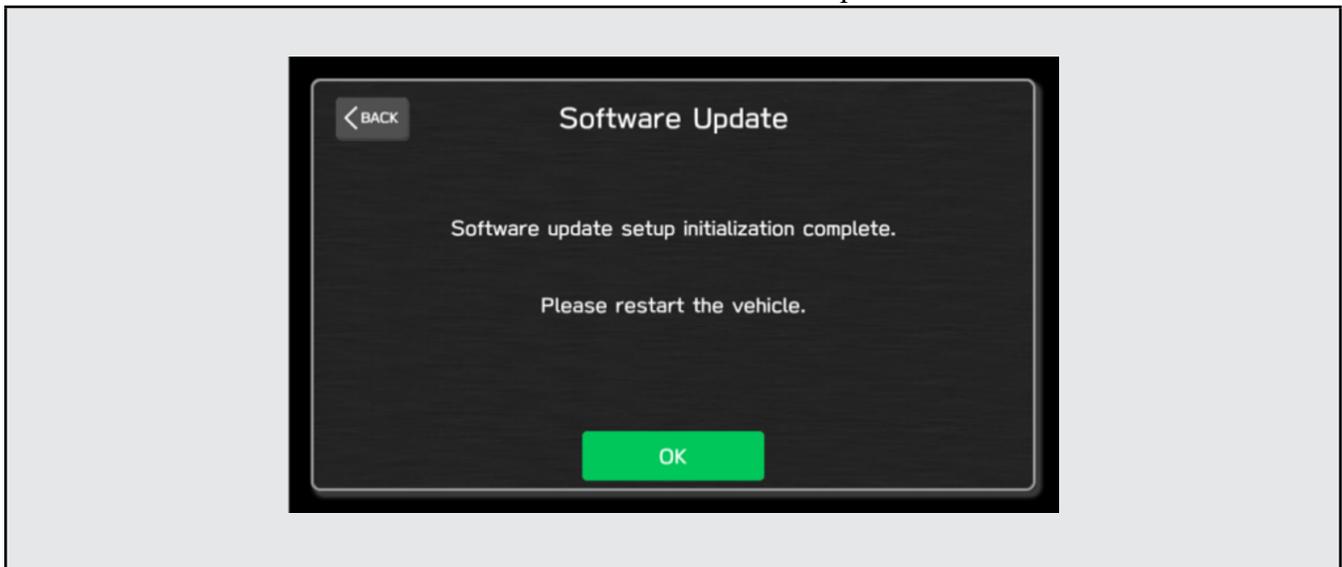
- You will see the screen below when the initialization is complete.

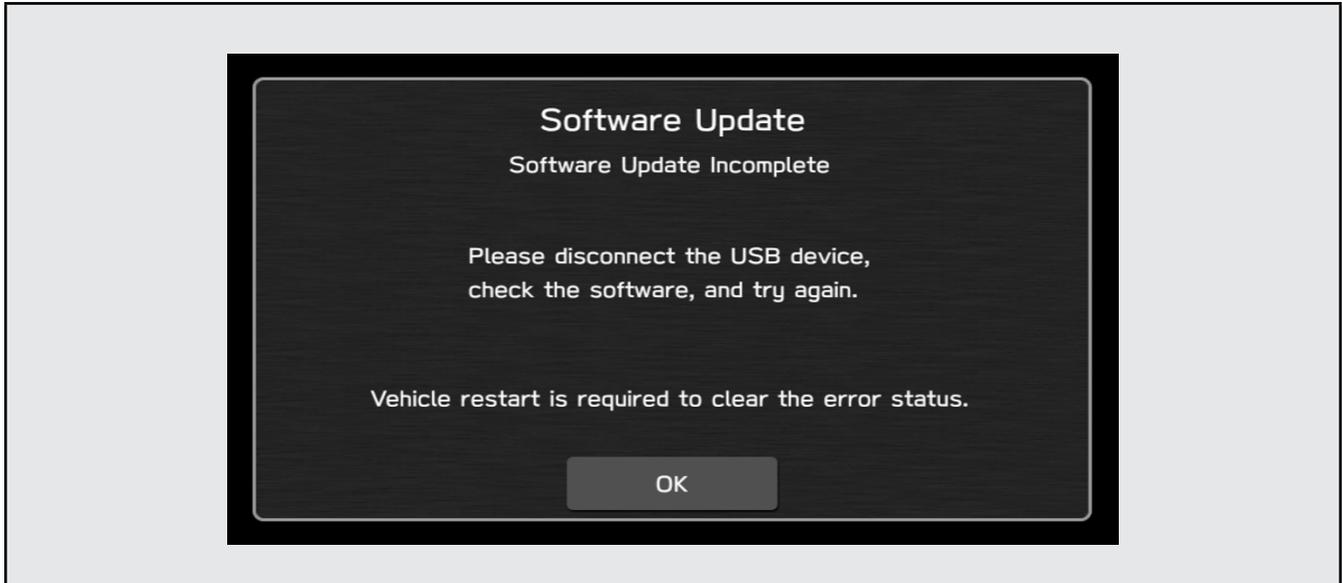
### 1-1. Select OK in the screen below

- If the first attempt of update fails with the message below, please perform procedures 1-2 to 1-8 before retrying the software update.

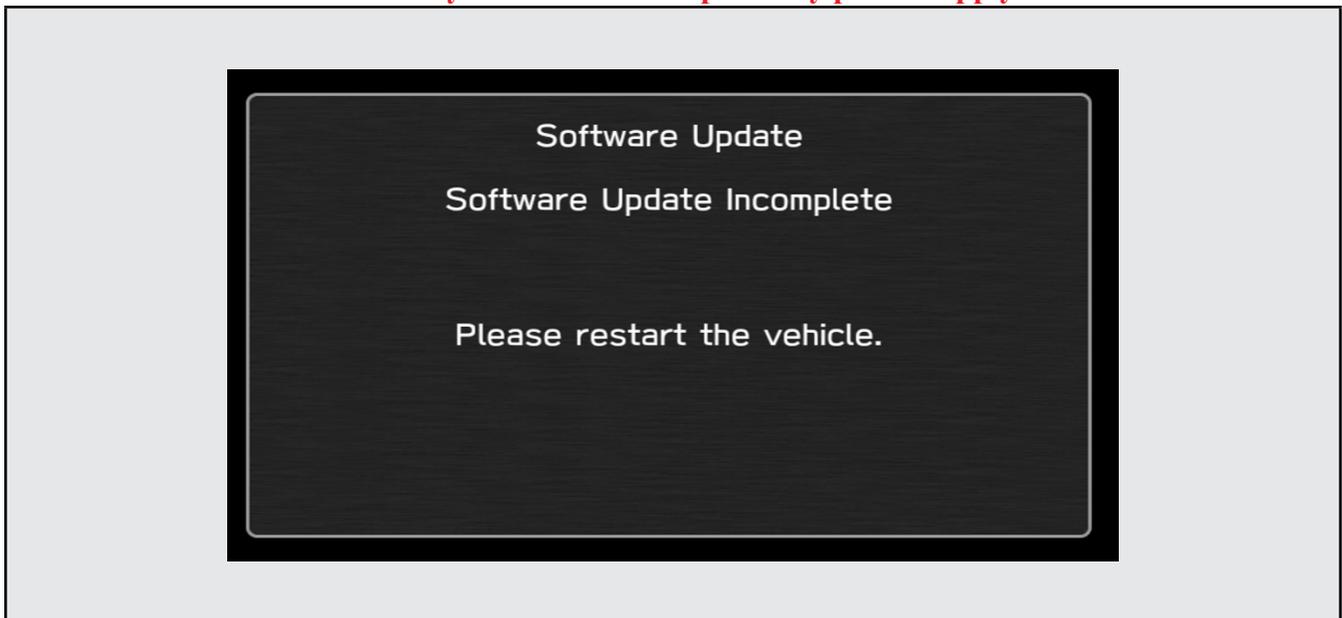
### 1-2. Turn the ignition switch or the engine OFF, and turn it ON again.

**Caution: Do not remove battery terminal and keep battery power supply.**

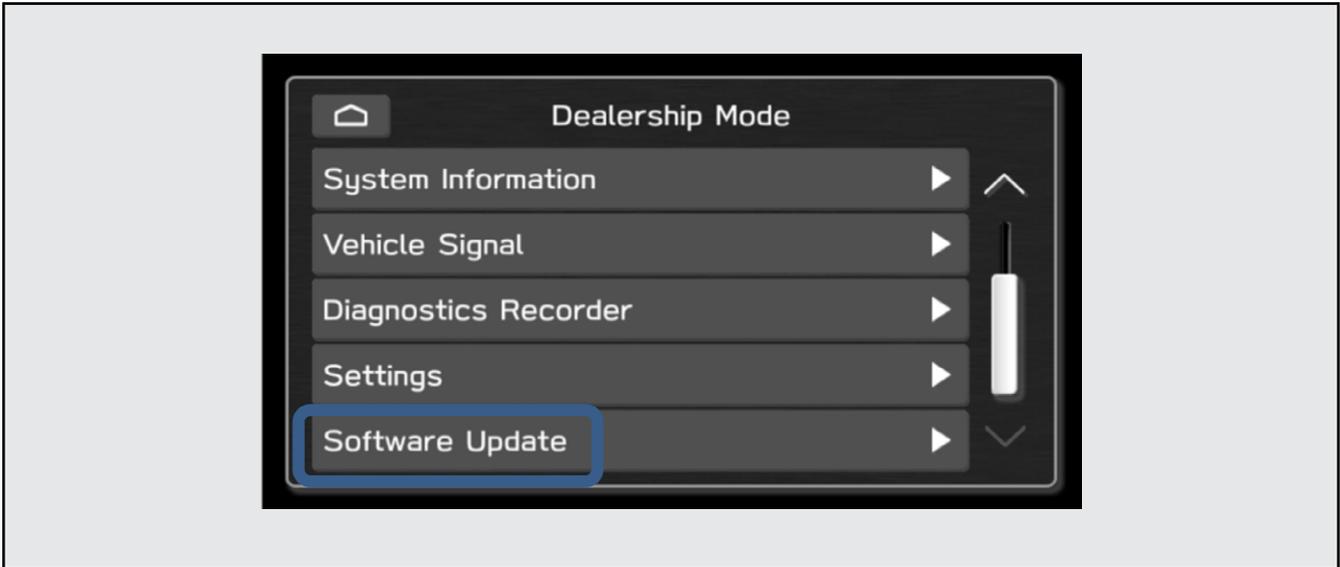
**1-3. Select Software Update in the Dealership Mode diagnostics screen.**

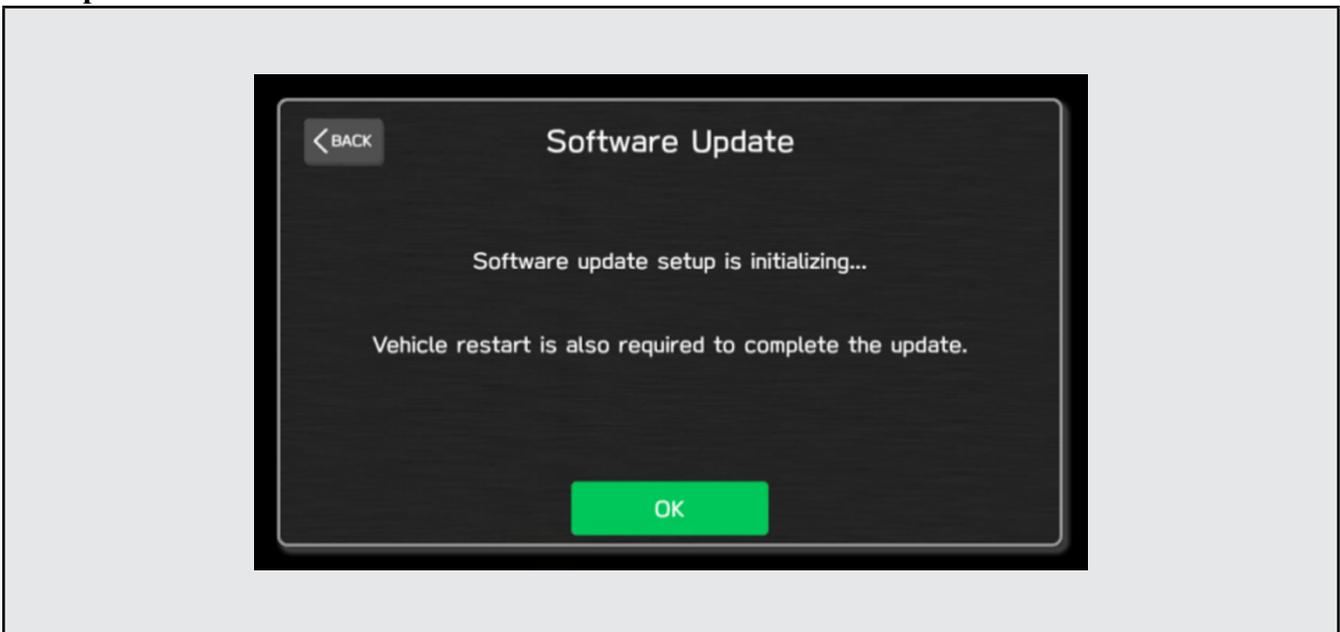
**1-4. When you see the screen below, wait for approx. 15 minutes until the initialization is complete**

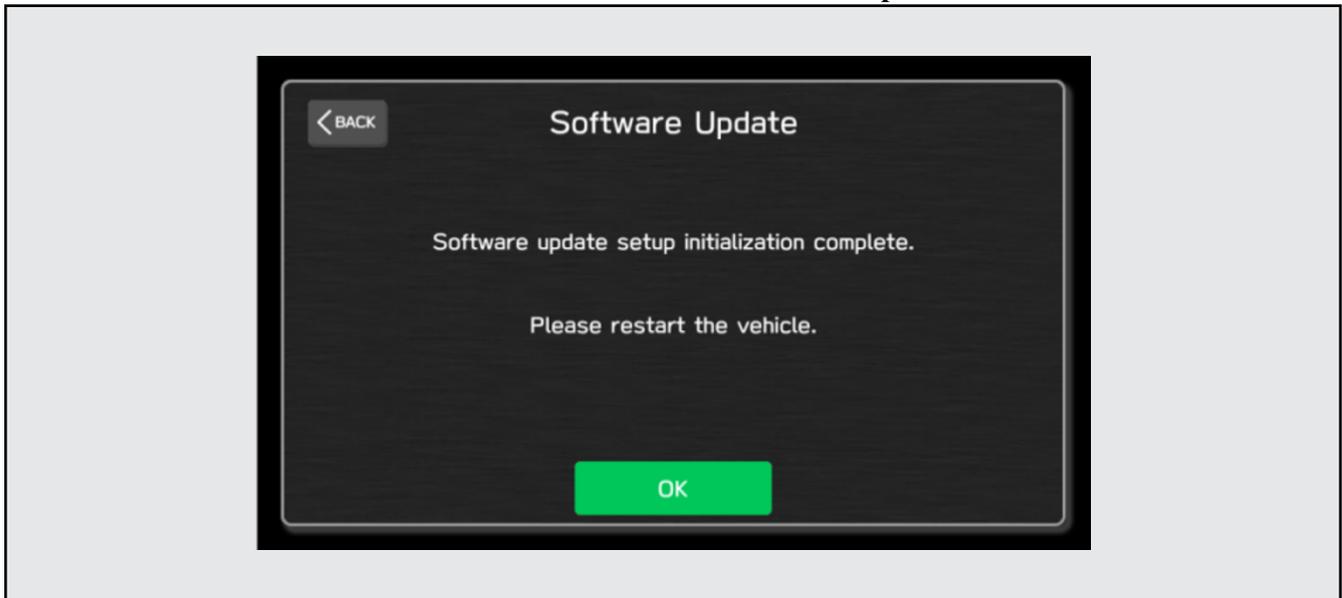
**1-5. You will see the screen below when the initialization is complete.**

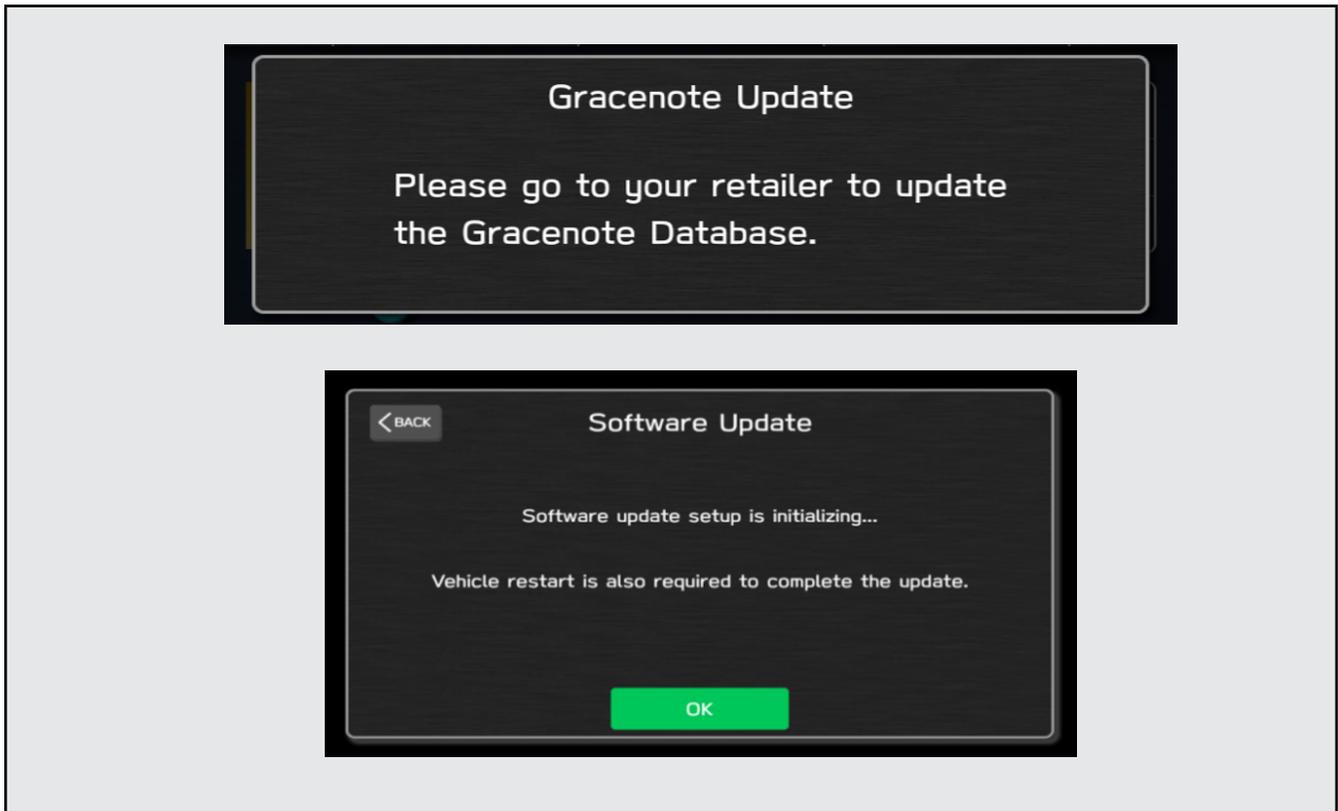
In case the Gracernote update popup screen appears or software initializing screen does not go away for more than 20 minutes, please perform procedures 2-1 to 2-11.

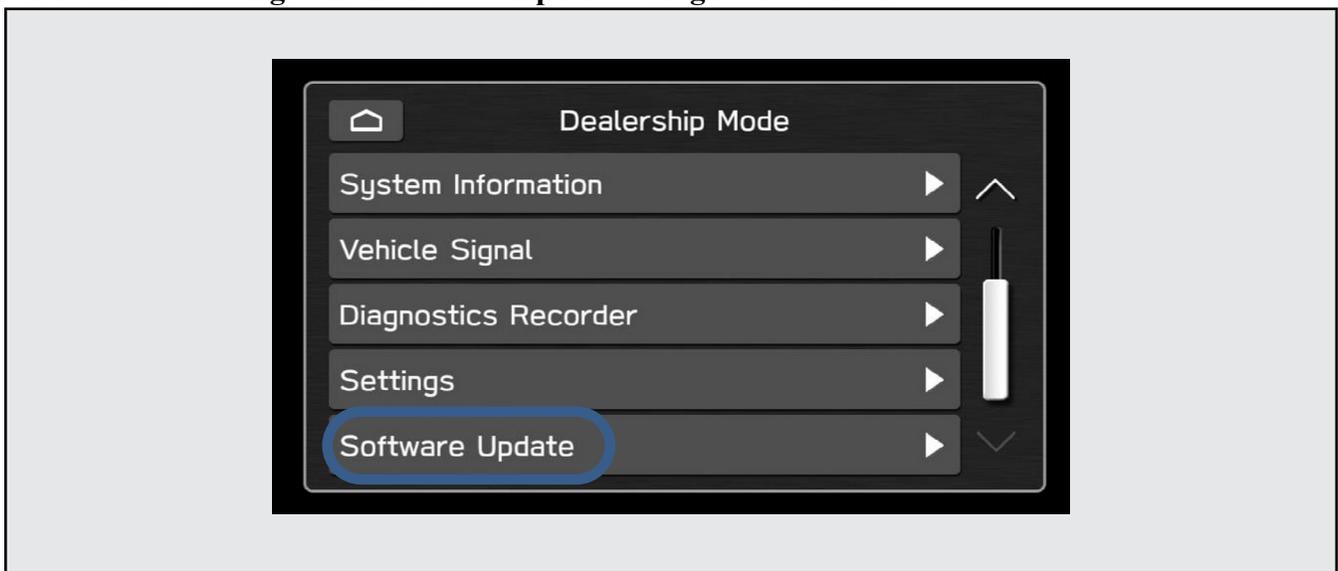
2-1. Select “Settings” in the Dealership Mode diagnostics screen.

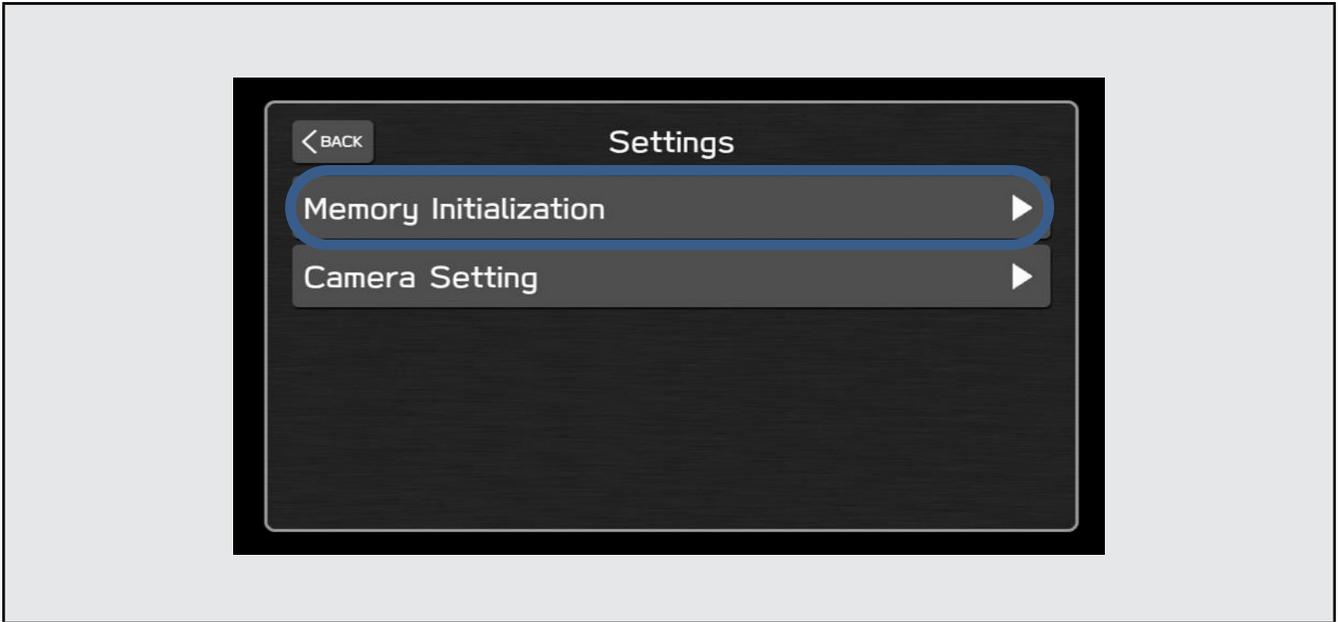
**2-2. Select “Memory Initialization”**

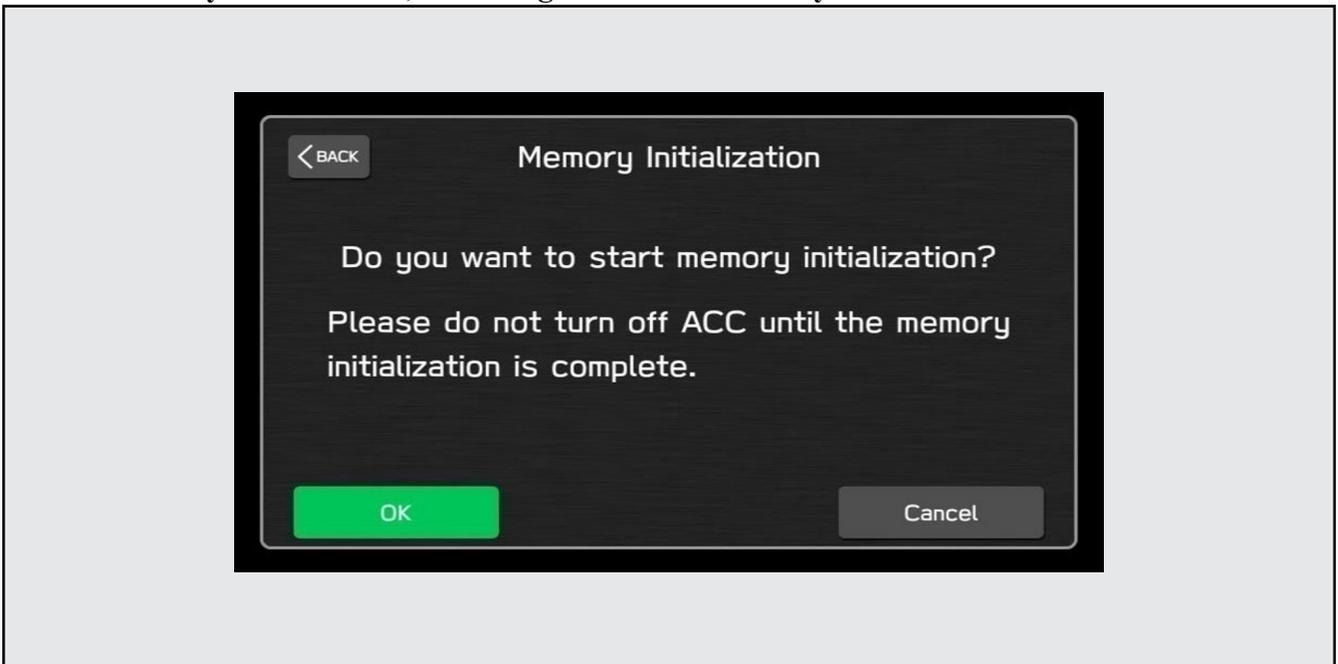
**2-3. Select “OK”**

**After Memory Initialization, all settings are reset to factory default.**

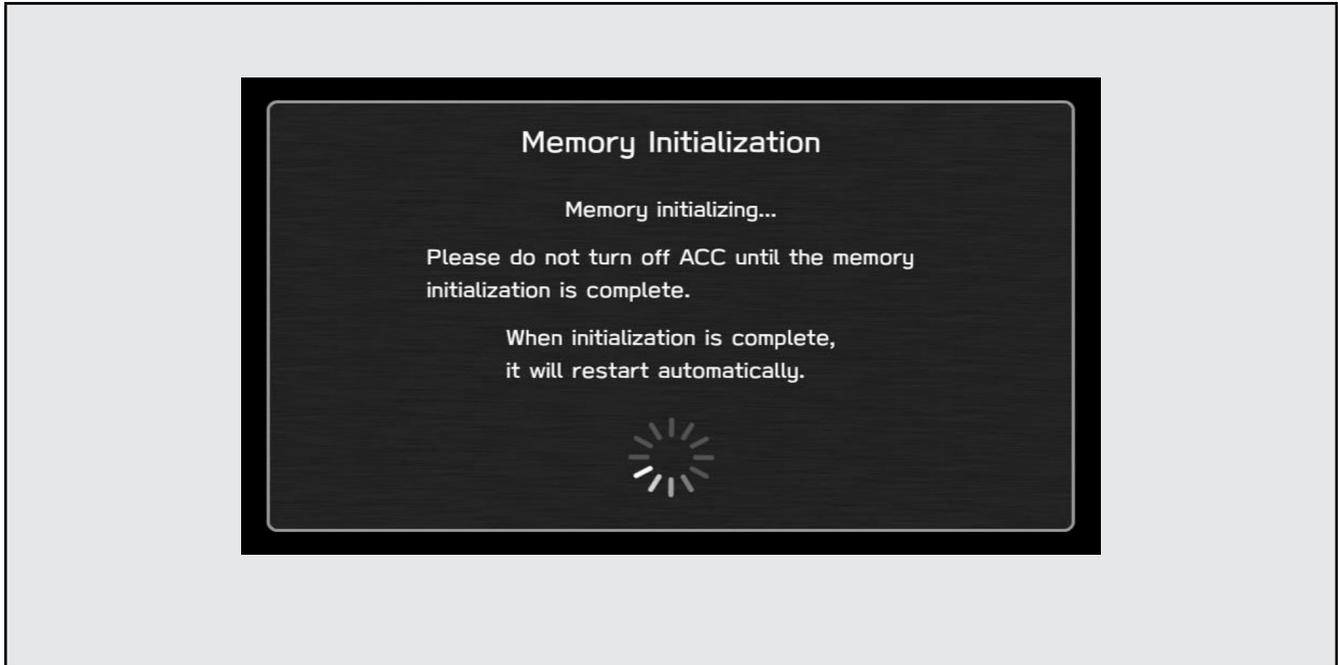
**2-4. You will see the following screen**

**2-5. After a few seconds, system restarts itself.**

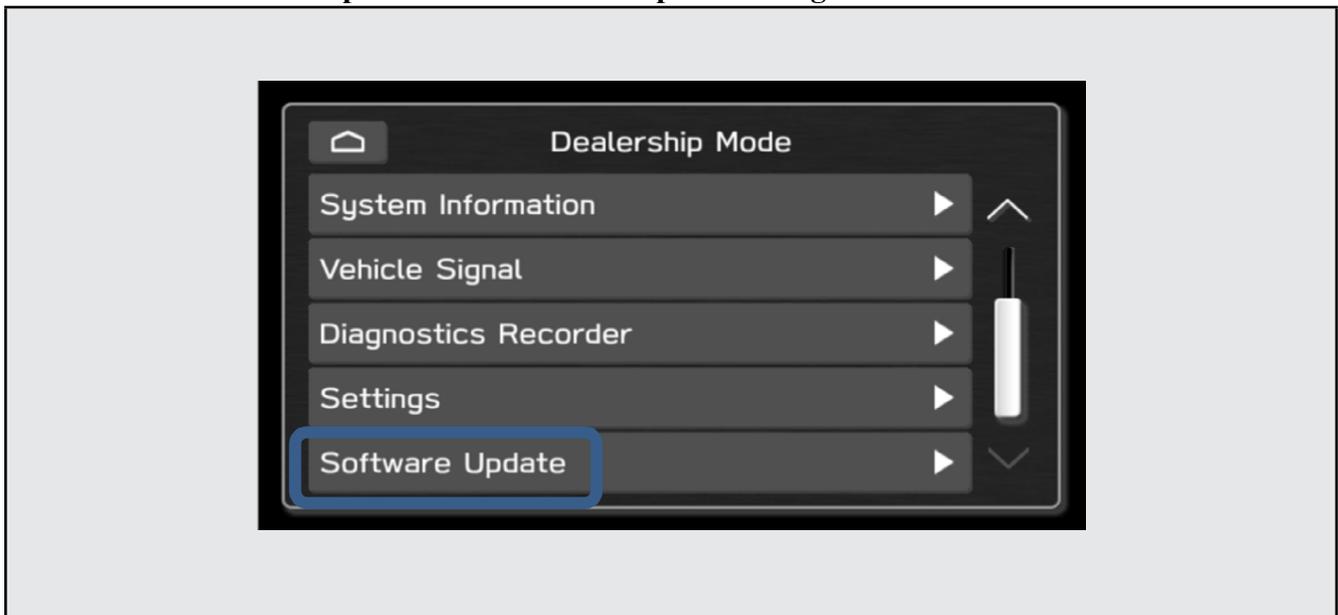
**2-6. Select "Software Update" in the Dealership Mode diagnostics screen.**

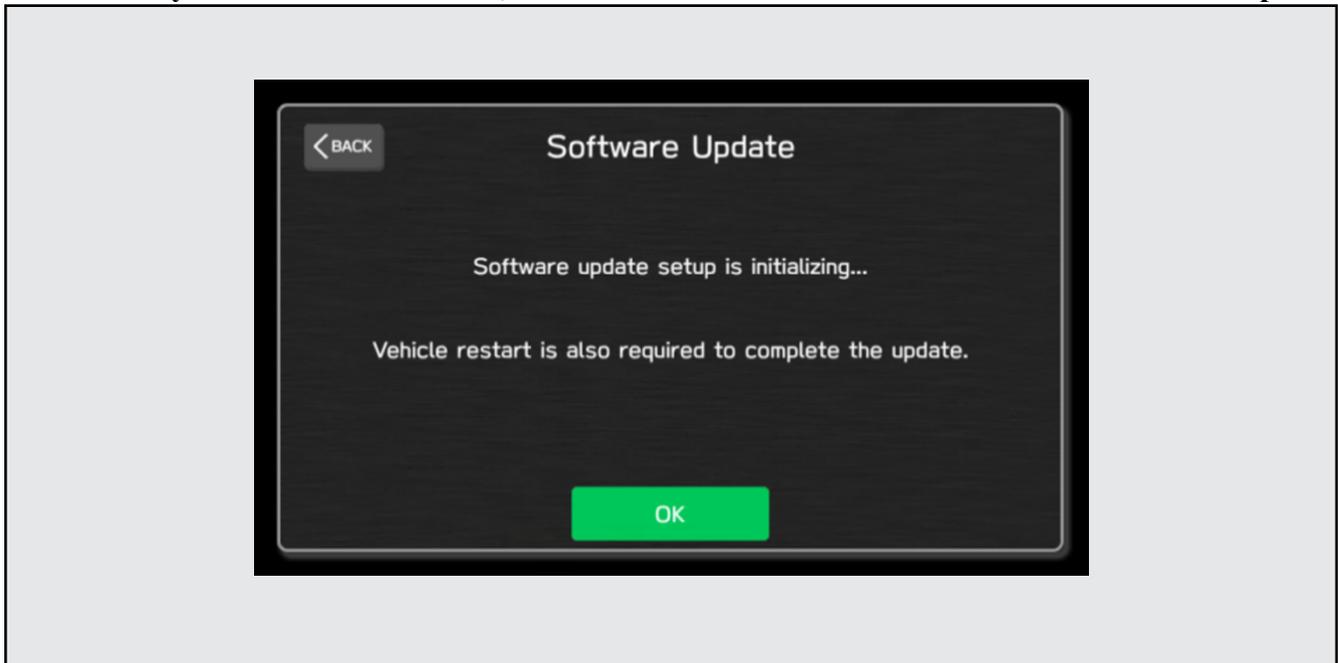
**2-7. When you see the screen below, wait for about 15 minutes until the initialization is complete**

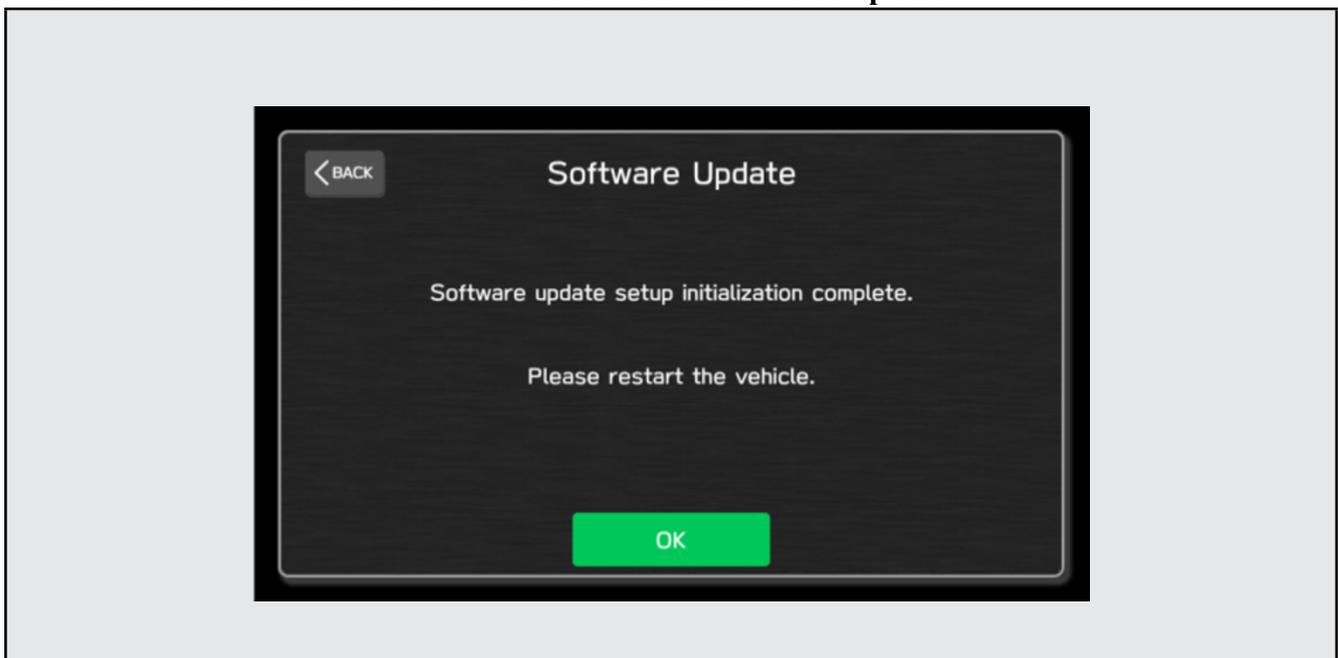
**2-8. You will see the screen below when the initialization is complete.**
